Michael A. Berardi
Director
Service Engineering Operations
Ford Customer Service Division

SUBJECT: **Customer Satisfaction Program 12M02 - Supplement #2**
Certain 2011-2014 Model Year Vehicles Equipped with SYNC[®] and MyFord/MyLincoln Touch[™]
Warranty Extension Covering Accessory Protocol Interface Module (APIM) Software and Hardware

Certain 2011-2014 Model Year Vehicles Equipped with SYNC[®] and MyFord/MyLincoln Touch[™]
Application Performance Upgrade

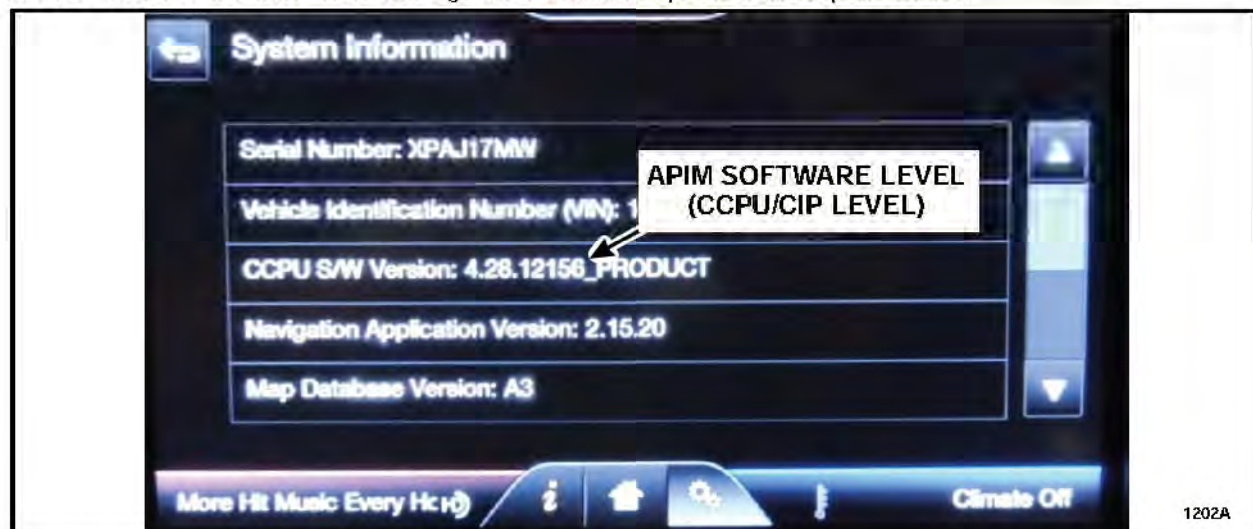
FIGURE 1

1. Determine the vehicle's current Accessory Protocol Interface Module (APIM) software level (CCPU/CIP level). See Figure 1.
 - a. On the Front Display Interface Module (FDIM), select "Menu" then select "Help".
 - b. Select "System Information".
 - c. Note the last five digits of the CCPU/CIP#. See Figure 1.

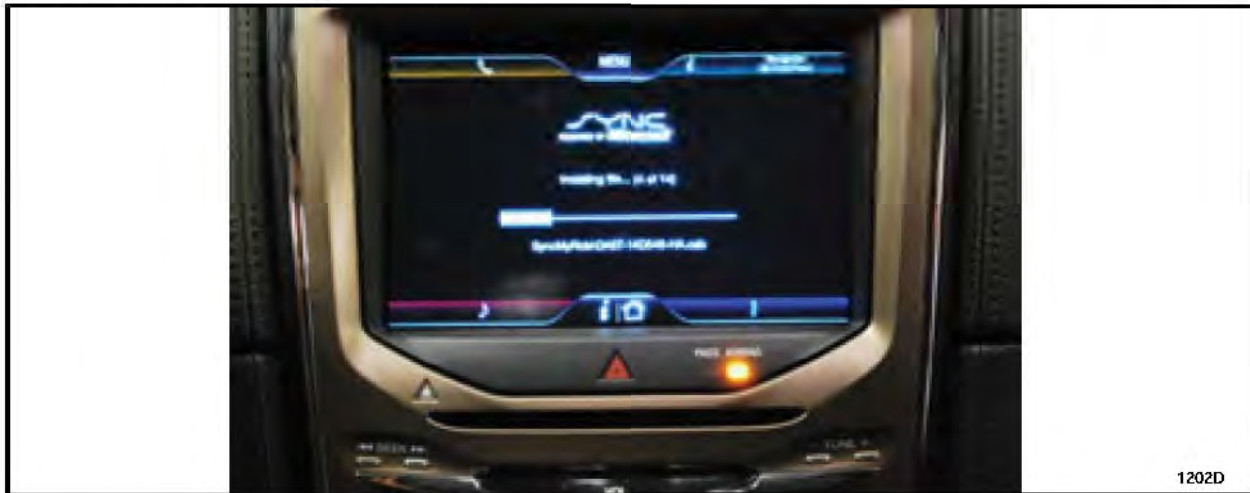
FIGURE 3

5. During the reprogramming process a series of screens may appear and/or the system will reboot with a blank screen. See Figures 3, 4, and 5.

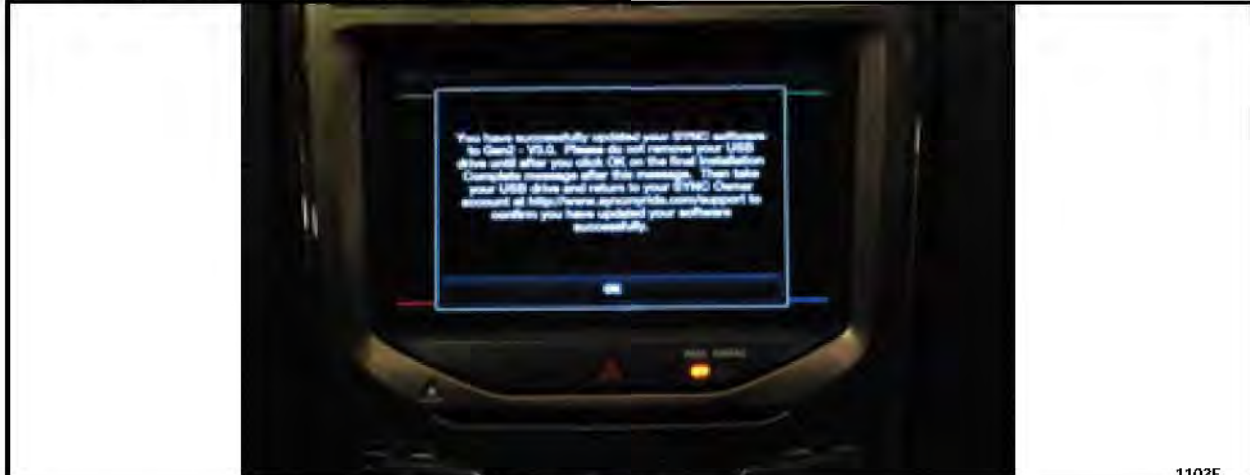
FIGURE 6

6. When the programming is completed, a screen stating the software update was successful will appear, tap "OK". See Figure 6.

- **DO NOT** remove the USB flash drive.

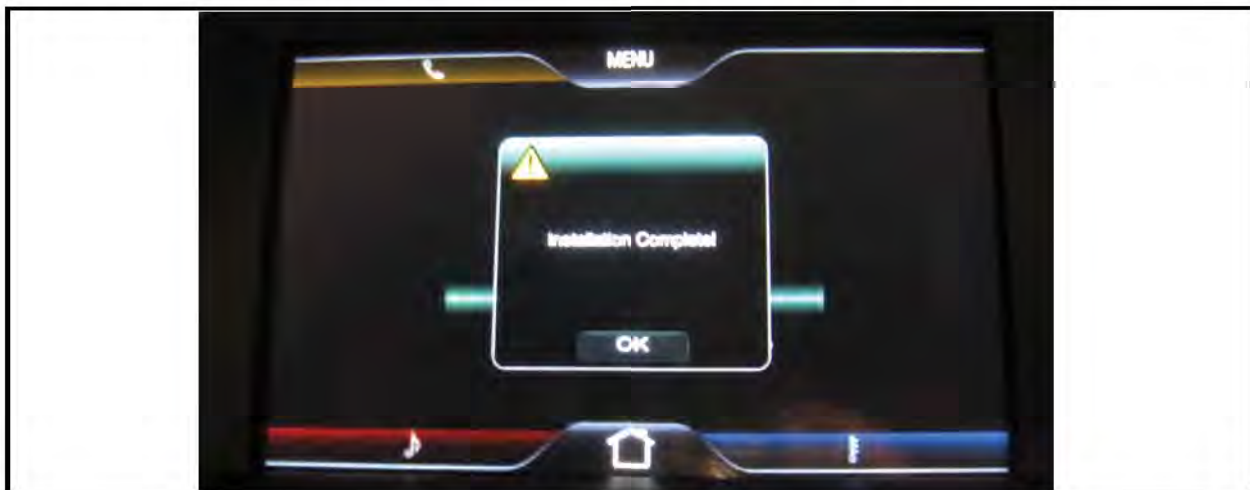
FIGURE 7

7. When the "Installation Complete!" screen appears tap "OK". See Figure 7.

NOTE: The entire upgrade is complete when you see an "Installation Complete!" message and you press "OK" on the center screen or when the home screen appears.
