Service Bulletin

SUBJECT: Special Coverage Adjustment – Loss of Power Steering Assist

**MODELS: 2008-2011 Buick Enclave
2009-2011 Chevrolet Traverse
2007-2011 GMC Acadia
2007-2010 Saturn OUTLOOK**

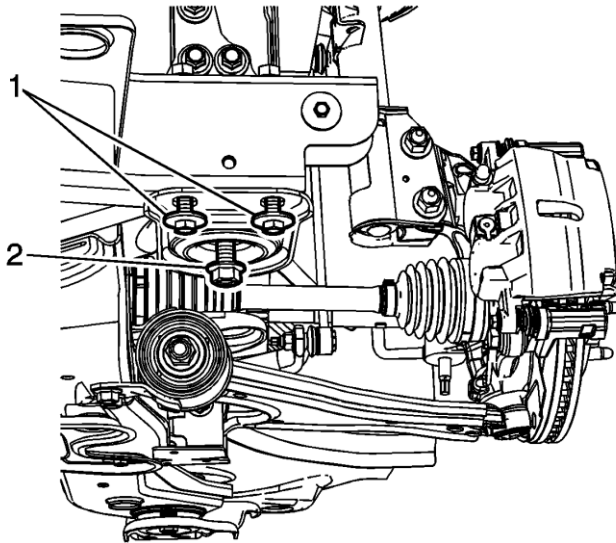
1856458

13. Loosen the front frame reinforcement mounting bolts (1). The left side is shown. The right side is similar.
14. Loosen the front frame mounting bolts (2). The left side is shown. The right side is similar.

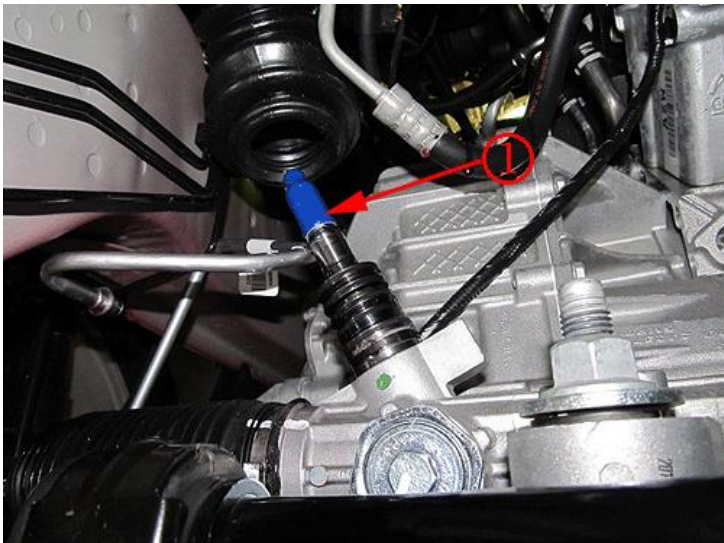
2691992

31. Install the blue seal protector (1) provided in kit onto the steering gear pinion shaft to prevent damage to the seal when installing the housing.
32. Install the new steering gear housing and bolts to the steering gear. Remove the seal protector.
