Subject: TPMS WARNING LIGHT ON	Bulletin No: 02-002/15
	Last Issued: 05/13/2015

2014-2015 Mazda6 vehicles (except Canada and Mexico) with VINs between JM1 GJ1 ***** 100027-225009 (produced between October 25, 2012 - December 01, 2014)

2016 Mazda6 vehicles with VINs between JM1 GJ1 ***** 400011-412885 (produced between November 24, 2014 - February 11, 2015)

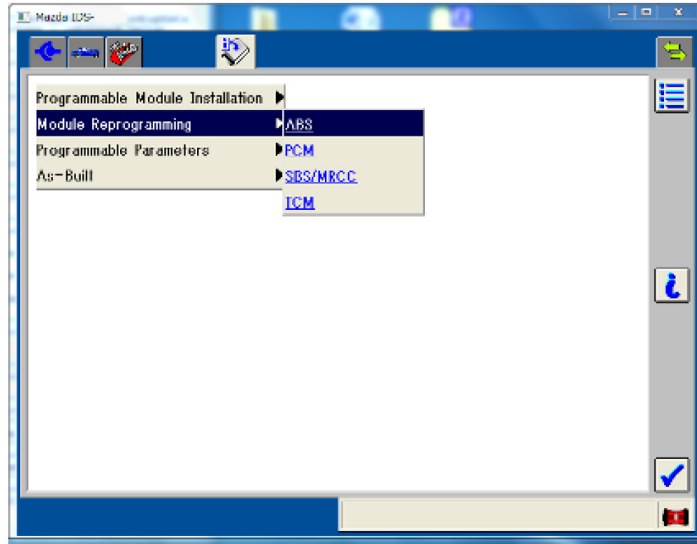
- a. Select “Module Reprogramming”, then select “ABS”.

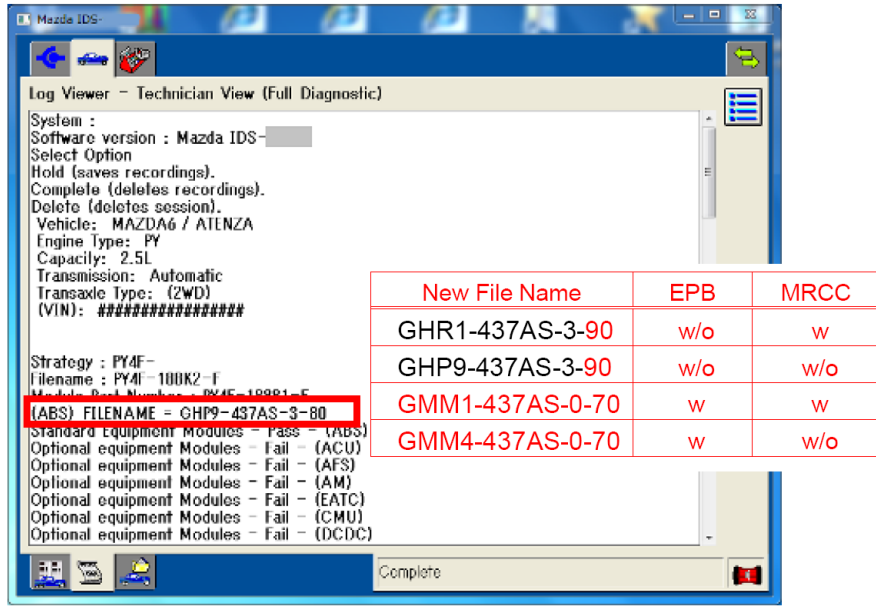
- c. After reprogramming, remove the session. Then, open a new session again and go to the “Log Viewer” screen on which the programmed file name is displayed as shown in figure below. If the new file name matches the list, the reprogramming has been successfully completed.

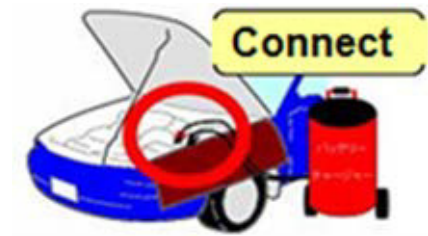
- c. When performing this procedure, we recommend using the “Power Supply” mode in the Battery Management System to keep the vehicle battery up to capacity. If a different charger is used, make sure it does not exceed 20 AMPS. If it exceeds 20 AMPS, it could damage the VCM.

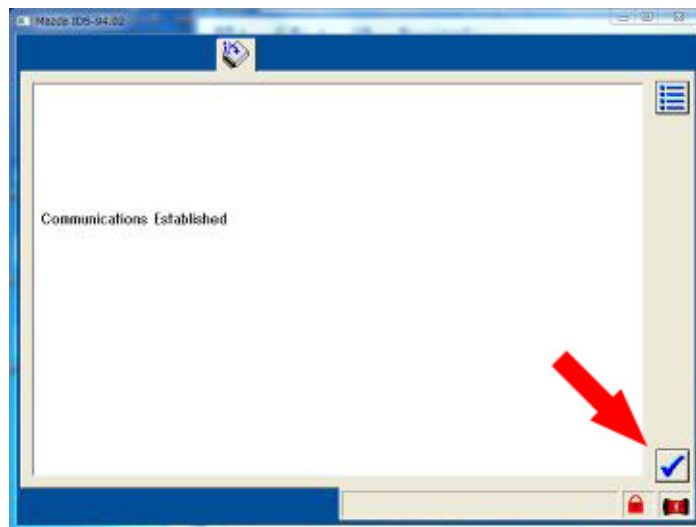
- e. Click the check button.

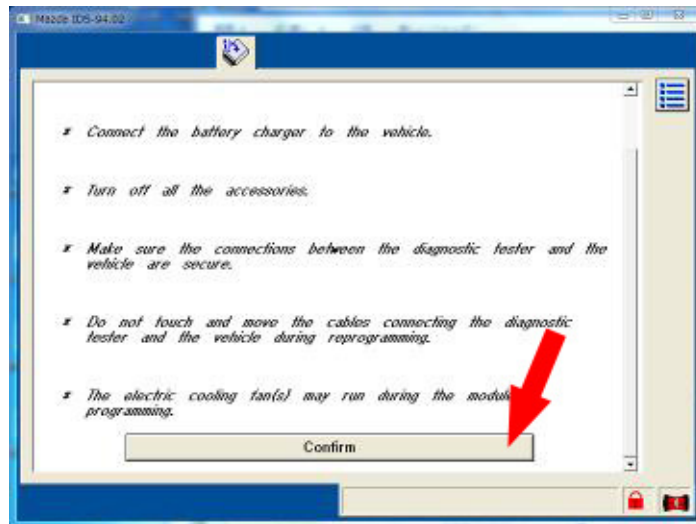
f. Click the "Confirm" button.
