2012-2013MY Rio (UB)
2012-2013MY Soul (AM)

118 (REV 2, 10/08/2013)

TECHNICAL SERVICE BULLETIN

SUBJECT: COMBINED TSB/SERVICE ACTION – RIO, SOUL 1.6 GDI MIL
ON WITH DTCS P0456/P0461/P050A/P2188/P2192/P0128 (SA152)*** NOTICE**

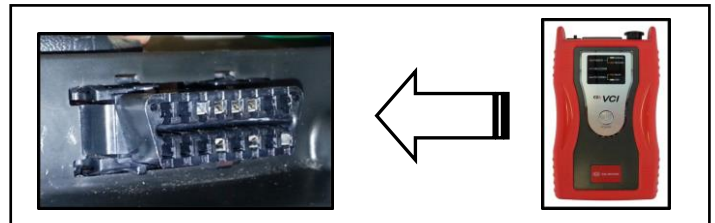
3. Connect the Main 16-pin DLC cable (GHDM – 241000) to the VCI.

4. Connect the Main 16-pin DLC cable (GHDM – 241000) to the OBD-II connector, located under the driver's side of the instrument panel.

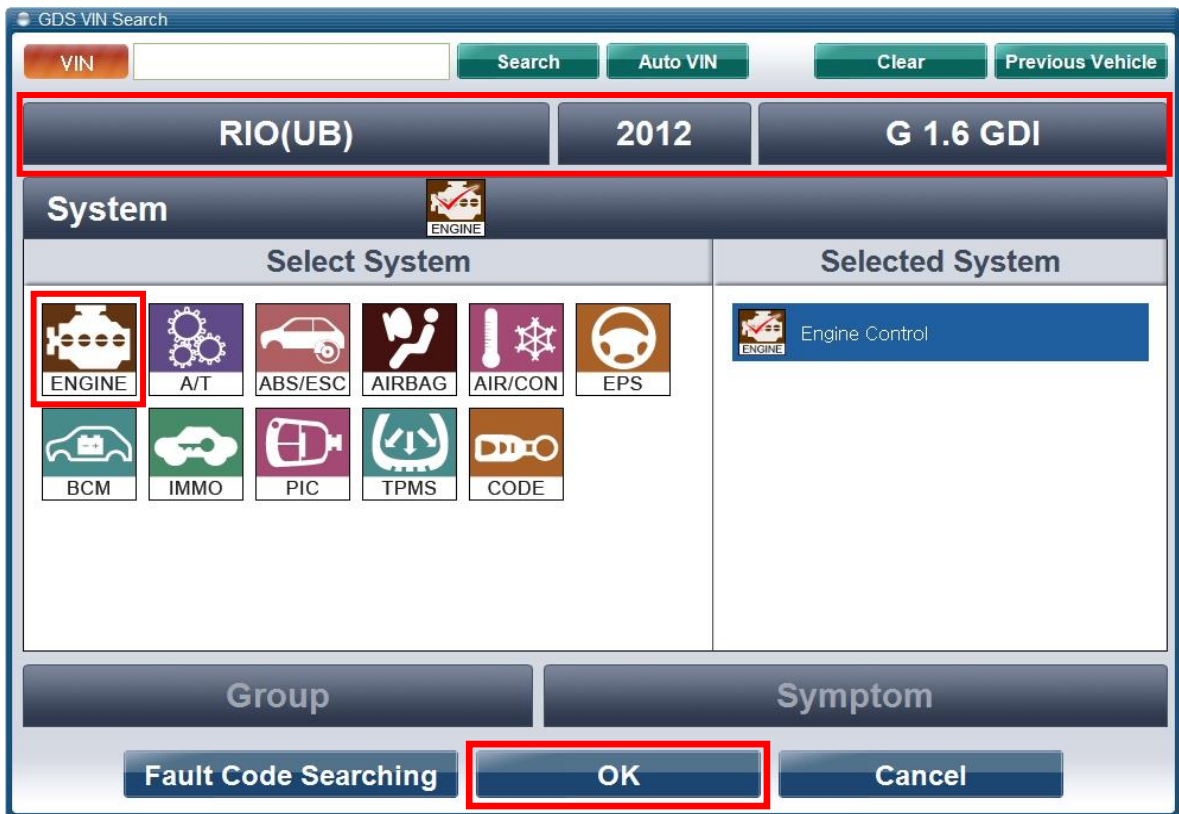
5. With the ignition key ON, turn ON the VCI and GDS tool. Access the GDS vehicle identification number (VIN) screen and configure the vehicle using the **VIN AUTO DETECT** Function. Connect the Main 16-pin DLC cable (GHDM – 241000) to the OBD-II connector, located under the driver's side of the instrument panel.
6. Select **ENGINE** system and click **OK**.

Display screen above is for demonstration purposes only and will vary depending on model.

7. Select **ECU Upgrade** from the bottom right-hand corner. Next select **Auto Mode**, and then **Engine**. Perform the ECM upgrade in accordance with normal GDS tool ECM upgrade procedures.
