MODEL
2012-13MY Sorento (XM)
& 2012MY Sedona (VQ)

NUMBER
023

TECHNICAL SERVICE BULLETIN

SUBJECT: ECM UPGRADE - CYLINDER CONTRIBUTION / BALANCE

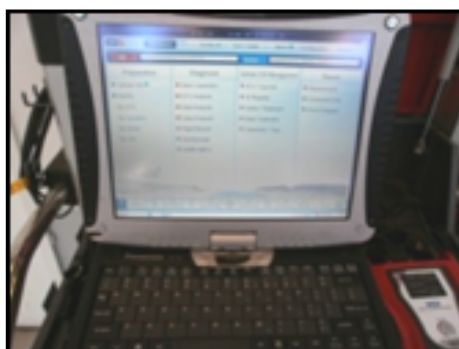
Global Diagnostic System (GDS)

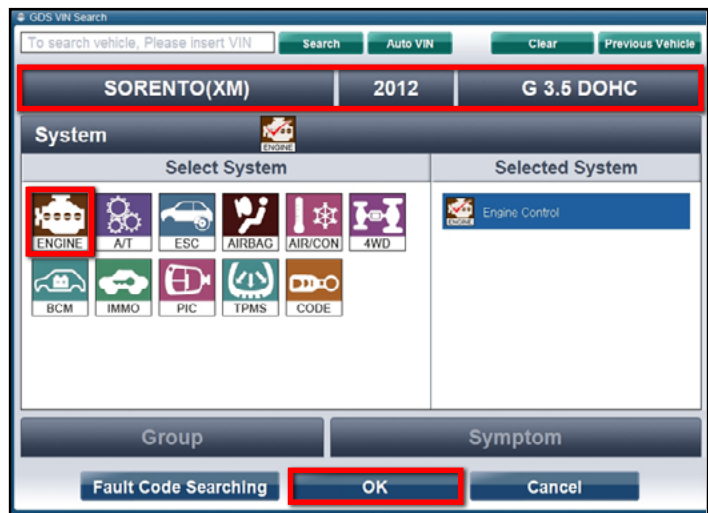
- 5. With the ignition key **ON**, turn on the VCI and GDS tool. Access the GDS vehicle identification number (VIN) screen and configure the vehicle using the VIN Auto Detect function.

Note: Screen image to the right is for demonstration purpose only.
