MODEL
2014MY Forte (YD)
w/2.0L GDI

NUMBER
027 (REV 1, 11/15/2013)

TECHNICAL SERVICE BULLETIN

SUBJECT: COMBINED TSB/SERVICE ACTION: ECM UPGRADE – MIL ON
WITH DTC P0461 (SA156)

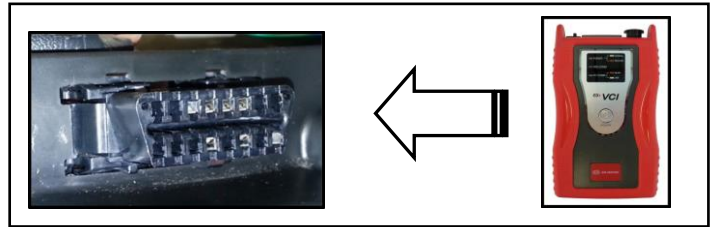
3. Connect the Main 16-pin DLC cable (GHDM – 241000) to the VCI.

4. Connect the Main 16-pin DLC cable (GHDM – 241000) to the OBD-II connector, located under the driver's side of the instrument panel.

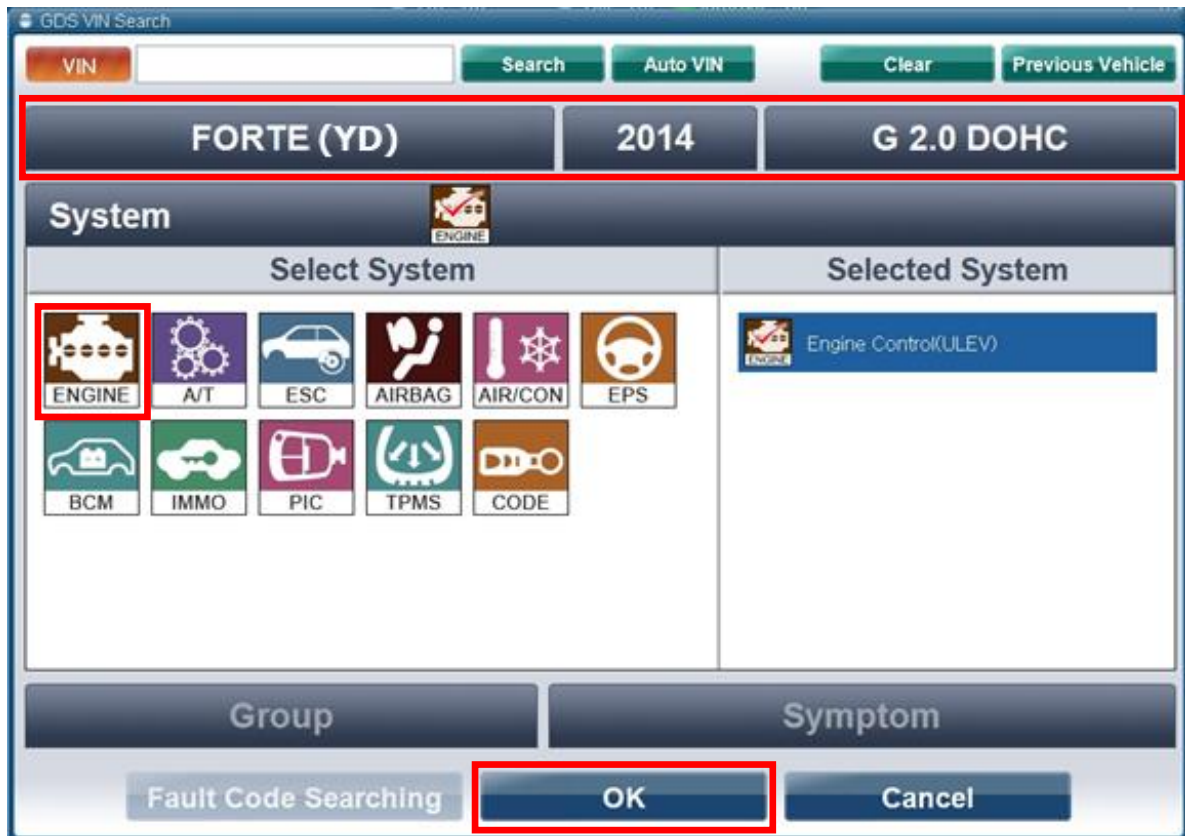
5. With the ignition key ON, turn ON the VCI and GDS. Access the GDS vehicle identification number (VIN) screen and configure the vehicle using the **VIN AUTO DETECT** Function.

6. Select **ENGINE** system and click **OK**.
