MODEL
2015MY
K900 (KH)

NUMBER
054 (REV 1, 11/04/2014)

TECHNICAL SERVICE BULLETIN

SUBJECT: COMBINED TSB/SERVICE ACTION: K900 (KH) SHIFT LOGIC IMPROVEMENT - TCM UPGRADE (SA174)

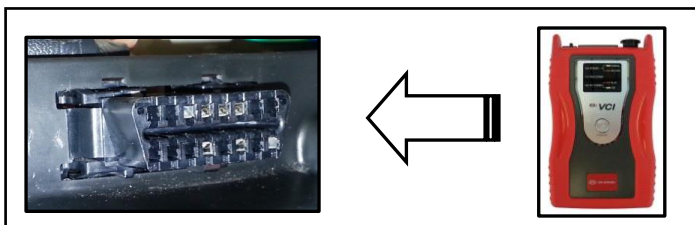
3. Connect the Main 16-pin DLC cable (GHDM – 241000) to the VCI.

4. Connect the Main 16-pin DLC cable (GHDM – 241000) to the OBD-II connector, located under the driver's side of the instrument panel.
