NUMBER  
070

DATE  
November 2014

**SUBJECT:** SERVICE ACTION: NAVIGATION UNIT SOFTWARE  
UPGRADE (SA172)

This bulletin provides the procedure for upgrading the navigation system software of some Sedona (YP), Soul (PS) and Optima (QF) vehicles to resolve concerns related to no sound coming from the head unit after ending a Bluetooth call. Kia is requesting the completion of this Service Action on all affected vehicles. Before conducting the procedure, verify that the vehicle is included in the list of the affected VINs.

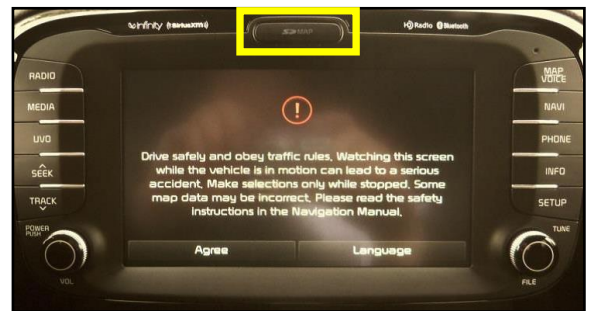
3. Touch the **Agree** icon on the screen.

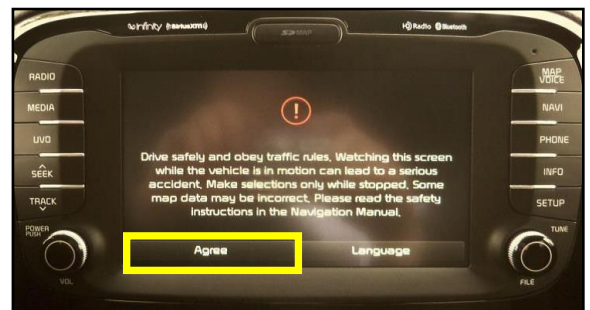
This AVN software update will take approximately twenty (20) minutes to complete.

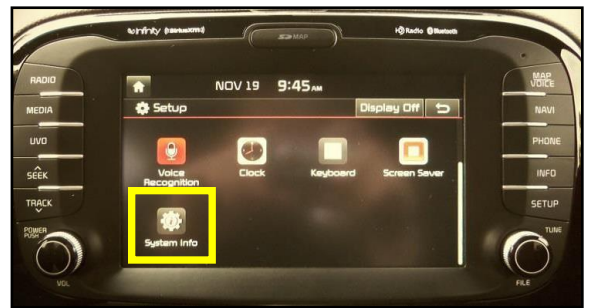
5. Scroll to the bottom of the screen and touch **System Info**.

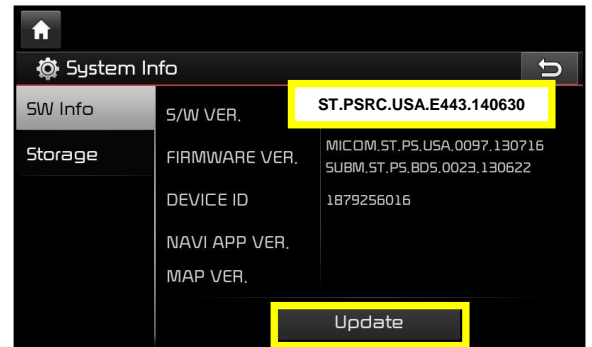
6. Compare the original software version to the versions shown in the table below and press **Update**.

Model	Original Software Version
Sedona (YP)	ST.YP.USA.E445.140708
Soul (PS)	ST.PSRC.USA.E443.140630
Optima (QF)	ST.TF.USA.E443.140630

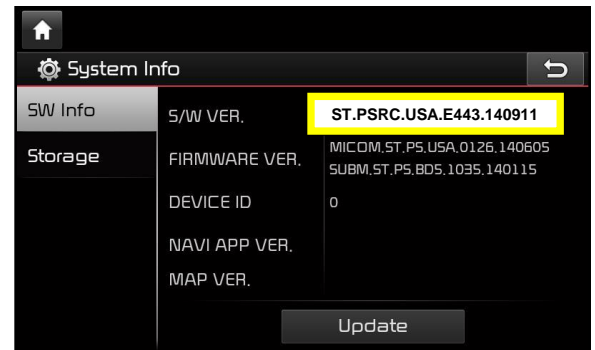
10. Touch the **System Info** button on the screen and verify the software version by referring to the information on the table below.

Model	New Software Version
Sedona (YP)	ST.YP.USA.E445.140904
Soul (PS)	ST.PSRC.USA.E443.140911
Optima (QF)	ST.TF.USA.E443.140911
