MODEL
2015MY
Optima (QF)

NUMBER
055

TECHNICAL SERVICE BULLETIN

SUBJECT: SERVICE ACTION: BLIND SPOT DETECTION (BSD) SYSTEM LOGIC IMPROVEMENT (SA 187)

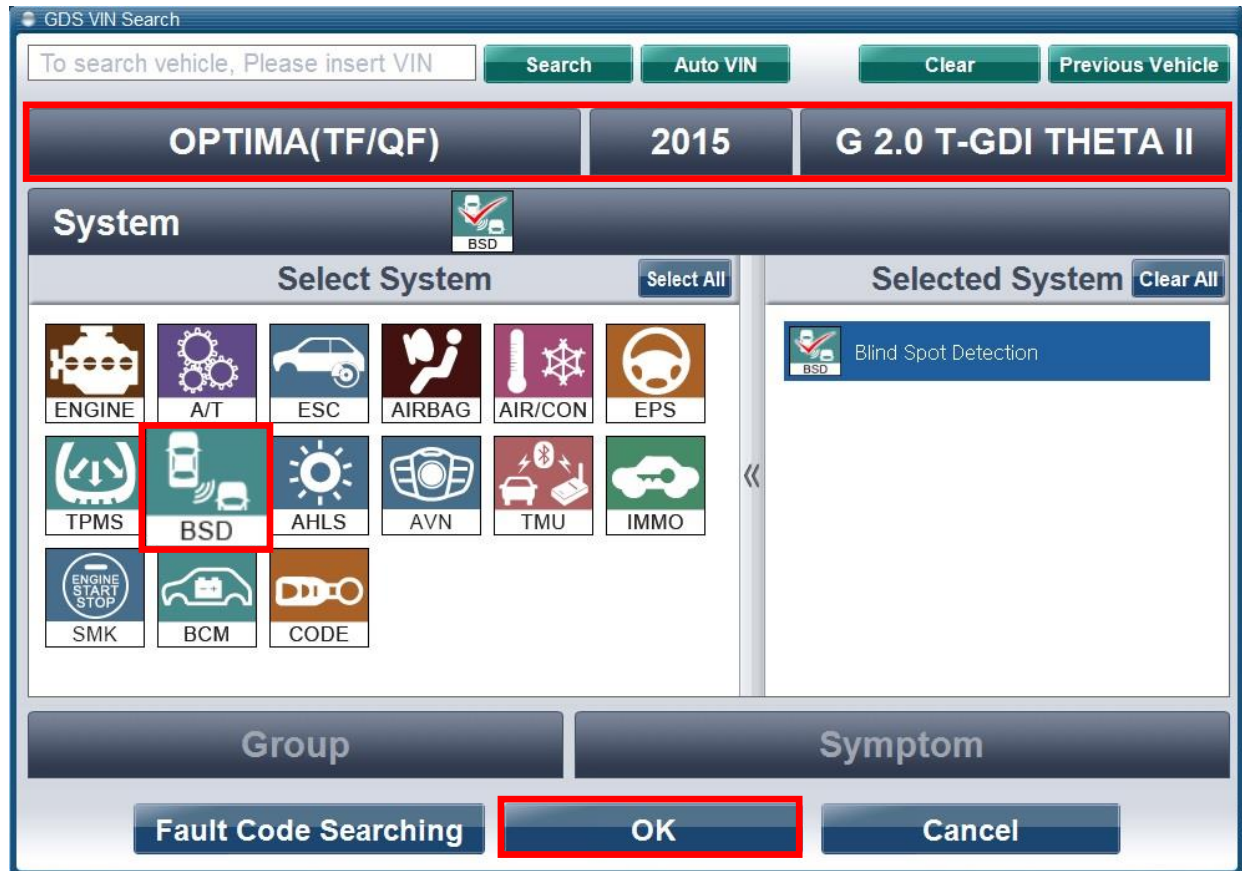
5. With the ignition key ON, turn ON the VCI and GDS. Access the GDS vehicle identification number (VIN) screen and configure the vehicle using the **VIN AUTO DETECT** Function.

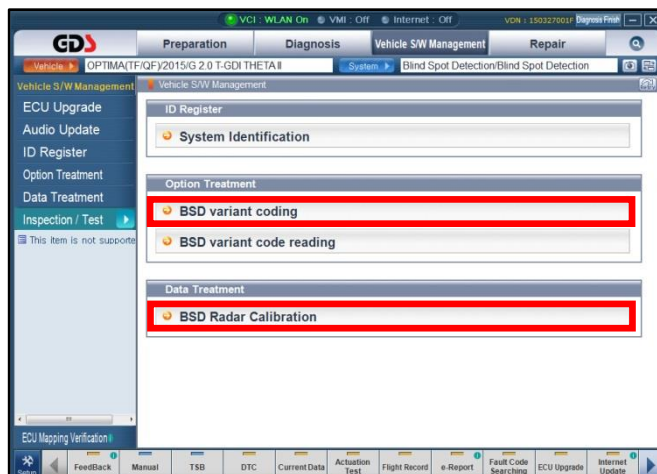
7. After upgrade is complete, perform the following procedures:

- **BSD → Vehicle S/W Management → Variant Coding**
- **BSD → Vehicle S/W Management → Radar Calibration**

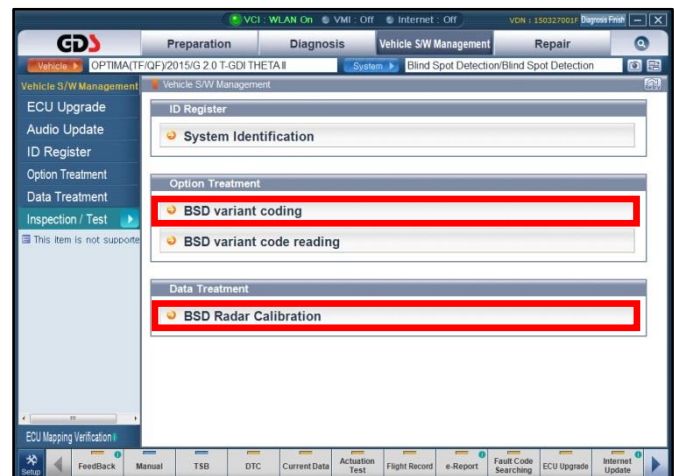
1. Within the ECU Upgrade screen, select **Manual Mode** in the left column, select **ENGINE** system and then select **Upgrade Event 250.QF BSD S/W LOGIC IMPROVEMENT**. Select the appropriate control unit part number by referring to the ROM ID Information Table on Page 2, and click **OK**.
2. Enter the appropriate password from the table above, and click **OK**.
3. Upgrade will begin and the progress of the upgrade will appear on the bar graph.
4. When the GDS reports that the upgrade has been successfully completed, click **OK** and turn the ignition off for ten (10) seconds.
5. After upgrade is complete, perform the following procedures:

- **BSD → Vehicle S/W Management → Variant Coding**
- **BSD → Vehicle S/W Management → Radar Calibration**
