01577 Version 1

Navigation Reboots or Navigation Display Flickers

Year	Model	VIN Range
2014	Pilot with Navigation	ALL

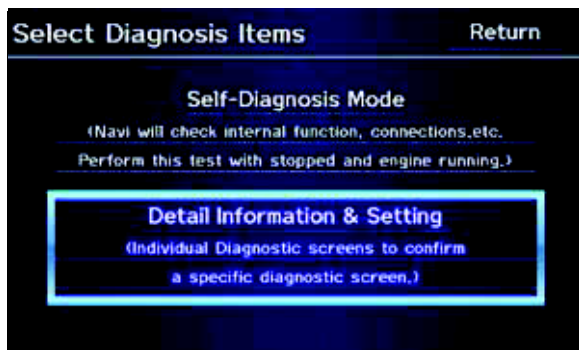
5. Use the interface dial to select **Detail Information & Setting**.

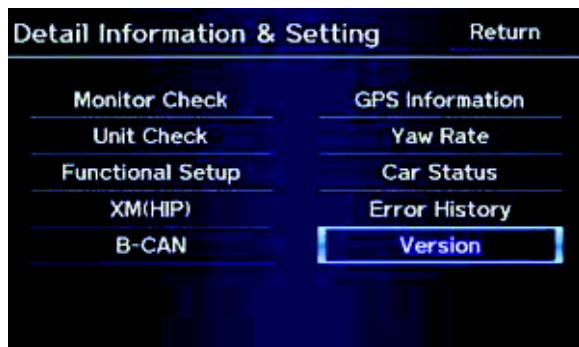
6. Select **Version**.

10. Repeat steps 5 and 6 to enter the **Version** screen.

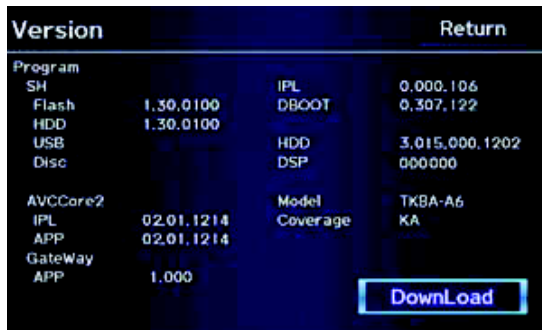
7. Select **Download**.

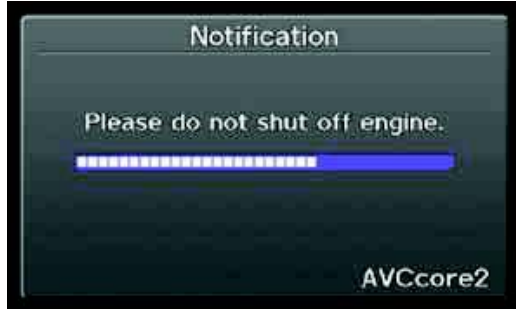
8. The software update begins. A loading bar will appear on the Notification screen.

NOTE: The sub-display screen is blank.

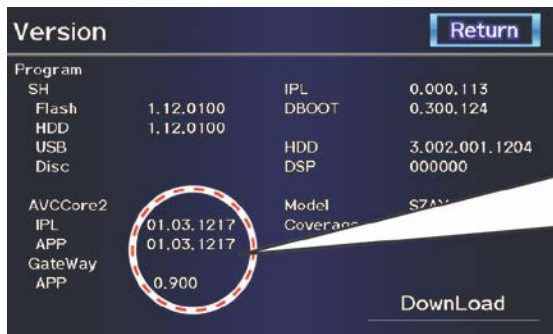
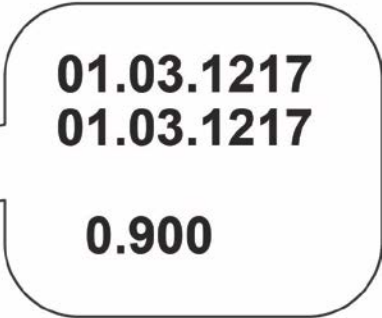
Without RES

11. Verify that the AVCCore2 (IPL, APP) software was updated to the new applicable version listed below. If the software is not updated, turn the ignition switch to OFF, then go back to step 2 and repeat the update procedure.
