02202 Version 1

Vehicles with Navigation: Audio Turns Off After Using HFL, No Sound/Static in Rear Headphones, and Other Listed Issues

Replaces S/B 14-019, Product Update: Audio-Navigation Unit Software Update

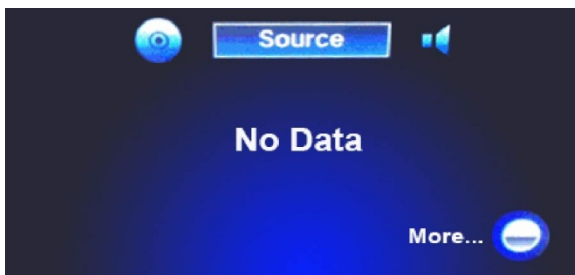
Navigation screen

- The software update will begin. The screen will show a **Reading the Disc** message, then display **No Data**. Do not eject the disc. The unit is uploading the update and may take up to 1 minute before beginning. Both screens will shut off for about 10 seconds and reboot with the update started on both screens. The display should change to a **Notification** screen loading bar.
- The engine does not need to be running to do this update, even if it says so on the screen.
- If the **No Data** screen does not change after about a minute, the software may already be updated. Go to step 9 to confirm the software versions.

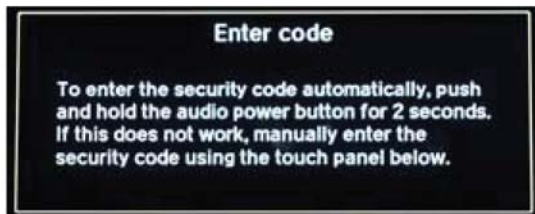
Navigation screen

4. When the update is complete, the system will reboot to the HondaLink screen. The **Enter code** message and keypad will appear on the screens, although they may not appear at the same time. **Wait for both screens to appear**, then set the power mode to OFF.

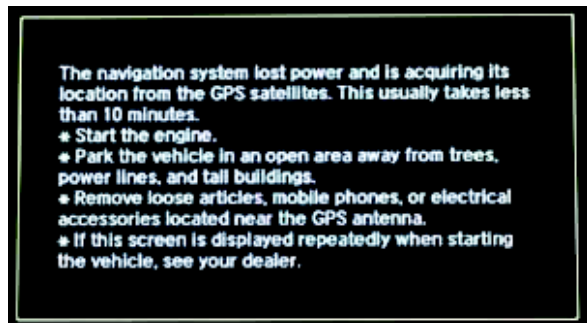
5. Eject the DVD and wait at least 1 minute.
6. Set the power mode to ON. Once both **Enter code** screens appear, press and hold the power button for 2 seconds until you hear a beep. The navigation screen will show the GPS initialization message.

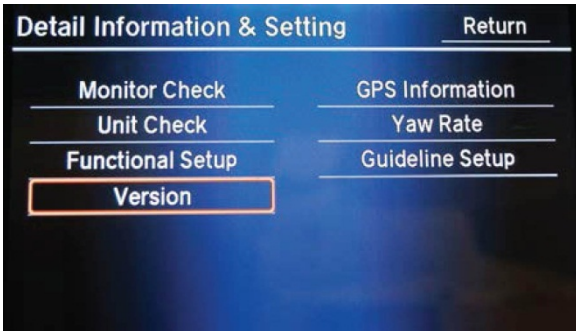
8. Select **Detail Information & Setting**.
 9. Select **Version**.

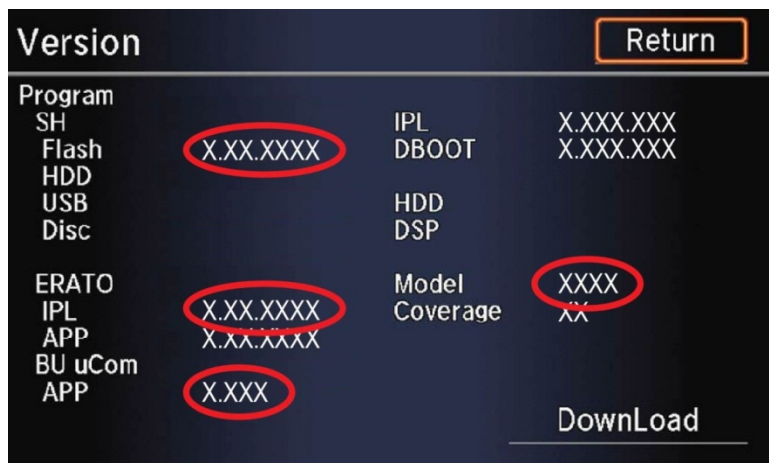
10. Verify that the software was updated to the new version as shown below. **Please note the SH-Flash, ERATO IPL, BU uCom APP, and model version information and make sure it matches the table below.**

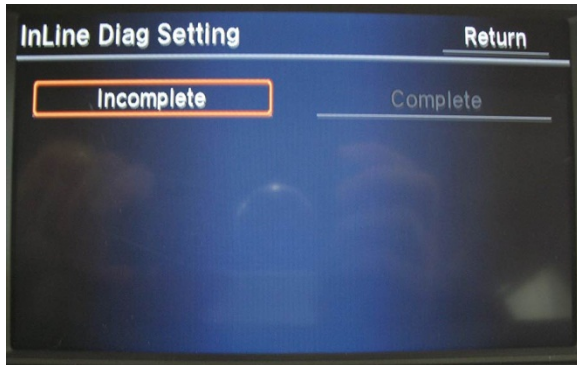
11. Make sure the rear camera, and LaneWatch are working properly. If not, reset the rear camera and LaneWatch.
 - Move vehicle to an open area. Start the engine if not already done.
 - Press and hold the NAVI, BACK, and MENU buttons.
 - Press and hold the NAVI button.
 - Select **Incomplete**. The system restarts.

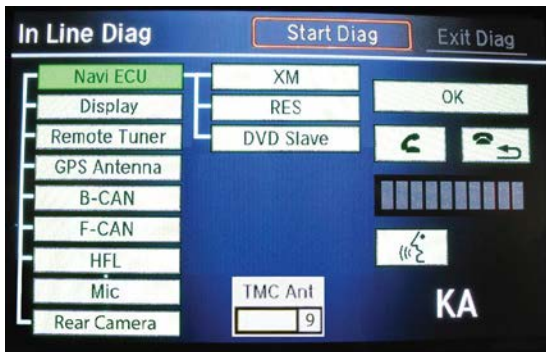
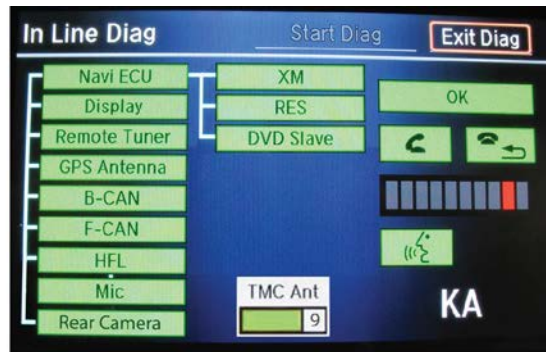
- When the **In-Line Diag** screen appears, select **Start Diag**.
- Make sure all the icons turn green.

- Press the Pick-up button.
- Press the Hang-up button.
- Press the Talk button.
- Snap your fingers in front of the microphone to complete the test.
