01438 Version 2

Wind Noise from the Driver's or Front Passengers Side Window

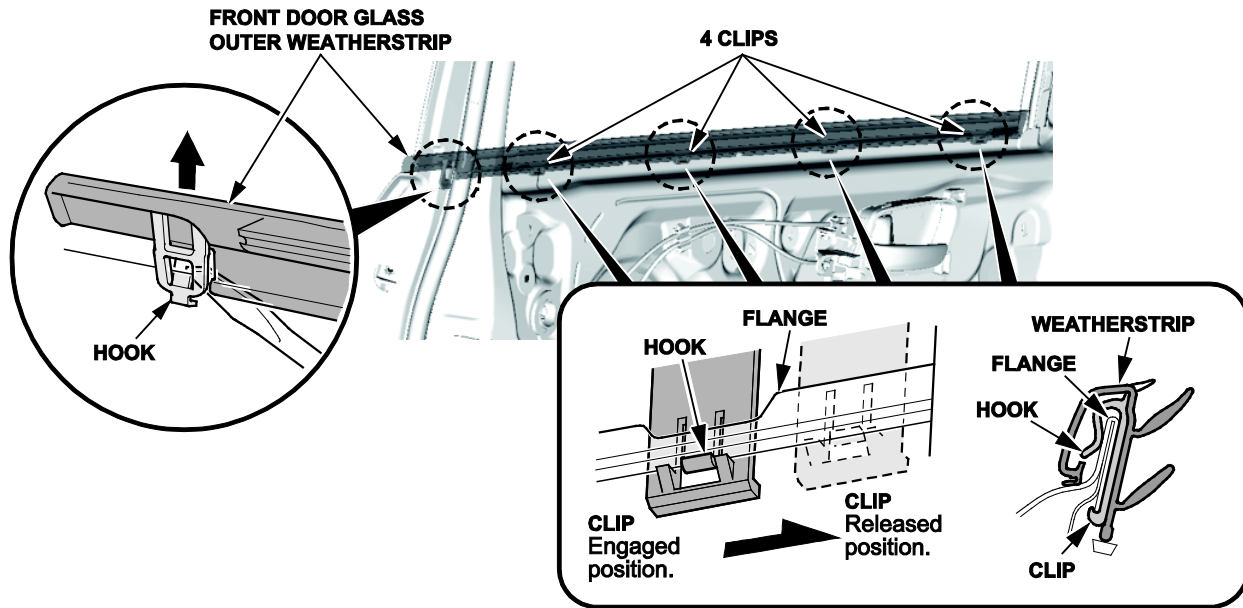
4. From the inside of the door, slide the clips on the front door glass outer weatherstrip to release the hooks from the flanges on the door. Release the hook with a flat-tip screwdriver from inside of the door.

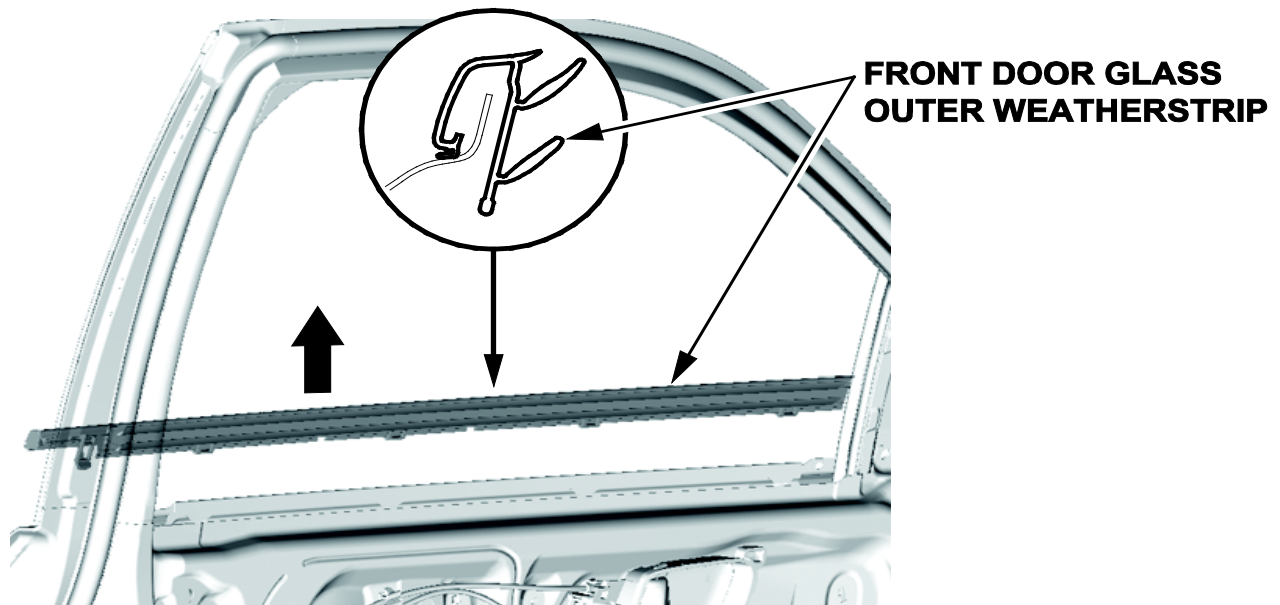
5. Remove the front door glass outer weatherstrip.

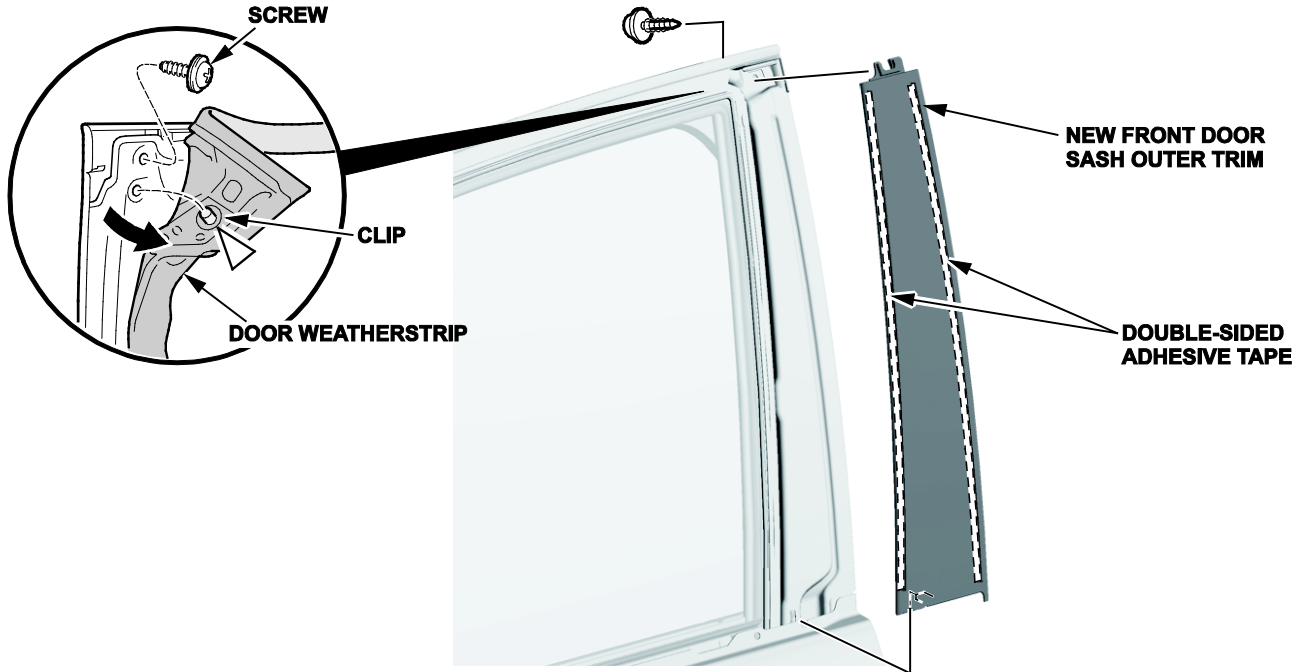
- Lightly pull away the door weatherstrip from the top corner just enough to remove the screw on the end of the chrome molding. Lightly pull away the top end of the chrome molding, detach the clip, then remove the door sash trim.

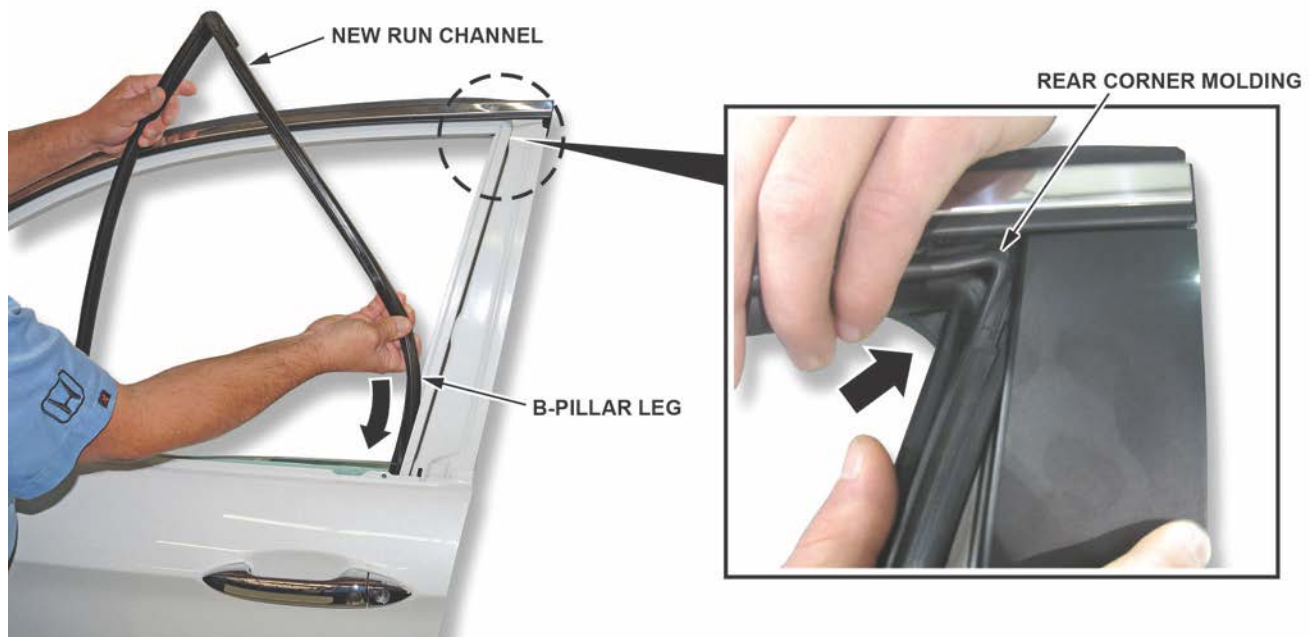
- Remove the run channel from the window frame.
- Install the new run channel by sliding the B-pillar leg all the way down between the glass and the vertical steel channel first, then install the rear corner molding of the run channel.

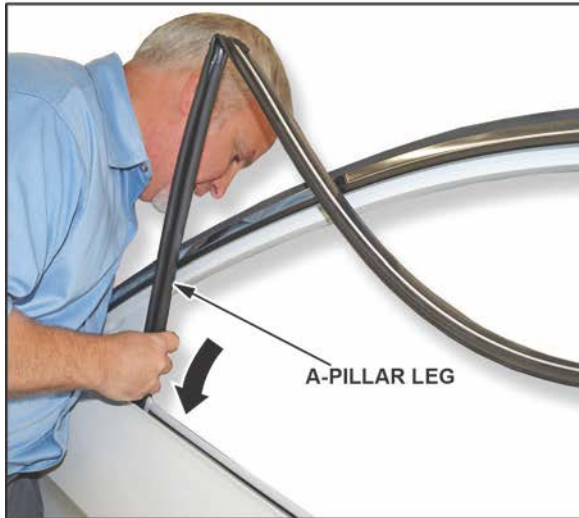
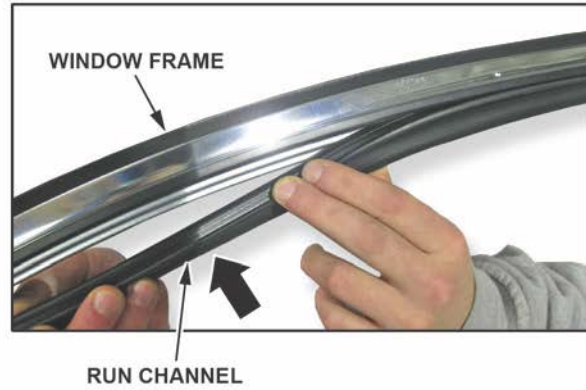
3. After setting the rear corner molding, begin setting the run channel in the window frame toward the front sash. Now slide the A-pillar leg of the run channel down between the glass and the front steel channel.

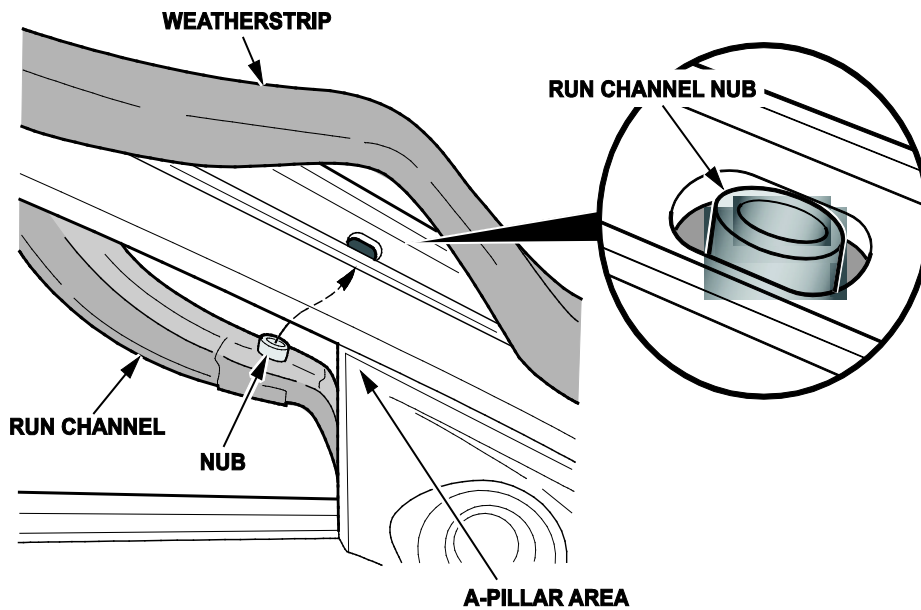
4. Set the front corner molding.
5. Gently pull up on the weatherstrip on top of the door frame near the door mirror.
6. Check that the run channel is set by making sure the run channel nub is seated in the oval hole.

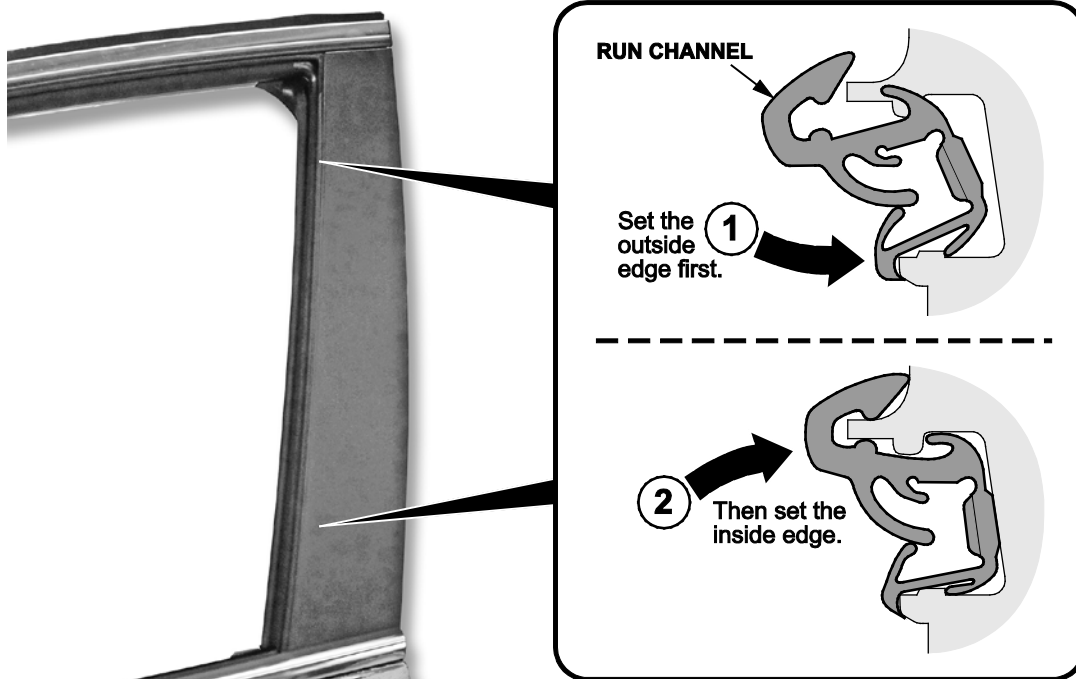
7. Set the A-pillar leg of the run channel down into the door. Set the outside attachment first, then set the inside attachment of the run channel.

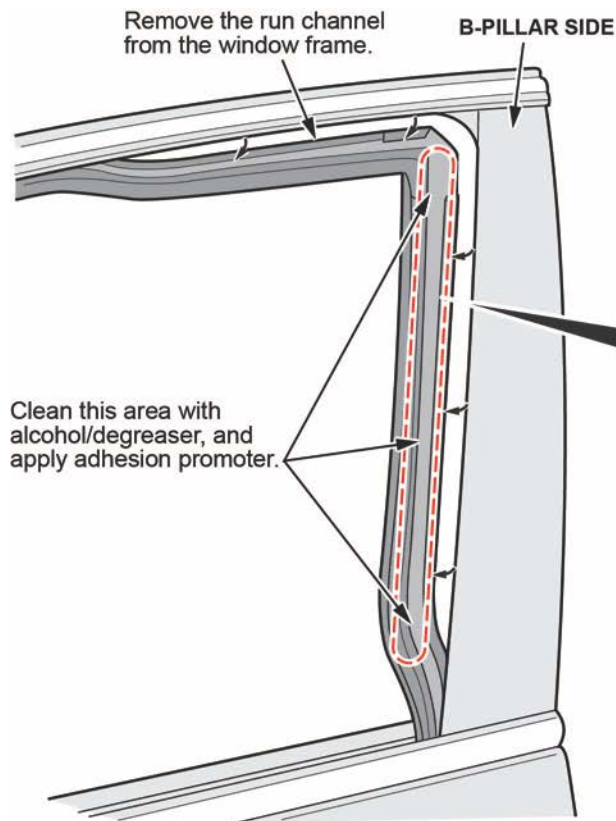
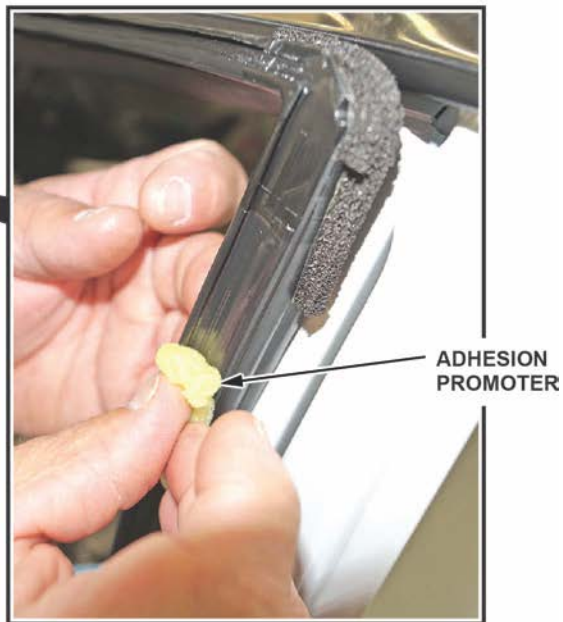
1. Replace the sash trim (see Sash Trim Replacement under REPAIR PROCEDURE A).
2. Open the window.
3. Remove the run channel from the upper part of the door frame.
4. Remove the run channel from the top corner of the B-pillar to B Line.

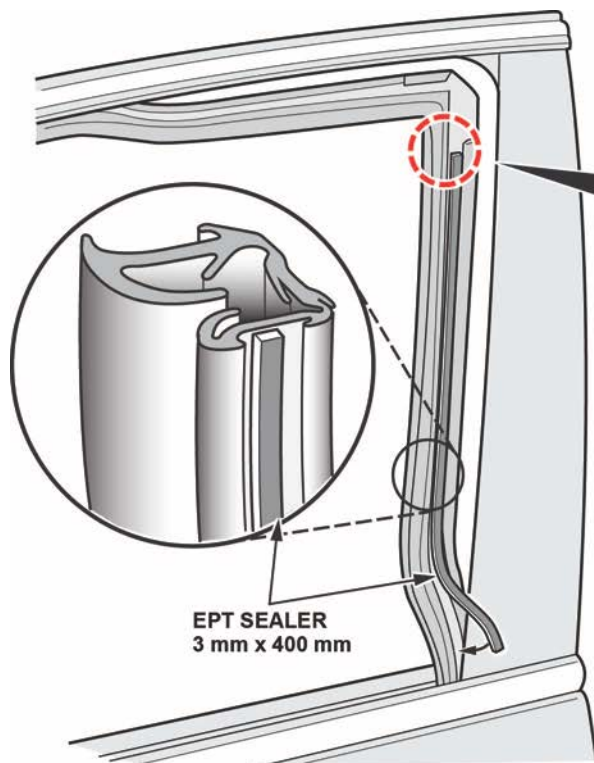
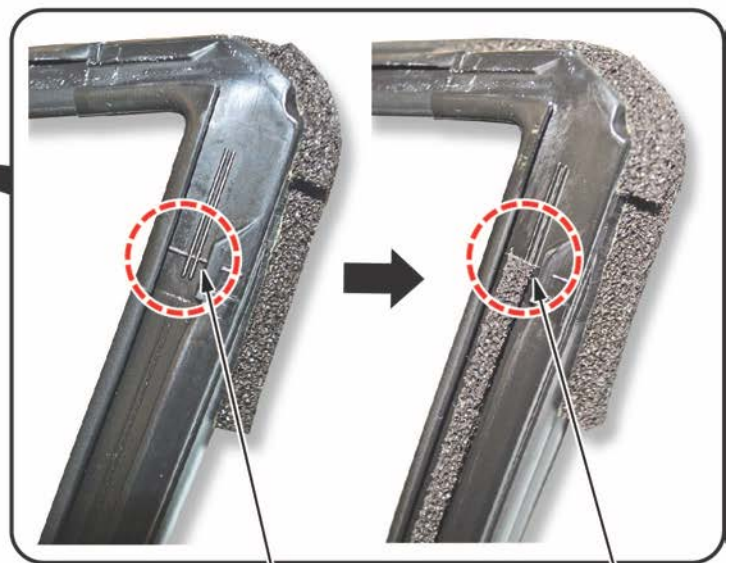
EPT SEALER

5. Clean the run channel groove along the B-pillar with rubbing alcohol.
6. Apply primer (3M Adhesion Promoter 4298UV) to the run channel groove along the B-pillar.
7. Cut a strip of EPT sealer that measures 3 mm x 400 mm x 3 mm and attach it to the groove of the run channel. Start at the top corner and install the strip down the run channel. Center the strip around the hash marks on the run channel.

Start the EPT sealer strip where these hash-marks cross.
