51786-02199 Version 3

Product Update: Audio-Navigation Unit Software Update

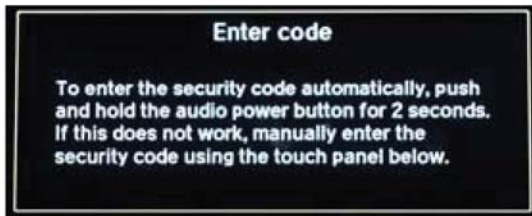
Navigation screen

4. When the update is complete, the system will reboot to the AcuraLink screen. The **Enter code** message and keypad will appear on the screens, although they may not appear at the same time. **Wait for both screens to appear**, then set the power mode to OFF.

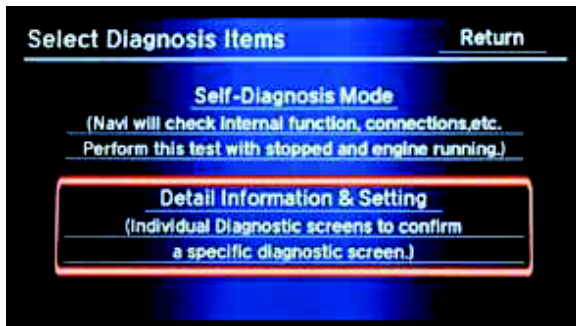
7. Press and hold the **NAVI**, **BACK** and **MENU** buttons until the **Select Diagnosis items** screen appears.

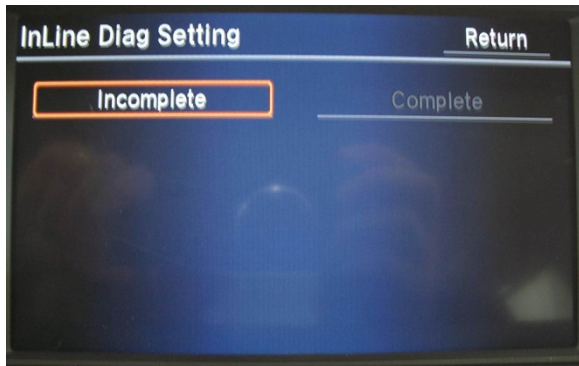
- Move vehicle to an open area. Start the engine if not already done.
- Press and hold the NAVI, BACK, and MENU buttons.
- Press and hold the NAVI button.
- Select **Incomplete**. The system restarts.
