BTB 51198-00353 (1411) REV-1

i-MID Reads “12 Volt Battery Charging System Problem” with DTC P16E3

Replaces 14-028, dated April 16, 2014, to revise the information highlighted in **yellow**.

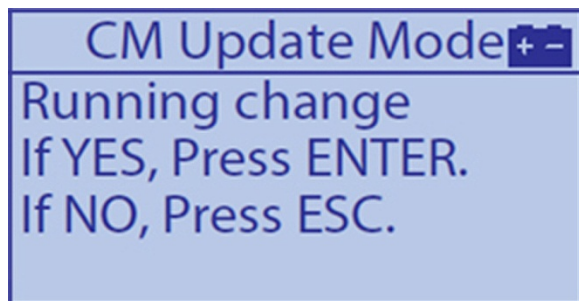
3. On the **Select System** screen, select **Meter** and press ENTER. You will see the message **Press the "ENTER" button to begin the Control Module Update**. Press ENTER.
4. The **CM Update Mode Running Change** screen appears. Press ENTER to begin the gauge control module update.

NOTE: Some of the gauge control module indicators will blink, and the headlights may come on. This is normal.
