March 22, 2017

05972 Version 7

## Firm 2nd to 3rd Gear Upshifts Under Certain Driving Conditions

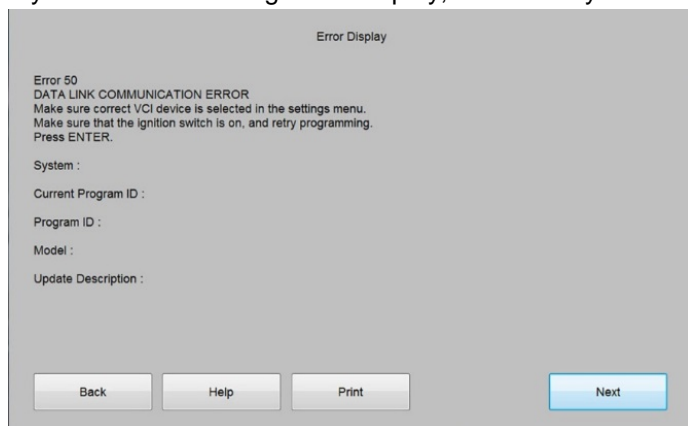
- You can't update the vehicle using the MVCI as a standalone tool.
- **Do not** use the MongoosePro VCI tool.
- Make sure the 12 volt battery is fully charged before starting an update.
- Connect a fully charged jumper battery to the vehicle and leave it connected during the entire procedure to maintain steady voltage.
- Never turn the ignition to OFF or ACCESSORY during the update. If there is a problem with the update, leave the ignition turned to ON.
- To prevent transmission control unit damage, do not operate anything electrical (headlights, audio system, brakes, A/C, power windows, door locks, etc.) during the update.
- If you see the following Error Display, check that you are using the correct tool (MVCI or DST-i) with the i-HDS.

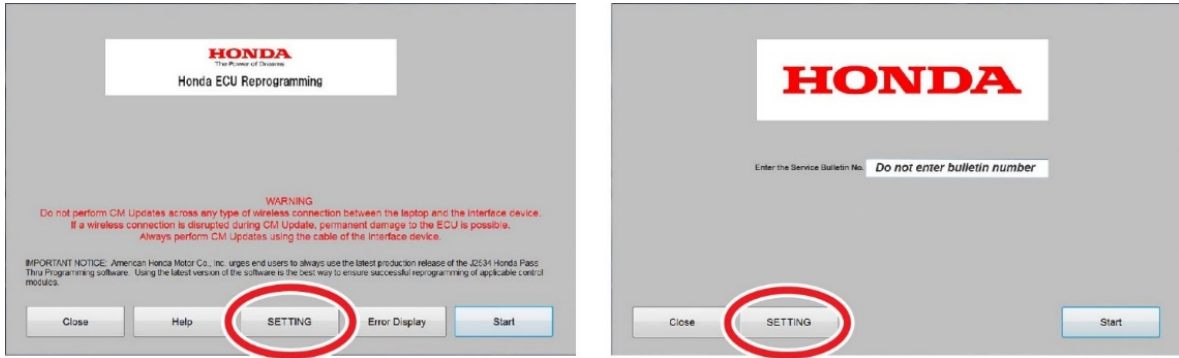
To change this, click on either of the SETTING selection buttons at the bottom of the J2534 initial screens as shown.

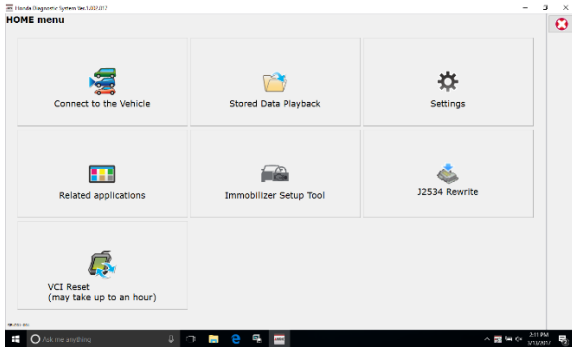
4. Select **J2534 Rewrite**.

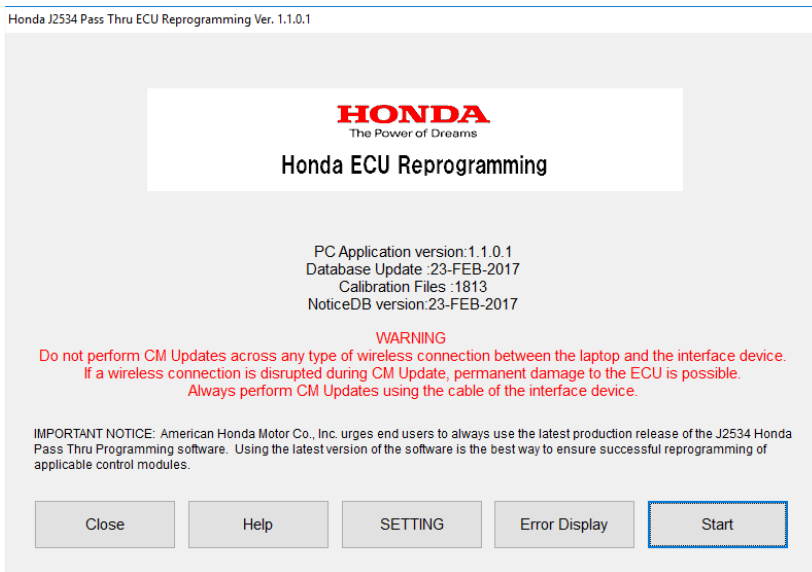
5. Confirm the software is the same **or later** as listed in SOFTWARE INFORMATION.

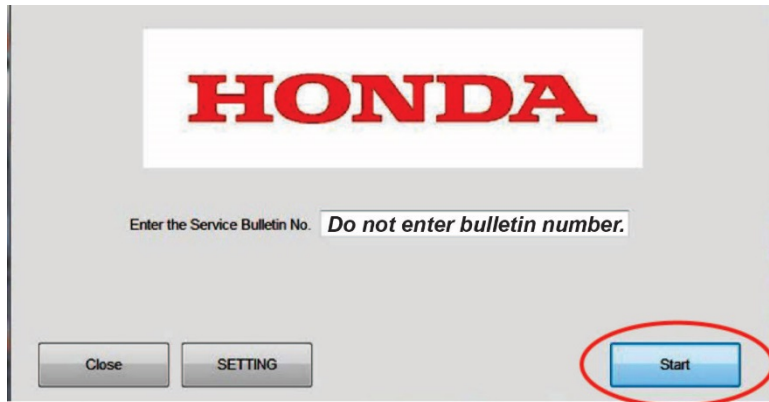
6. Select **Start**, then follow the screen prompts.

- **Don't enter a bulletin number.**
