**Technical Service
BULLETIN**

**M.I.L. "ON" VVTi DTCs — OIL CONTROL
VALVE (OCV)**

'06 – '08 RAV4 (2GR-FE)

**ENGINE
EG004-08**

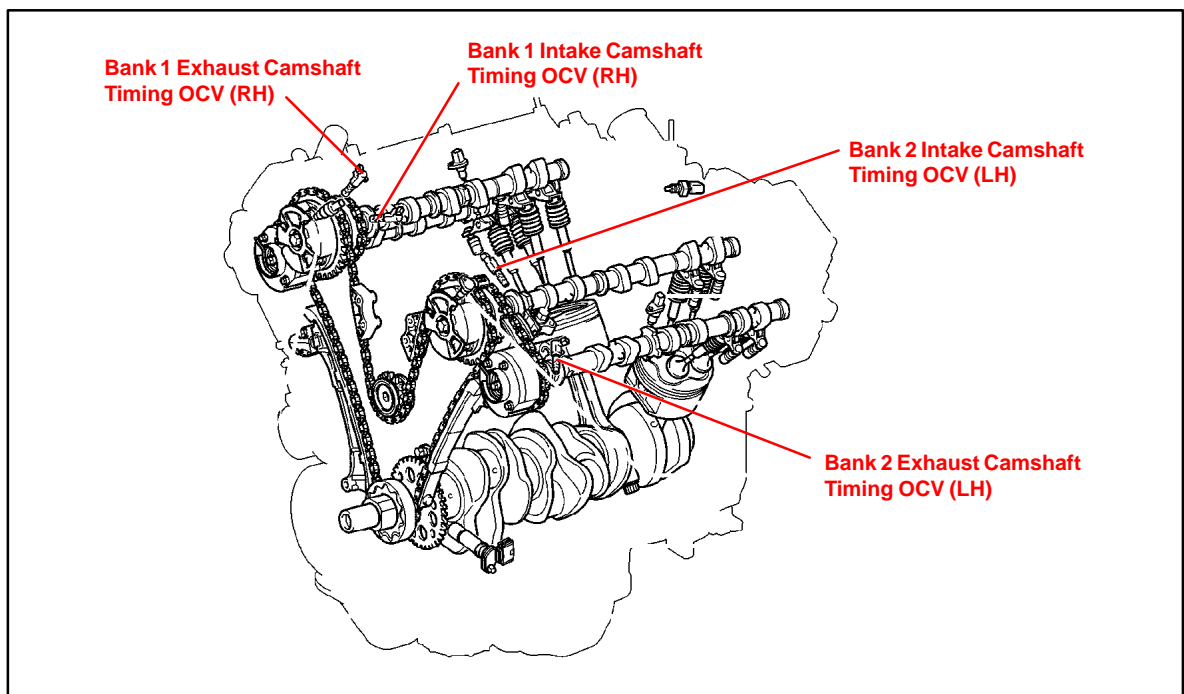
1. Remove the affected OCV.
2. Apply a light coat of engine oil to the O-ring on the NEW oil control valve.
3. Install the OCV and tighten the bolt.
Torque: 9.0 N•m (92 kgf•cm, 80 in.•lbf)
4. Confirm the repair.
