Procedure: L140-08.04

Operation: ECUs Re-flash (only for L140 with manual gearbox).

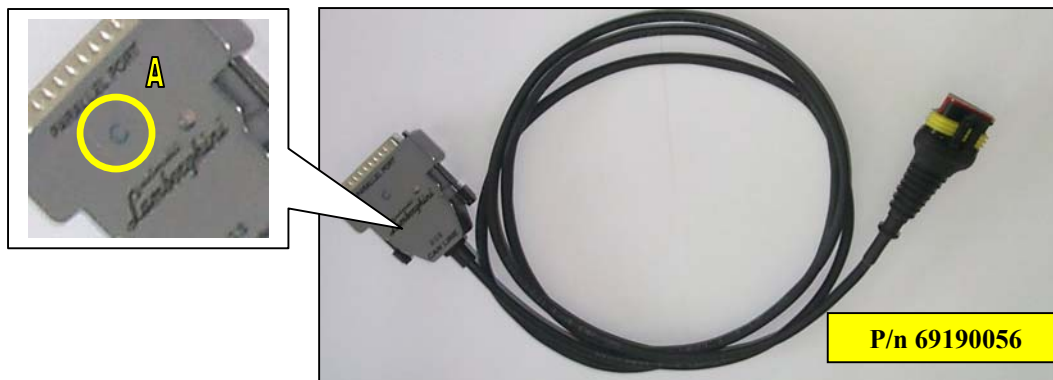
Pic.1

- 1.2** Can interface type “C”(fig. 1 p/n 69190056) recognizable from the old version from the sticker printed with the blue letter C (pic.1 ref. A).

- 1.4** Connect your p.c. by the can interface (pic.1 p/n 69190056) to the vehicle.
1.5 Open LDAS.
1.6 Key “on” battery e charged between 8-14 Volt.
1.7 From the tool bar select “ON line” (pic..2 ref. A).
1.8 Click on the command “Version” (pic.2 ref. B).

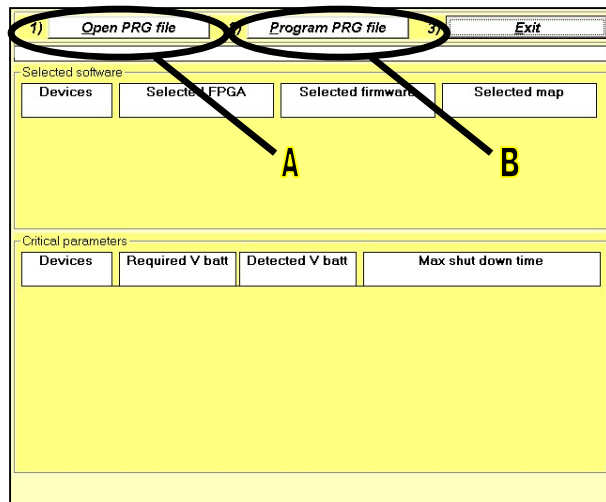
Pic..5

- 1.12 On the screen it is displayed the ECU program window (pic..8)
1.13 Select “*Open PRG file* (pic.5 ref. A).

- L714_RC_ = model: Gallardo.
- Step X = ECU program step.
- E = Europe: market version.
- **M** = **manual gearbox** (ref. D pic.5).
- E = E-gear. (ref. D pic.5).
- 04=model year.

- 1.16 Click on “open”(fig.9 B) and the system automatically loads the file.
- 1.17 Select “Program PRG file” (pic.5 ref. B)
- 1.18 Enter in “Chassis number”(pic.7) the complete V.I.N. of the vehicle (17 digits) then click “OK” in order to re-flash the ECU.
- 1.19 Click “OK” in pic.7b.
- 1.20 Clicca “Exit”. (pic.7b).

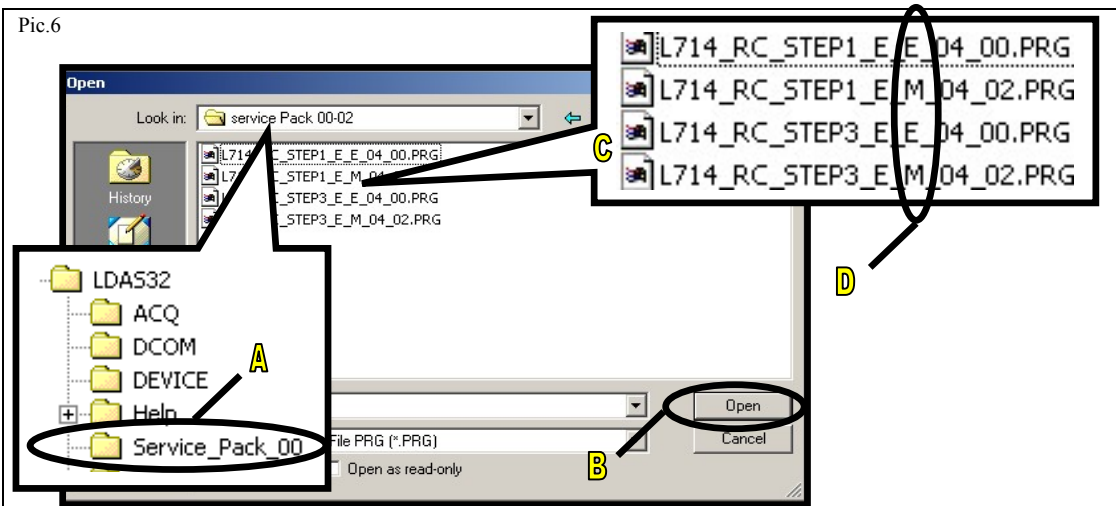
Pic.6

1.14 Click “service pack 00-02”(pic.n.6 A).

- L714_RC_Step1_E_M_04_02.PRG for vehicles which fit ECU with programming **step 1** (pic.6 C) **.
- L714_RC_Step3_E_M_04_02.PRG for vehicles which fit ECU with programming **step 3** (pic.6 C).**

****Warning:** Files are named (pic.n.6 C):

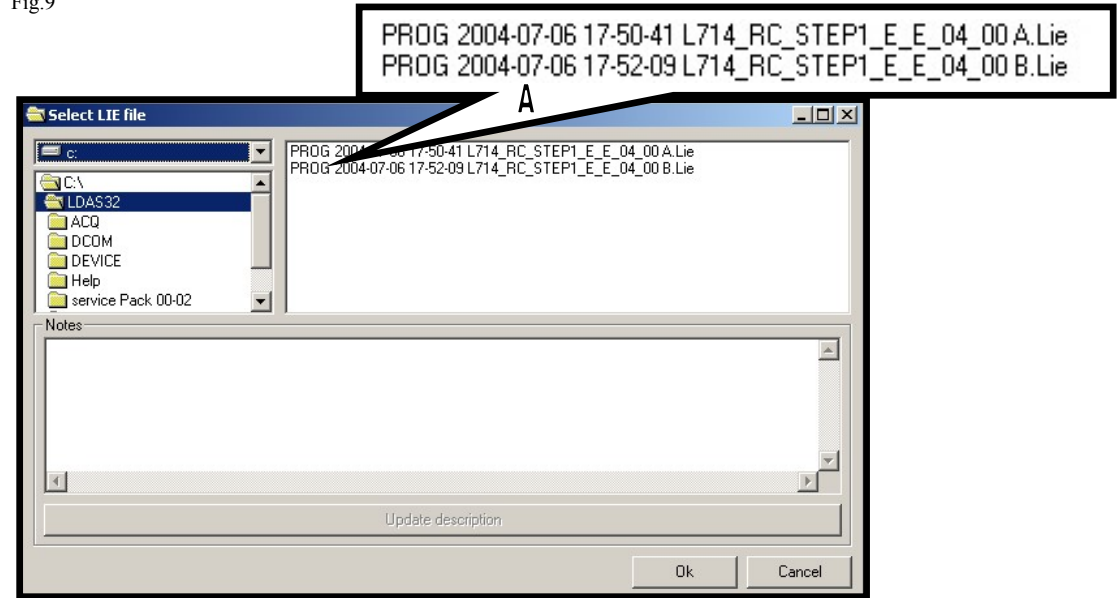
Fig.9

- 1.24** The system creates two files one that reports the data before the ECU programming and another one after it. They are identified by the capital letters A and B (pic.9 ref. A).

- 1.25** The system creates two files, one that reports the data before the ECU programming and another one after it. They are identified by the capital letters A and B (pic.9 ref. A).
- 1.26** Delete all the possible errors stored in the system using LaRA-AS and LDAS (erase fault memory code).

- 1.27** Enclose the mentioned files (pic.9 ref. A) to the **warranty claim ont the Warranty Web System.**
- 1.28** Put on the two LIE ECUs the sticker (p/n 901475000) for identification that the reflash was done. Fill in with the number: L140.A-???.04 (?? Number of the service group) and date.
