To Only for USA Lamborghini Dealers and Licensed Service Point  
From Customer Service Department  
Subject Distance to Empty Indication update  
Group L140.0.17  
Attachments -  
Date 15/05/2006  
Page 9

Distance to Empty Indication update

**All Gallardo USA MY '05** from VIN 1829 to VIN 2656.

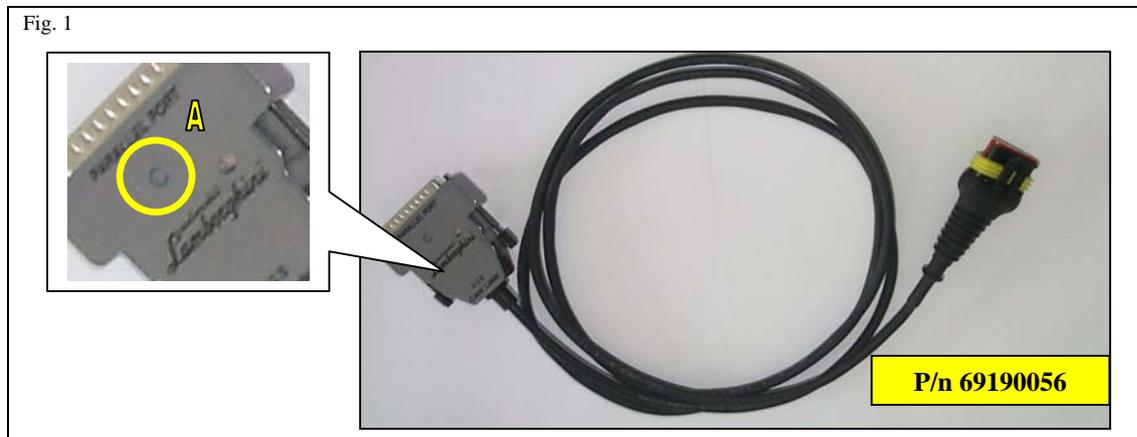
- 1.2 Can Line of type “C” (fig. 1 p/n 69190056) that can be recognized by the sticker on the socket “C” (fig.1 ref. A).

- 1.4 Connect your Laptop via Can line to the car (fig. 1 p/n 69190056).
- 1.5 Start LDAS.
- 1.6 While charging the battery between 8 and 14 Volt, toggle the key to the on position.
- 1.7 Select “ON line mode” from the toolbar (fig.2 ref. A).
- 1.8 Click on “Version” (fig.2 ref. B).

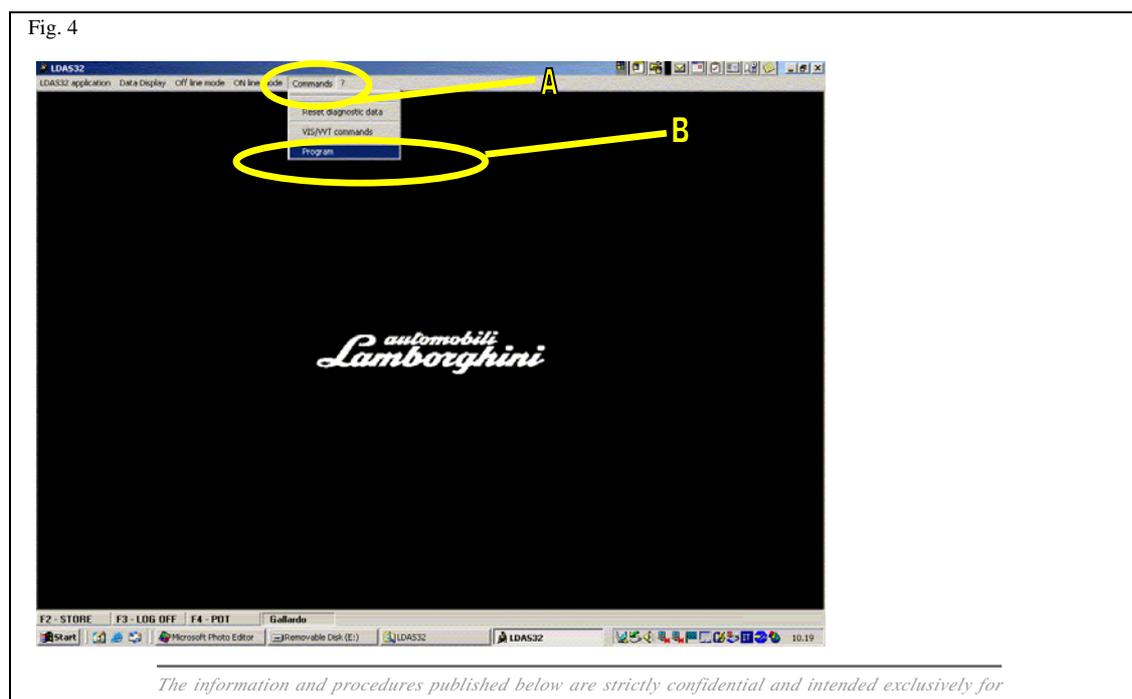
**1.11** From menu “Commands” (fig.n.4 A) select “Program” (fig.n.4 B).

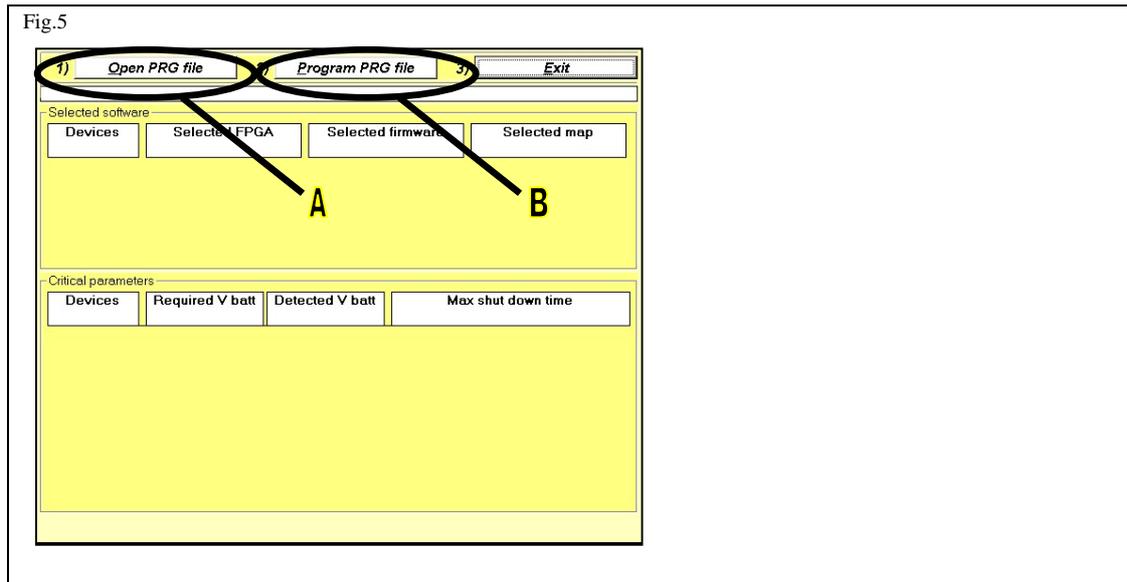
1.12 The programming window will appear (fig.5)

1.13 Select “Open PRG file” (fig.5 A).

1.14 Select “Service Pack 00-02” in “Look in” (fig.n.5 A).

- 1.16 Select “Open”: the system will load the file automatically.
- 1.17 Select “Program PRG file” (fig.5 rif. B).
- 1.18 The system recognizes automatically the VIN of the car (fig.6a).  
Then click “OK” in order to start the ECU reprogramming.
- 1.19 Click “OK” in fig. 6b.
- 1.20 Click “Exit” (fig. 6b).

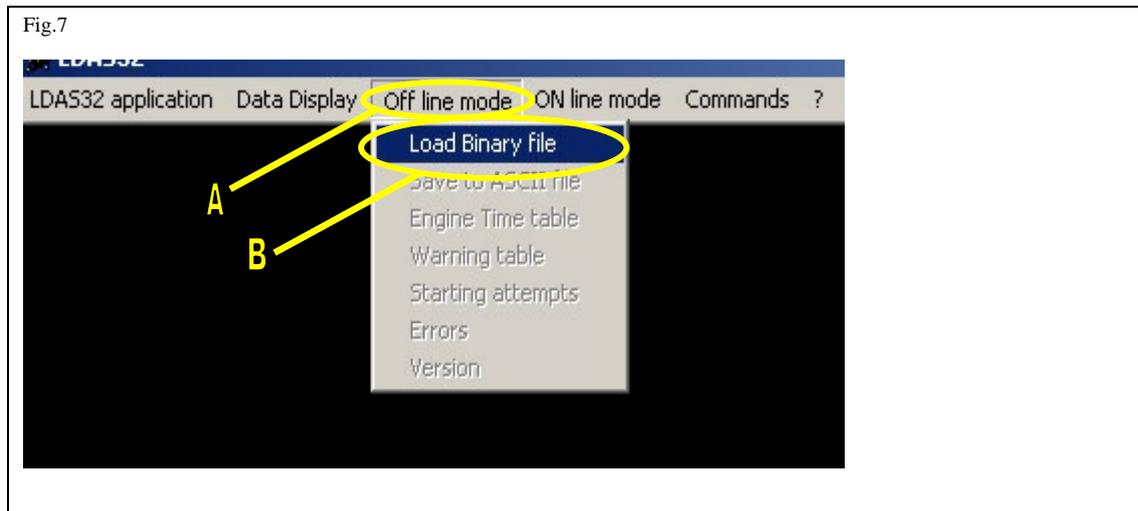
1.22 Select from the toolbar “Off line mode” (rif. B fig.7).

1.23 Select from the menu “Load Binary file” (fig.7)

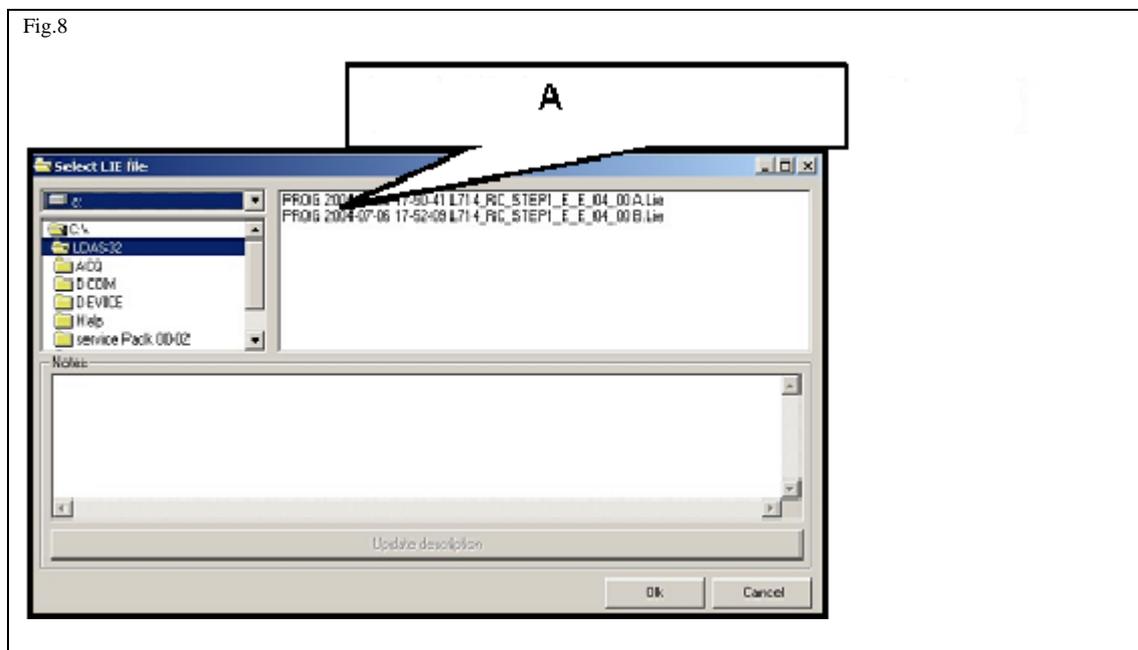
1.24 The system creates two files that report the configuration condition before and after the reflash. These files are indicated by the letter A (before) and B (after) (fig.8 rif. A).

1.25 Remember to attach these files to the claim request (fig.8 ref. A).
