To Only for USA Lamborghini Dealers and Licensed Service Point
From Customer Service Department
Subject Distance To Empty Indication update
Group L147.0.17
Attachments -
Date 15/05/2006
Page 9

Distance To Empty Indication update.

All Murcielago (coupè & roadster)USA MY '05 from VIN 1303 to VIN 1712.

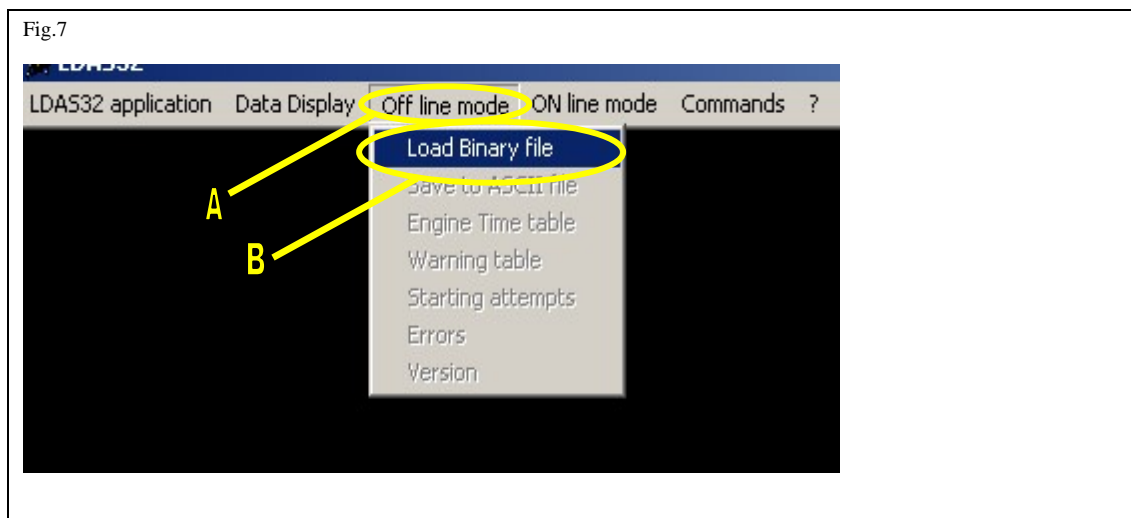
1.22 Select from the toolbar “Off line mode” (rif. B fig.7).

1.23 Select from the menu “Load Binary file” (fig.7)
