L615-A.02.16	To:	Official After Sales Network

Subject:	Engine Software Update	
	Date:	March, 25 2016	
	Pages	15

SW Update

Gallardo Spyder

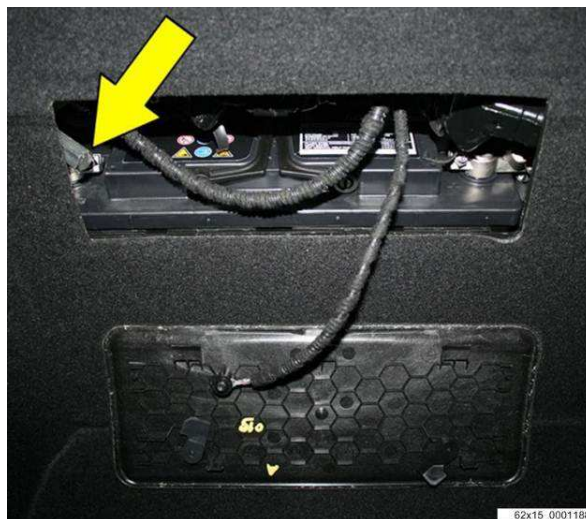
39. Open the trunk and remove the Battery inspection lid.

Disconnect the battery terminal clamp from the negative post.

Secure the clamp once it has been in order to prevent it from accidentally touching the battery post.

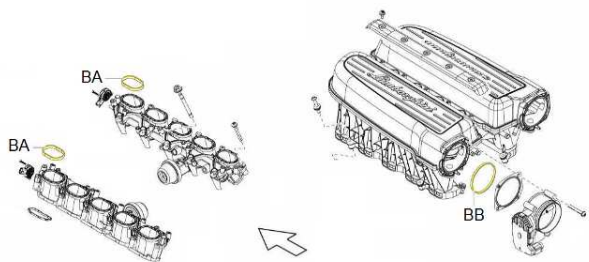
Main group: 01 Engine
 Subgroup: 29 Air intake manifold.

The items listed in the following template must be replaced before reassembling:

Ref.	Description
BA	Seal ring
BB	Seal ring

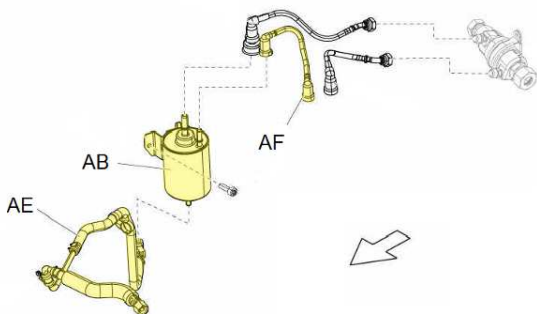
41. Dismantle the fuel filter and low pressure lines following scrupulously the instructions detailed in the Workshop Manual available on the Portal.

The items listed in the following template must be replaced before reassembling:

Ref.	Description
AB	Fuel Filter
AE	Pipe
AF	Pipe

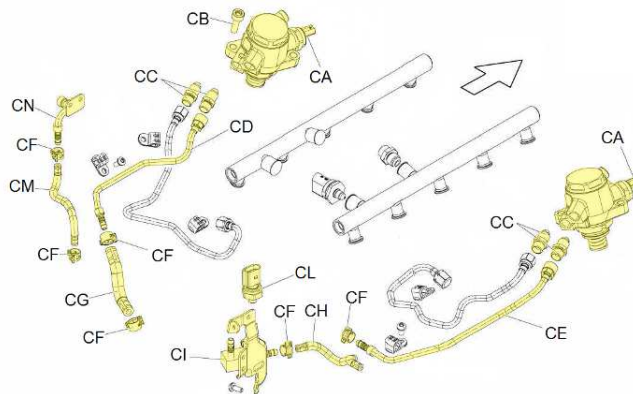
42. Disassemble the feeding pipes and the high pressure pumps following scrupulously the instructions reported in the Workshop Manual.

The items in the following template must be replaced before reassembling:

Ref.	Des.
CA	High pressure pump
CB	M8X30 Screw
CC	Union pipe
CD	Pipe
CE	Pipe
CF	Clamp
CG	Pipe
CH	pipe
CI	Union
CL	pressure sensor
CM	Pipe
CN	Union

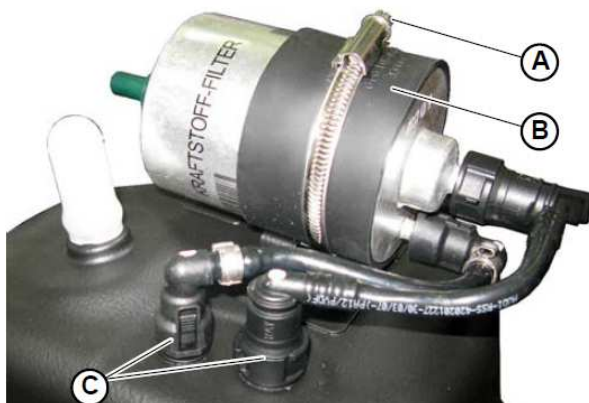
43. Install Low pressure lines together with the new fuel filter and the protection tube (B).

Fasten the clamp (A). to secure the filter

Connect the low press. lines and check the terminals are correctly inserted (C).

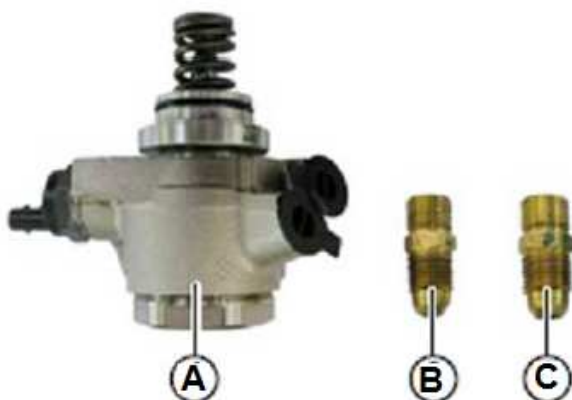
44. Connect the new high pressure pump (A) to the supplied union (B,C).

Screw the new union to the pumps without tightening.

Always Replace the union after every disassembly.
Use always new components. The Reemployment of used parts may cause damages to the vehicles.

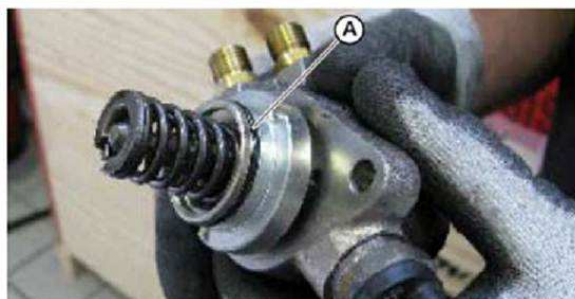
45. Soak with engine oil the seal ring (A) before installing the pump.

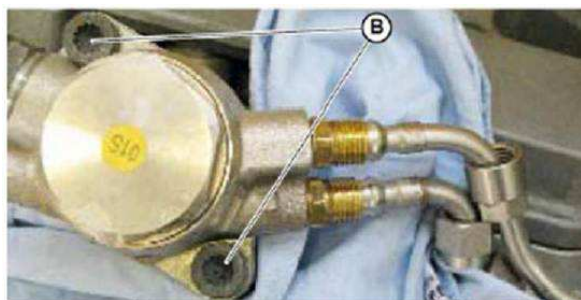
46. Install the pump and fasten them with the supplied screws (B). Alternate to each fasteners 2 turns of screws making the pumps perfectly adhere to their lodge.

Check the pumps are correctly installed on their own lodges, then tighten the fasteners.

Torque: **22Nm.**

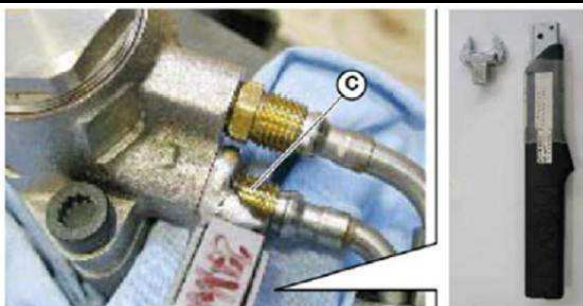
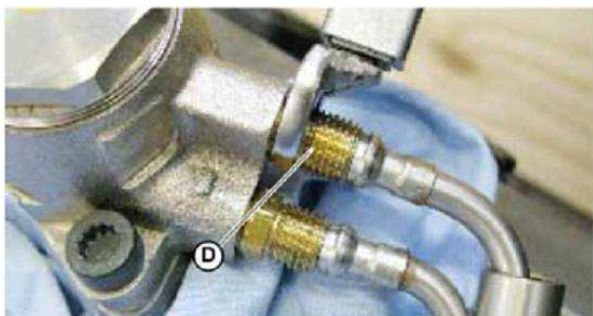
47. Torque the unions (C,D) you have previously installed on the pumps.

Torque: **35Nm.**

Perform the tighening before fitting the steel tubes.

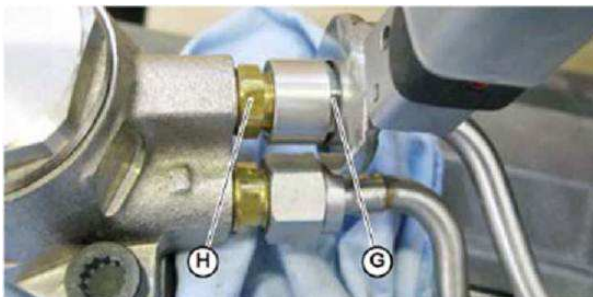
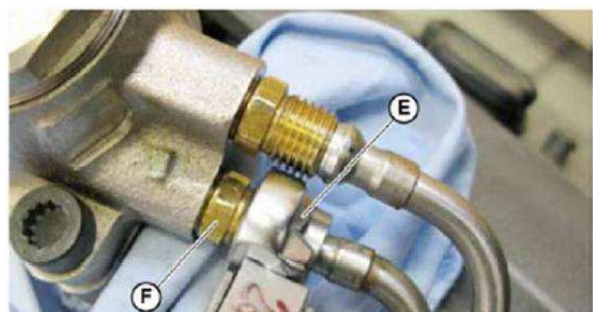
48. Assemble the feed and high pressure lines made of steel. Tighten the nut (G,E) to the pumps (H,F).

Junction tightening (H,F).
Torque : **25Nm**.

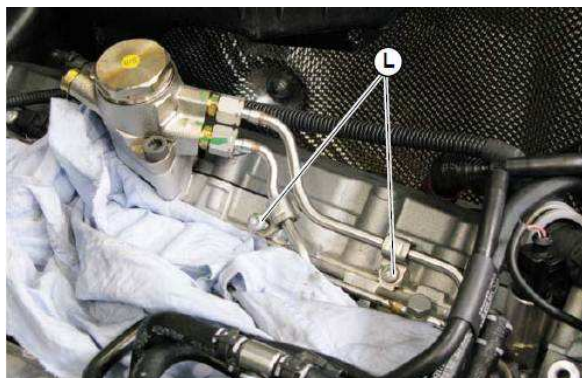
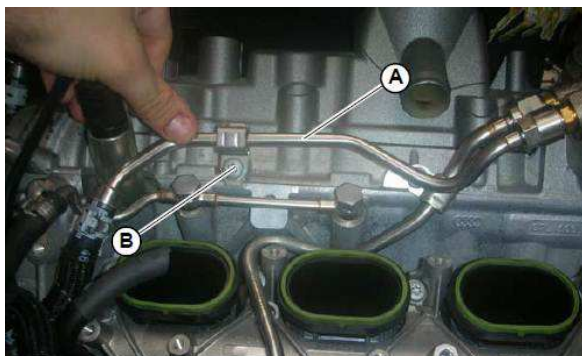
49. Fasten the feed and high pressure lines made of steel to the engine with the fasteners (L,B) removed during the preliminary dismantling operation.

Line tightening (L;B).
Torque: **7Nm + 90°**

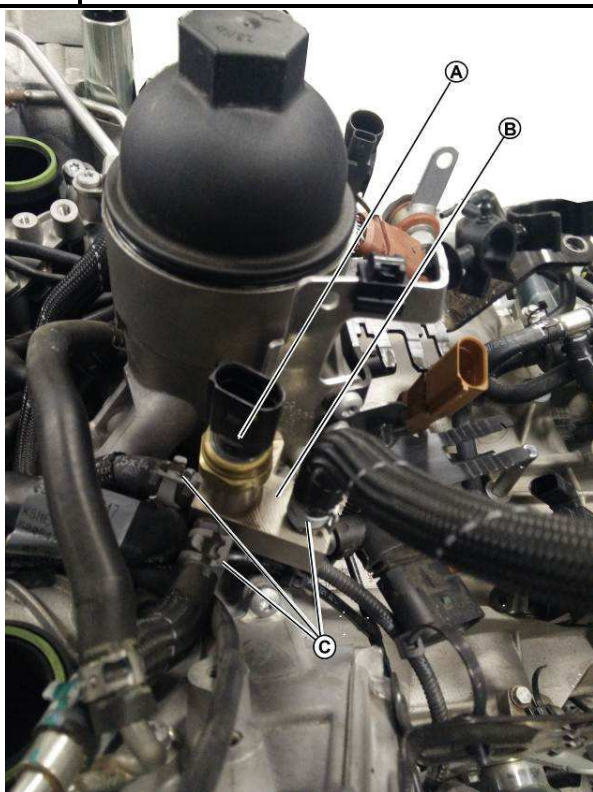
50. Install the mounting (B) of the fuel pressure sensor then fit the new sensor (A). Fasten the fuel lines with the supplied clamps (C).

Remark:
Replace clamps at every disassembly.

Tightening of sensor and mounting fasteners
Fuel sensor torque (A): **15Nm**;
fastener torque (B): **9Nm**.

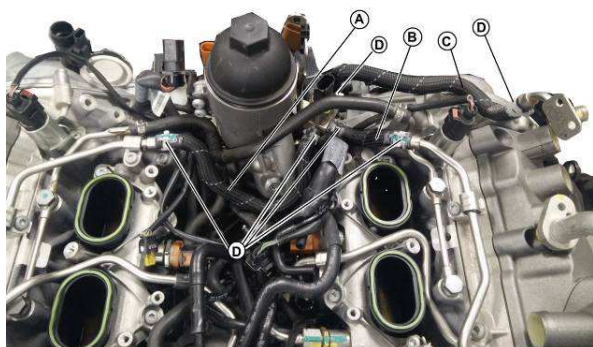
51. Install the feed rubber hoses (A,B,C). fasten the ilnes with the supplied clamps (D).

Replace the calmps at every dismantlemnt .

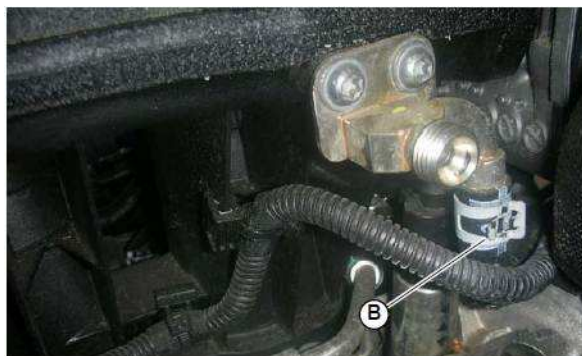
52. Fasten to the engine the feed lines which were previously installed at step 43 by the Union (B).

Torque: 28Nm

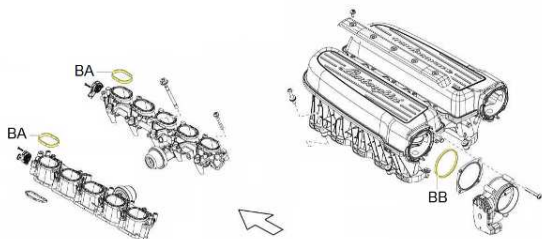
53. Restore the vehicle following the workshop instructions for the intake manifold consultable on the Dealer Portal.

The items here below must be replaced before the re-assembly get started:

Ref..	Desc.
BA	Seal ring
BB	Seal Ring

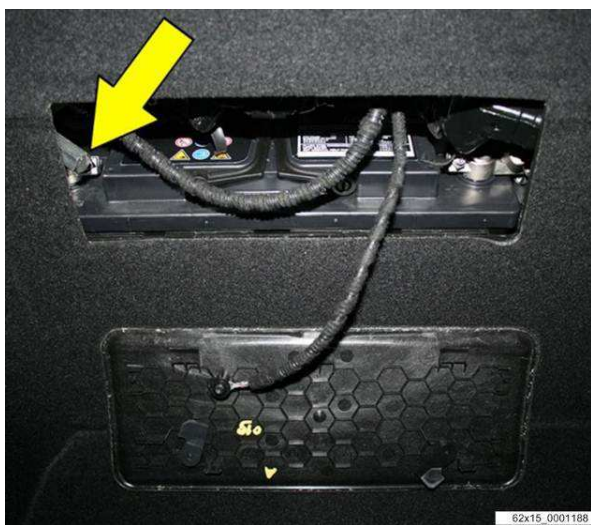
54. Access to the trunk and connect again the battery clamp to the negative post:

Torque: 5Nm.

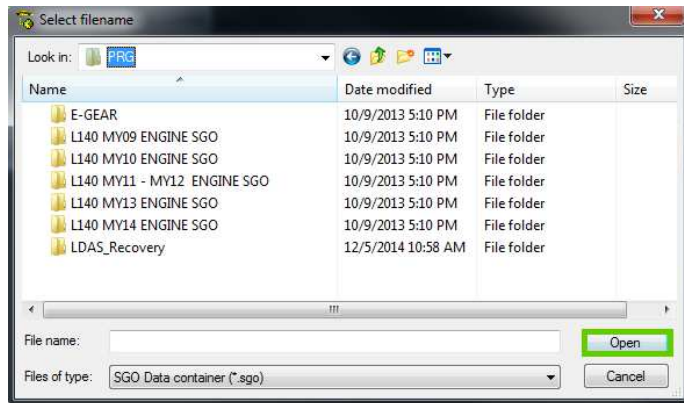
55. If no file is present in the default folder identified by the vehicle VIN:

it is necessary to select a different path (C:\RA Consulting\LaRA\PRG)

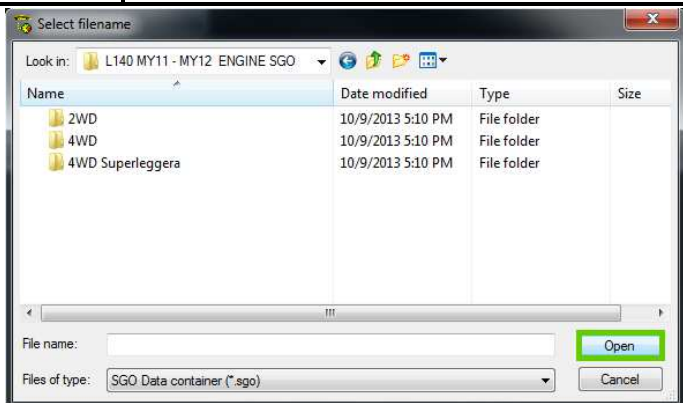
57. In the next dialogue box select the row which corresponds with the vehicle model type (e.g. if the vehicle is a Superleggera, select “4WD Superleggera”) and click “Open”.

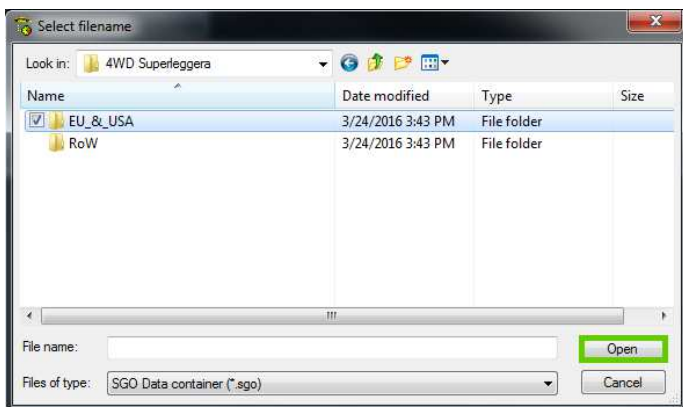
58. Then select the correct market (e.g. for a European market vehicle select “EU_&_USA”) and click “Open” again.

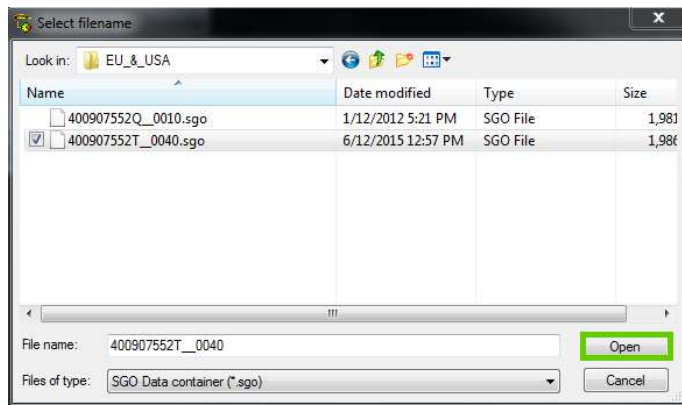
59. Select the correct SGO file with the following table:

(e.g. the correct software for a MY11 “Superleggera”, for European market is 400907552**T**, version: 0040)

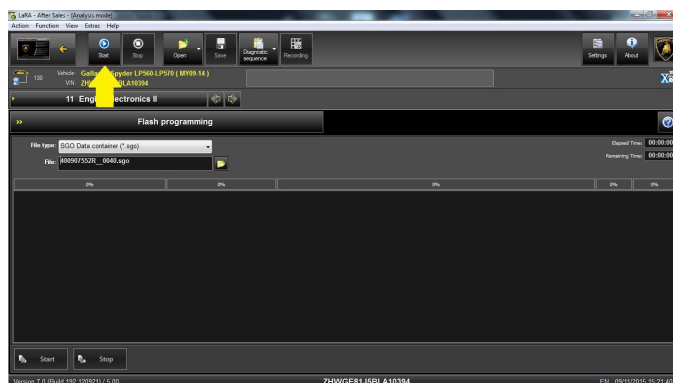
60. At this point the SGO file is correctly selected and it is possible to proceed with the installation following step **Errore. L'origine riferimento non è stata trovata.** and **Errore. L'origine riferimento non è stata trovata.** of this bulletin.
