L73X-
A.02.16

To: Official After Sales Network
Subject: Engine SW update
Date: January 15, 2016
Pages: 22

Subject.
Engine SW update

Model.
Aventador Coupè and Roadster;

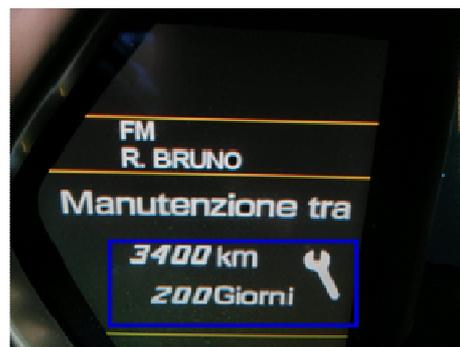
If instrument cluster ECU has to be updated, it is necessary to take note of distance and days to next service, shown in the instrument cluster menu.

(e.g 3400 km and 200 days)

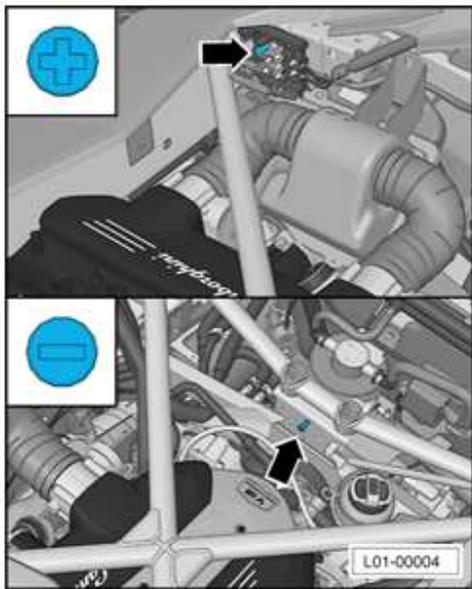
2. Please connect a battery charger to the recharge points available in the engine bonnet, as shown in picture.

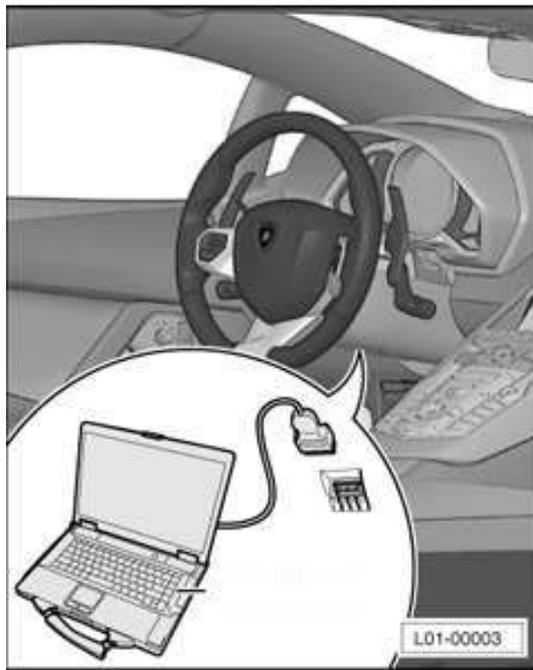
3. Please connect the VAS5054 interface to the vehicle's OBD plug and to the diagnostic laptop.

Turn the ignition ON

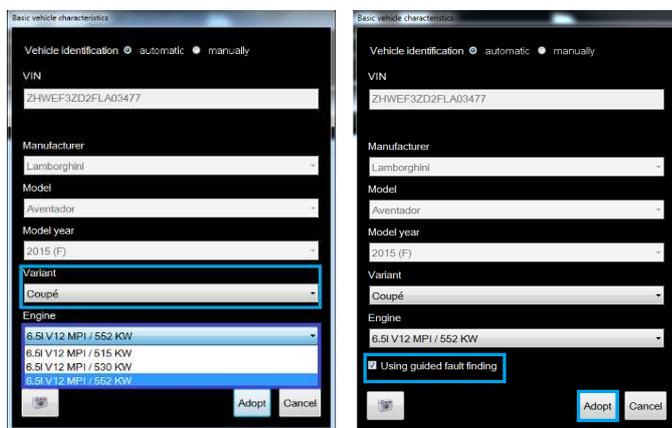
7. Check the vehicle identification on the window “Basic vehicle characteristics”.

Select the Variant (Coupe’ or Roadster) in the related menu.

Then select the Engine type (515 – 530 or 552 kW) in the related menu.

Leave the checkbox “Using guided fault finding” marked.

Click “Adopt”

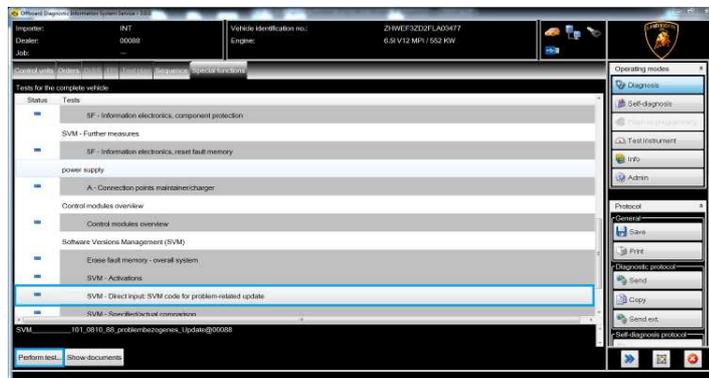
12. Select “SVM – Direct input: SVM code for problem related update” clicking the related row.

Click “Perform test...” to execute the SVM function.

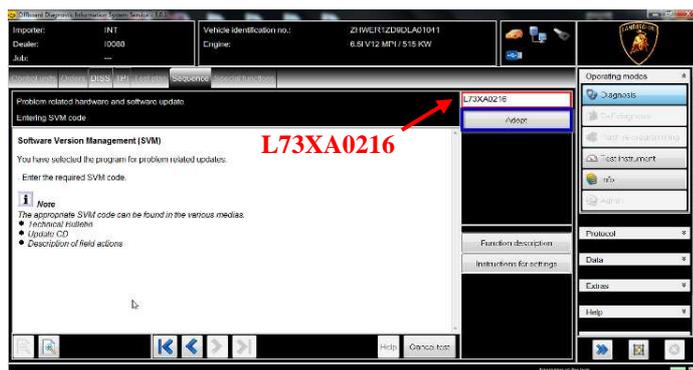
13. Insert in the upper box with the cursor the code: L73XA0216

Click “Adopt”.

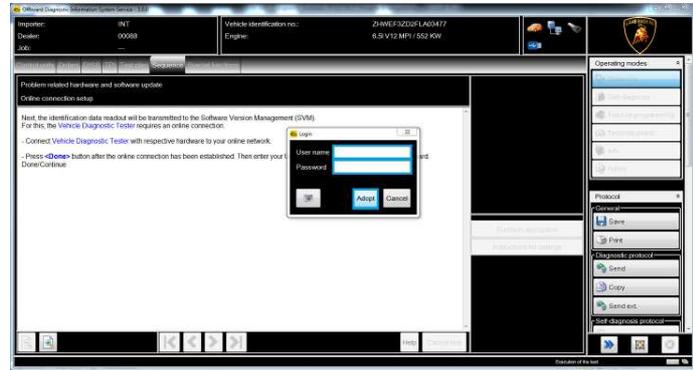
17. For the online authentication a valid GeKo account is necessary.

Be sure that your internet connection is working properly.

Click on “Done/Continue” to access the Login window.

Insert your GeKo user name in the field “User Name” and the pin 1324 + current 6 digit code displayed on your GeKo token in the field “Password”.

Then confirm clicking “Adopt”.

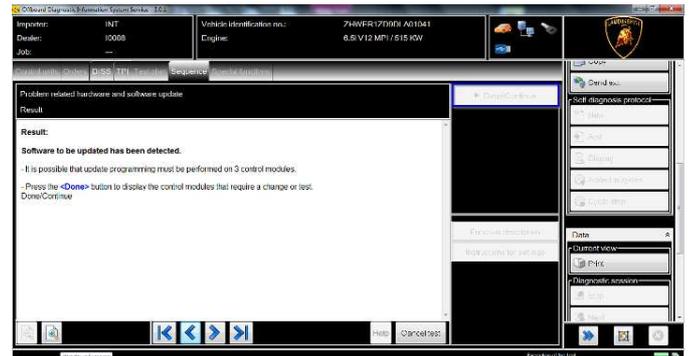
18. The communication is then established with the central server.

If you have not updated gearbox and instrument cluster softwares yet, at the end of communication you will receive the following feedback:

“Softwares to be updated have been detected (on **three** control units).”

Click “Done/Continue”.

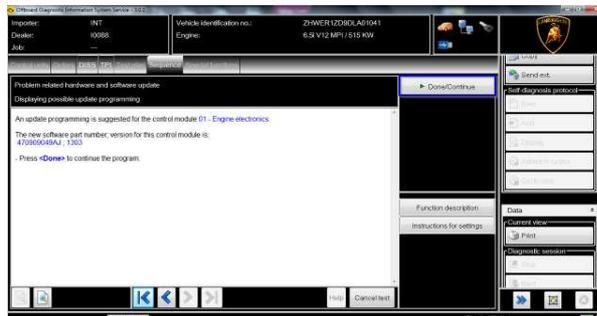
Aventador MY 13 was used in order to provide example pictures. Software versions refer to it and might vary with another vehicle.

In the picture below, software 1303 for ECU 01-Engine electronics is represented as an example.

Possible other updates are:

SW for 02 - gearbox electronics (e.g. 0937)

SW for 17 - instrument cluster (e.g. 0062)

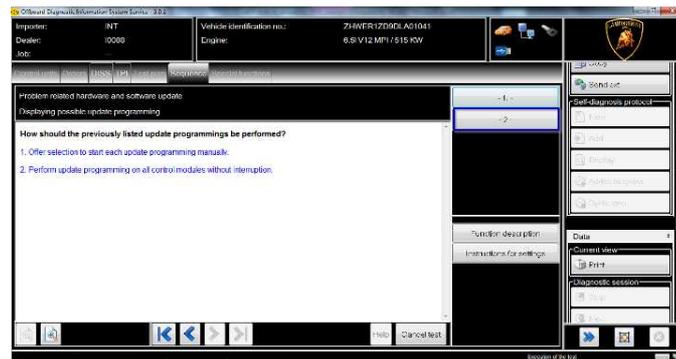
23. Click “2” to confirm the update of all ECUs without interruption.

Once an update starts it is not possible to interrupt it. Please make sure that the battery is in charge and do not remove the diagnosis interface until the end of the operation.

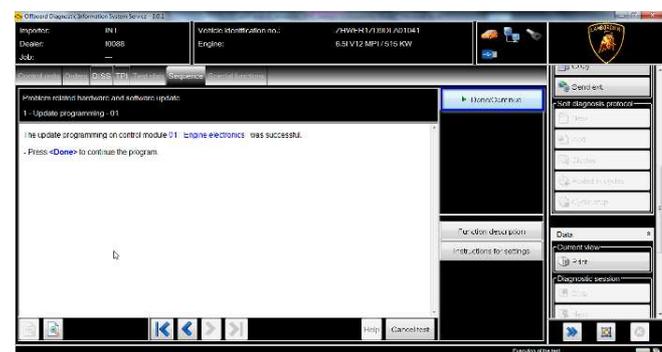
26. At the end of the update a feedback is shown.

Click “Done/Continue” to start the next ECUs update.

If the update has not been completed or has been unsuccessful:

Turn the ignition OFF;

Wait one minute before turning the ignition ON again;

click “Repeat” if asked by the program to retry to update, otherwise repeat the procedure from point 11.

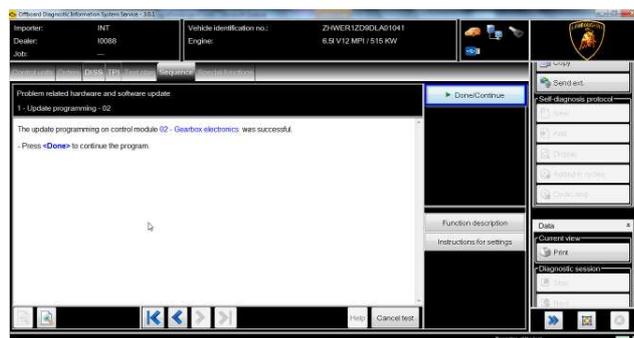
28. At the end of the update a feedback is shown.

Click “Done/Continue” to start the next ECUs update.

If the update has not been completed or has been unsuccessful:

Turn the ignition OFF;

Wait one minute before turning the ignition ON again;

click “Repeat” if asked by the program to retry to update, otherwise repeat the procedure from point 11.

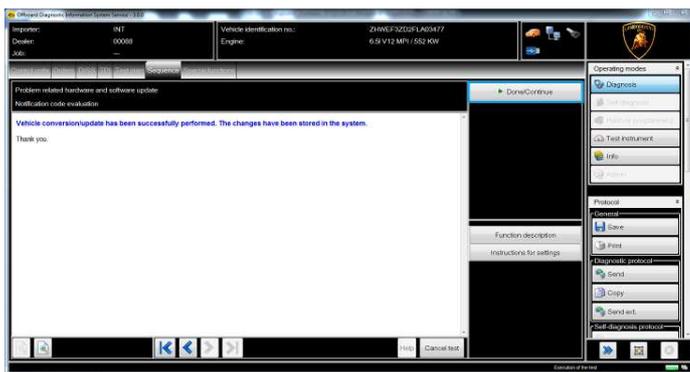
37. Once the data report has been sent to the server a feedback is displayed as in the picture below.

The software update has been completed successfully and all data have been stored in the system.

Press "Done/Continue" to exit the program.

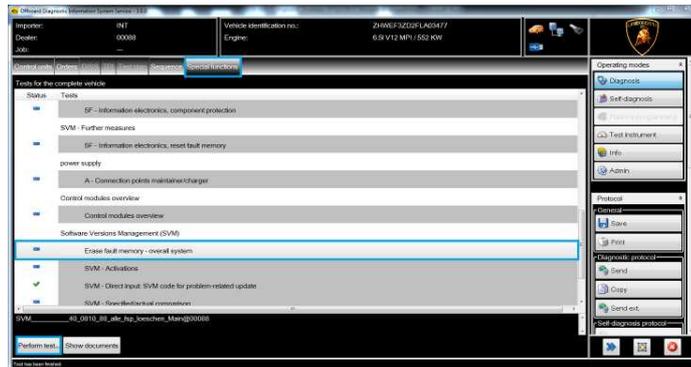
39. Go back to the tab "Special functions" and select "Erase fault memory – overall system" to clear all the faults stored because of the recent software update.

Execute "Erase fault memory – overall system" clicking "Perform test...".

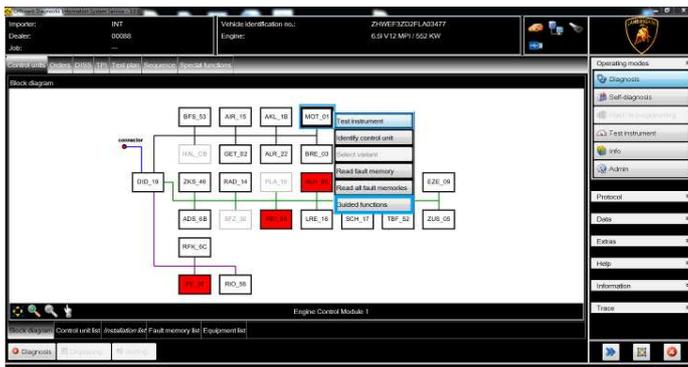
43. To verify that the update ended successfully select ECU “MOT_01 – Engine Control Module 1” and right click it to open the menu and choose “Guided Functions”.

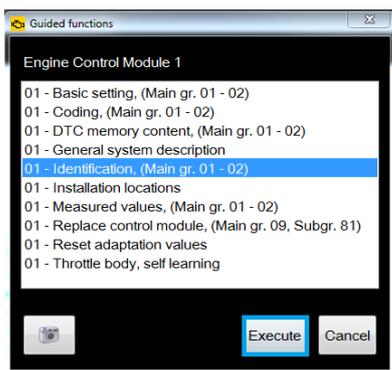
44. Select “Identification, (Main gr. 01-02)” and click “Execute”.

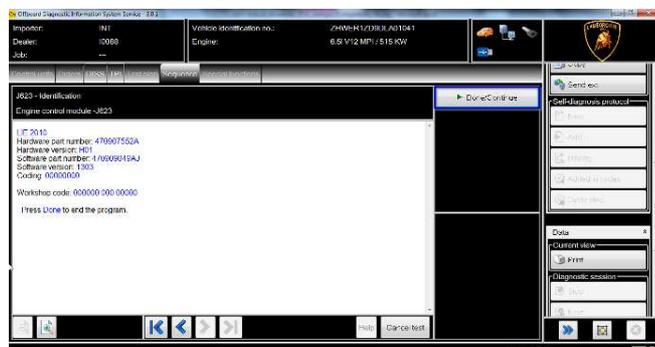
45. Verify that the SW version installed.

(e.g. SW N° 1303 for Aventador MY 13).

Click “Done/Continue”.

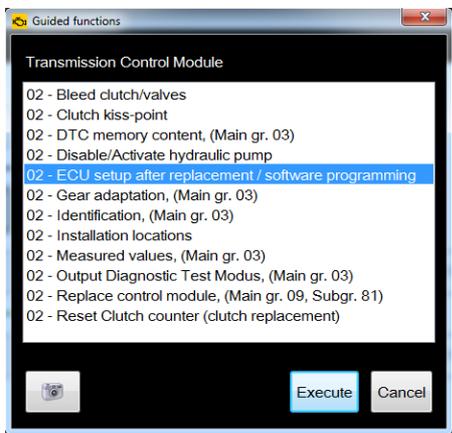
47. Go to Control Unit tab to select the gearbox ECU GET_02 guided function:

“02 – ECU setup after replacement / software programming”

Click “Execute”.

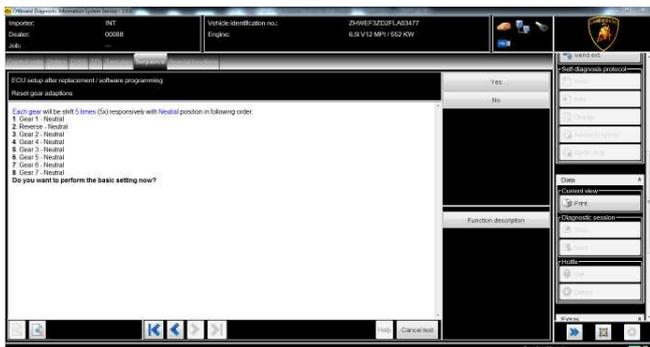
53. Click “YES” to start the basic setting.

You can check on the instrument cluster the gear shifting.

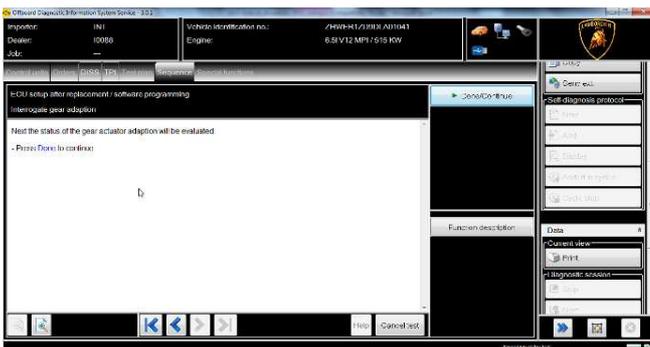
54. Click “Done/Continue” to evaluate the gear actuator adaption.

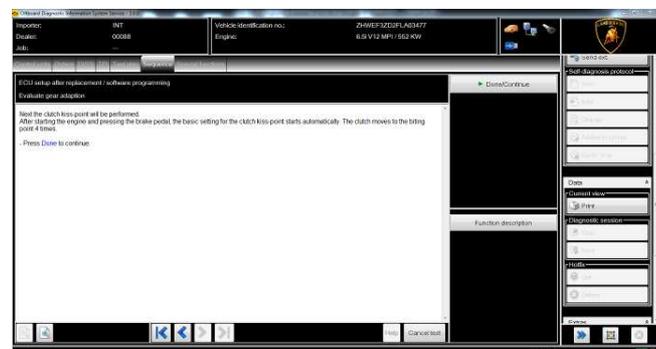
56. Click “Done/Continue” to perform the clutch kiss point test.

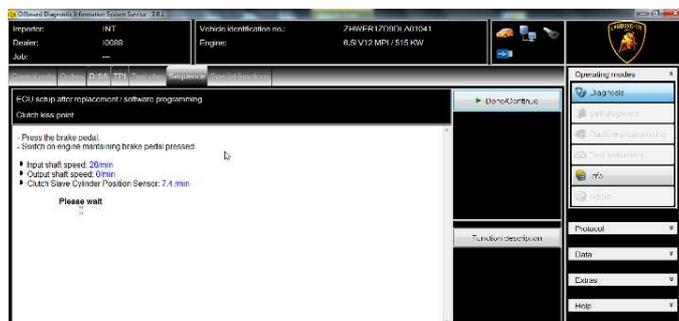
57. Press the brake pedal and start the engine.

Keep the brake pedal pressed until the end of the basic setting. (approx. one minute).

If you cannot turn the engine ON:

- Turn the key off;
- Disconnect the diagnosis interface;
- Wait at least one minute before turning the key on again;
- Connect the diagnosis interface again and start back from point 47.

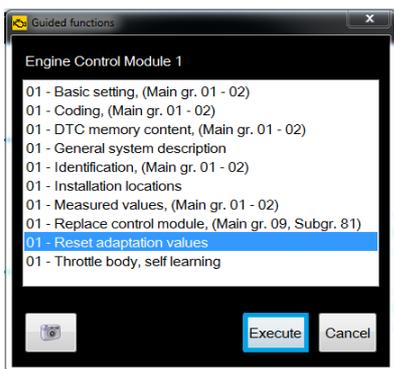
59. Go back to the Control Unit tab to select the Engine ECU MOT_01 guided function:

01 – Reset adaptation values.

Click “Execute” to start the procedure to reset adaptation values (Basic Setting 254).

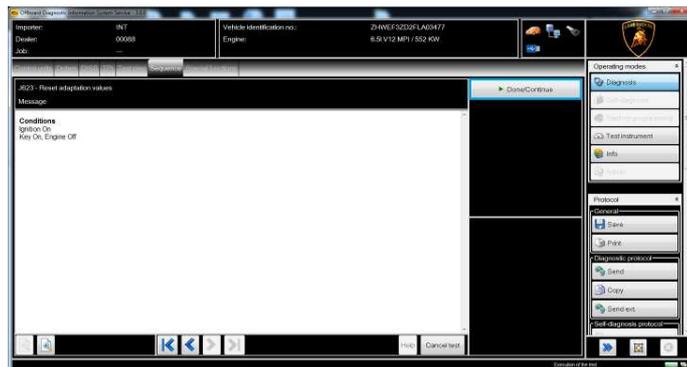
62. Make sure the activation conditions are respected:

- key ON;
- engine OFF;
- no faults stored in the Engine ECU memory.

Click “Done/Continue”.

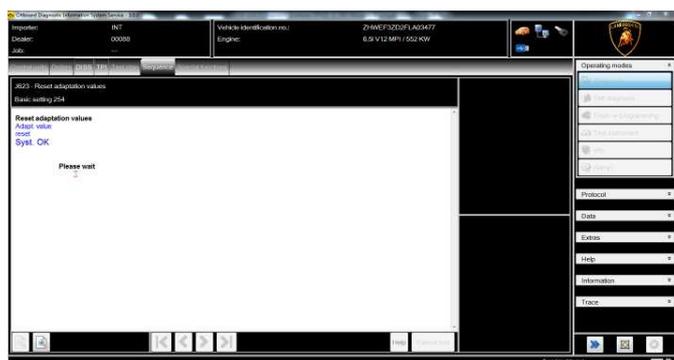
65. Wait until the feedback message is shown.

If the procedure has been performed successfully, the message “Syst.OK” will appear, as shown in the picture below.

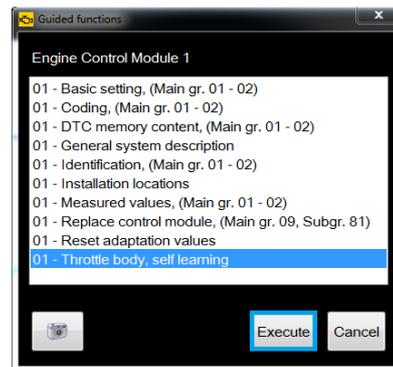
67. Go back to the Control Unit tab (block diagram or list view) to select the Engine ECU MOT_01 guided functions .

Select “01 – Throttle bodies, self learning” function and click “Execute”.

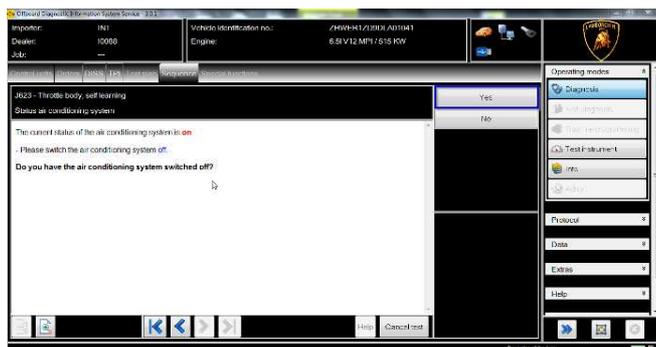
70. If you did not switch air conditioning OFF a warning message will appear.

Turn air conditioning OFF and click “Yes”.

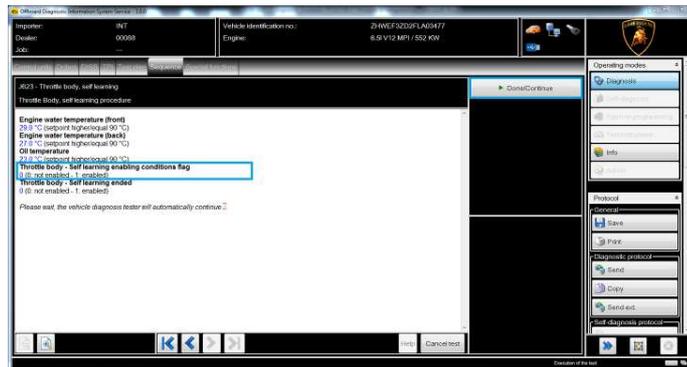
71. Self learning is an automatic procedure which is activated when engine water and oil temperature reach 90 °C.

Check the parameters from ODIS and wait until water and oil temperatures reach the target.

Don't perform any action on the car (e.g. pushing the accelerator pedal) if not necessary.

Once the conditions are met (water and oil temperature above 90°C) the “Throttle body – Self learning enabling conditions flag” switches from 0 to 1 indicating the beginning of the self-learning procedure.

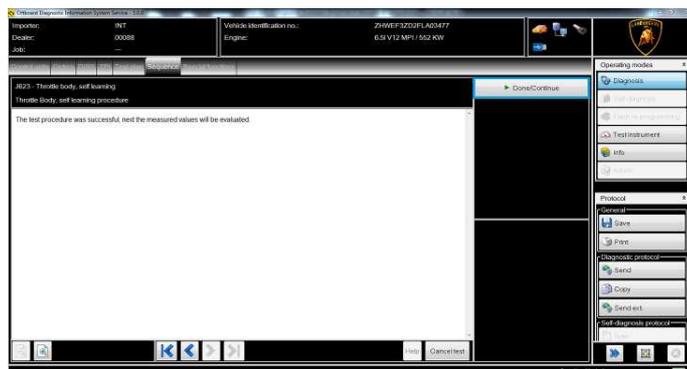
72. If the self-learning has been completed successfully a screen as in the picture below is shown.

Click “Done/Continue” to display the ignition advance values.

If the procedure has not been completed correctly:

- Switch the ignition OFF;
- Wait one minute before switching the ignition ON again;
- Restart the procedure from step 67.

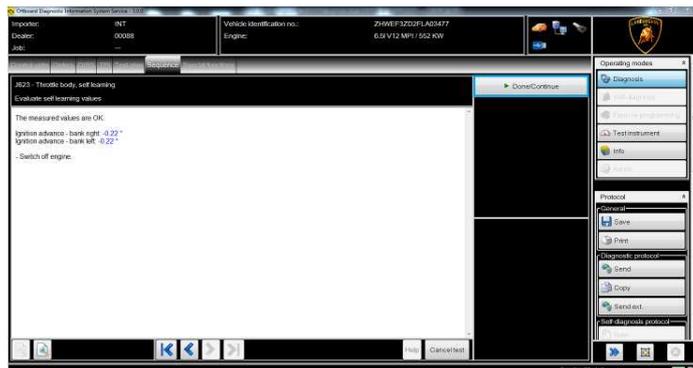
73. Ignition advance values must be inside the range [-2° 3°].

Switch the engine OFF and press “Done/Continue” to exit the program.

If these values were out of the range restart the procedure from step 67, leaving ignition Key OFF for at least one minute .

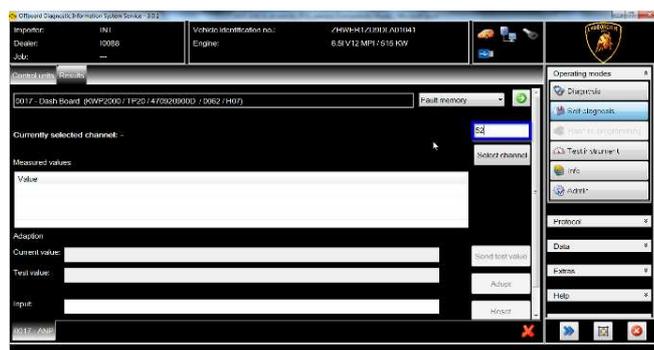
78. Write “52” in the channel box and click “Select channel” as shown in the picture.

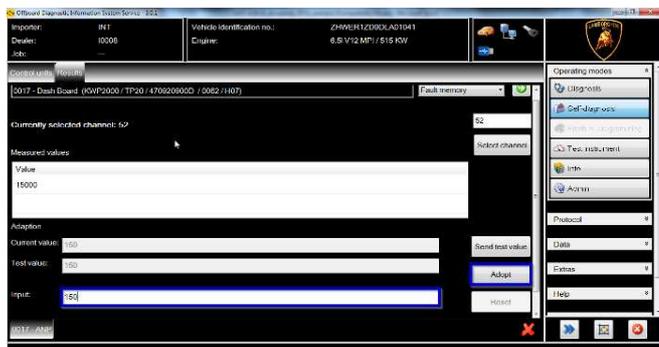
79. Insert the distance to next service divided by 100 in the input box.

(e.g. write 150 for 15000 km to next service)

Click “adopt”.

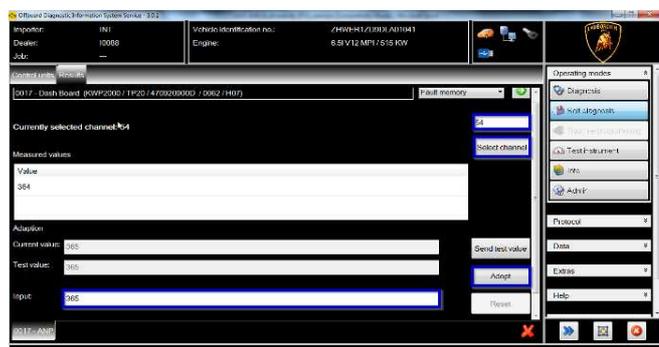
80. Write “54” in the channel box and click “Select channel”.

Then insert the days to next service in the input box.

(e.g. write 365 for 365 days to next service)

Click “adopt”.

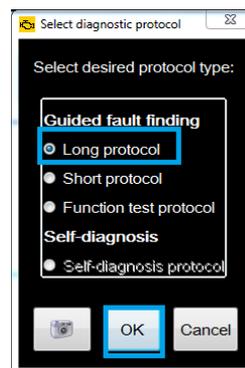
- **Long protocol.**

Clicking its row and then “OK”.

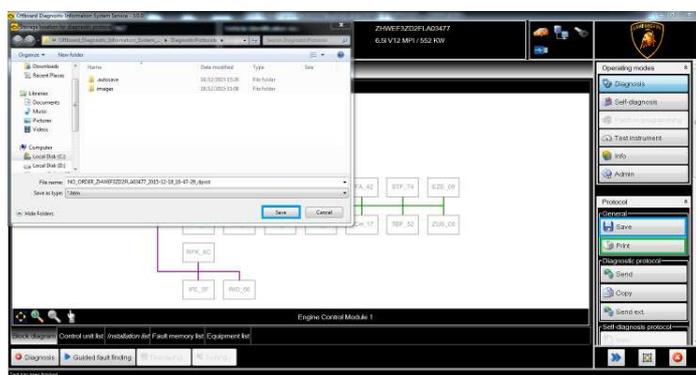
Click “Print” in the subgroup of buttons “General” to print the protocol directly on a pdf file (if Adobe pdf is installed) or in paper format sending it to a printer.

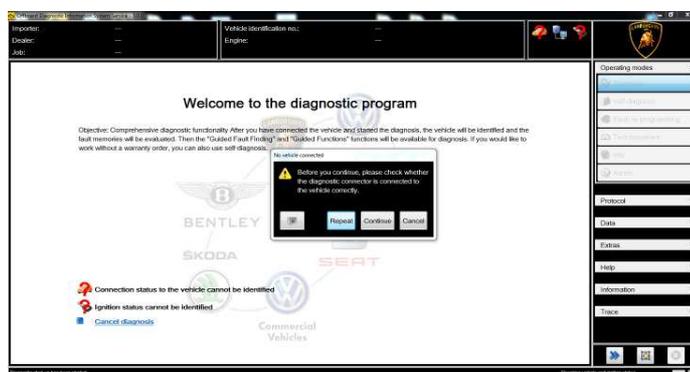
A. If the error message regarding the VAS5054 interface and the two icons for status of on board connection and key ON are shown as in the picture below:

- Click “Cancel”;
- Repeat the VAS5054 HW interface installation following the procedure (*) “VCI Manager v2.0”, by entering in the menu “Extras” on the right side and clicking on “Diagnostic interface”.

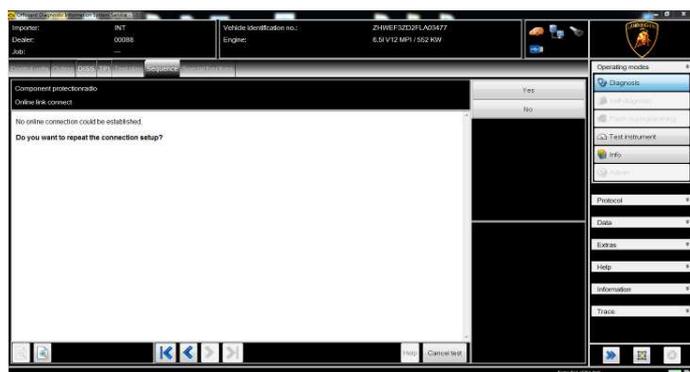
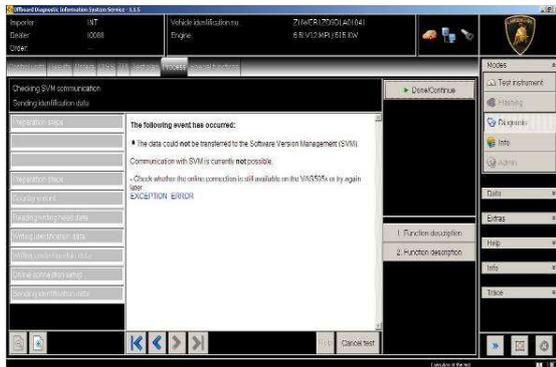
B. If one of the connection error screens is shown as in the pictures below:

- it is not possible to establish a connection with the central server. Please check carefully that the diagnosis laptop is properly connected to the internet network and retry clicking “Yes” or “Done/Continue”.

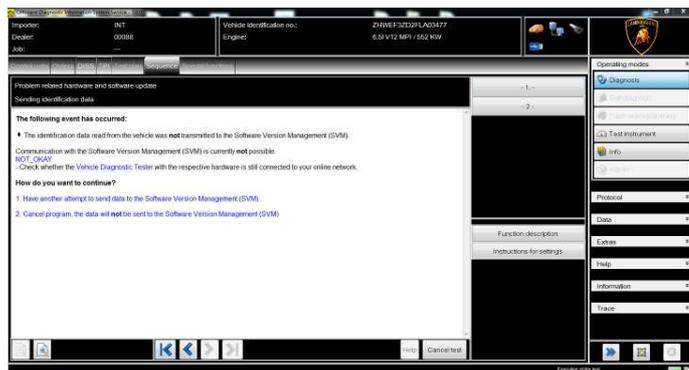
C. If the loss of connection happens during the target/actual comparison during SVM procedure:

- It is not possible to connect to central server, check the working connection of internet and retry by clicking “1”.

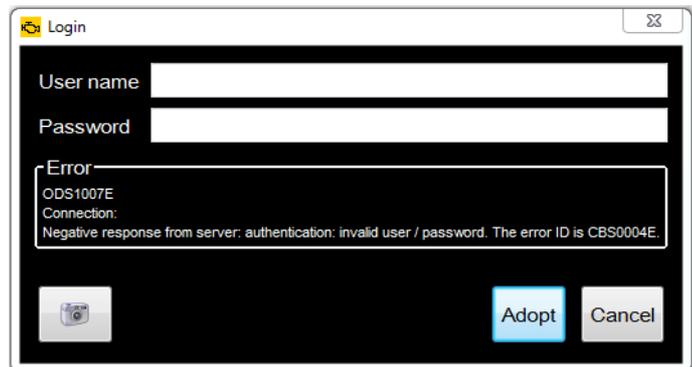
D. If the incorrect identification message is shown as in the picture below (error code: ODS1007E):

- be sure that your Geko account is valid;
- be sure that the label “Geko” is written on the token that you are using for the authentication;
- be sure the Password inserted is correct;
- click on Cancel and perform the application test (see document “ODIS_Checking_ConnectionServer_SVM_2.0” (*)).

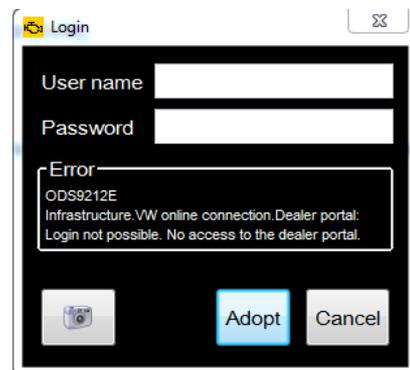
E. If the infrastructure error message is shown as in the picture below (error code: ODS9212E):

- be sure that your Geko account is valid
- be sure that the label “Geko” is written on the token that you are using for the authentication
- verify in ODIS settings you have “Internet” instead of “CPN” (see document “ODIS_Initial_Setup_2.0” (*))
- click on Cancel and perform the application test (see document “ODIS_Checking_ConnectionServer_SVM_2.0” (*))
