L83X-
A.04.14

Drivability enhancement

All Lamborghini Aventador MY 13 and 14 and up to VIN ELA02756.

As a result of continuous product monitoring, Automobili Lamborghini Spa has introduced a new software that manage engine, gearbox and instrument cluster to enhance driveability.

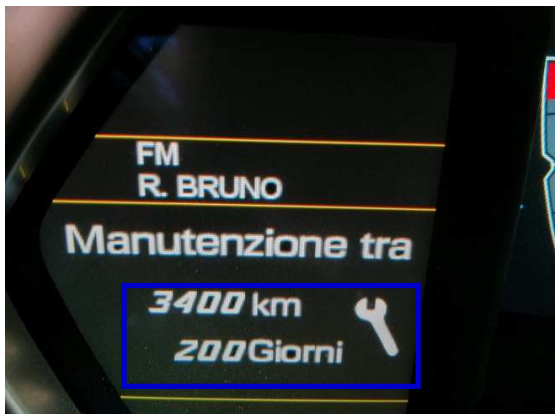
Before starting the drivability package installation procedure, it is necessary to take note of the current service interval status from the specific menu on the instrument cluster.

In this example it is 3400 km and 200 days.

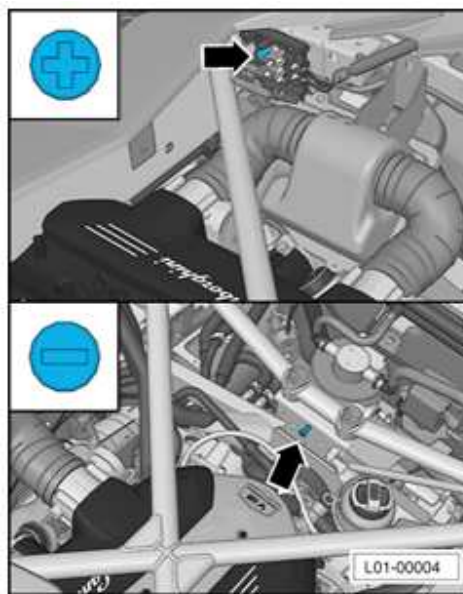
2. Please connect a battery charger to the recharge points available in the engine bonnet, as shown in picture.

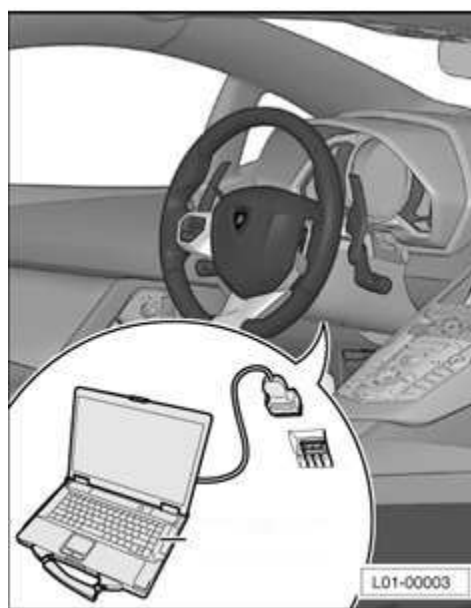
3. Please connect the VAS5054 interface to the vehicle's OBD plug and to the diagnostic laptop.

Turn the ignition ON

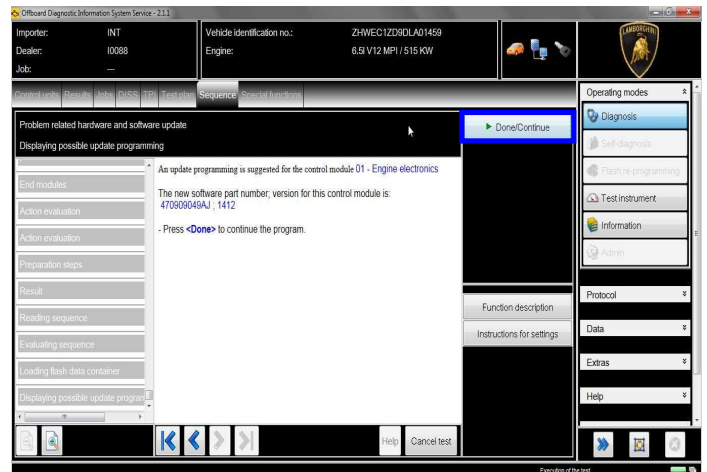
21. Engine Software Update.

Depending on the market and according to car's equipment, new engine software part number and version will be different.

The example in the figure below refer to software version for MY13 Coupe':

470909049AJ; 1412

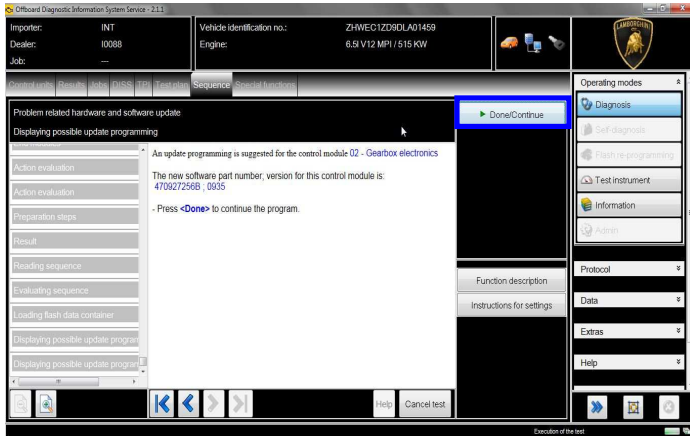
22. Gearbox Software Update.

The example in the figure below refer to software part number and version of the Gearbox.

470927256B; 0937

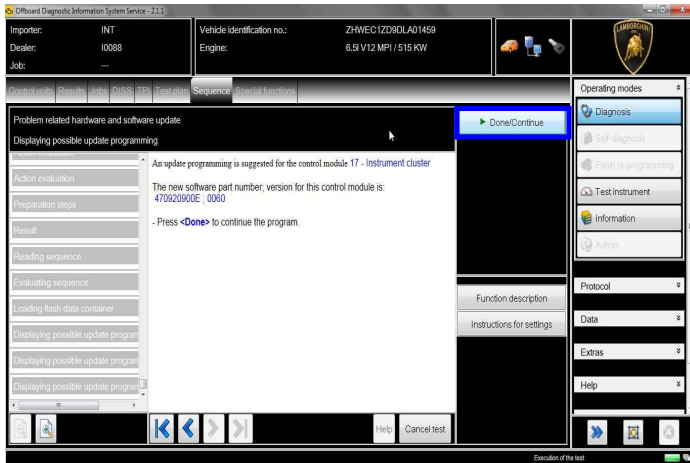
23. Instrument cluster Software Update.

The example in the figure below refer to software part number and version of the Instrument Cluster (Kombi) Software.

470920900E; 0060

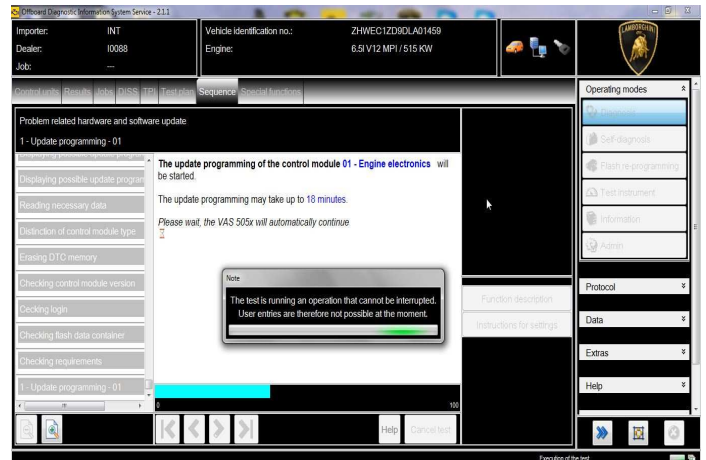
26. Wait until the update programming of the engine ECU is completed.

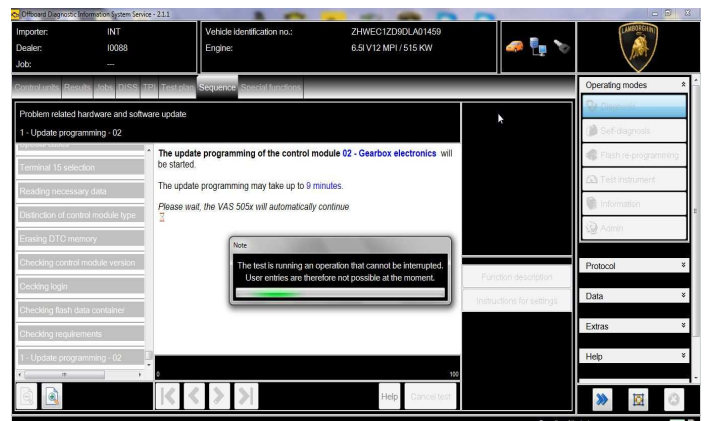
31. Wait until the update programming of the gearbox ECU is completed.

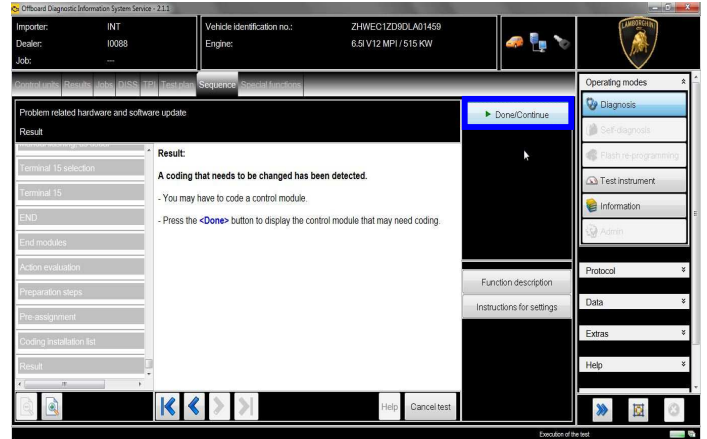
39. New coding has been detected.

Click “Done/Continue” to continue with the coding.

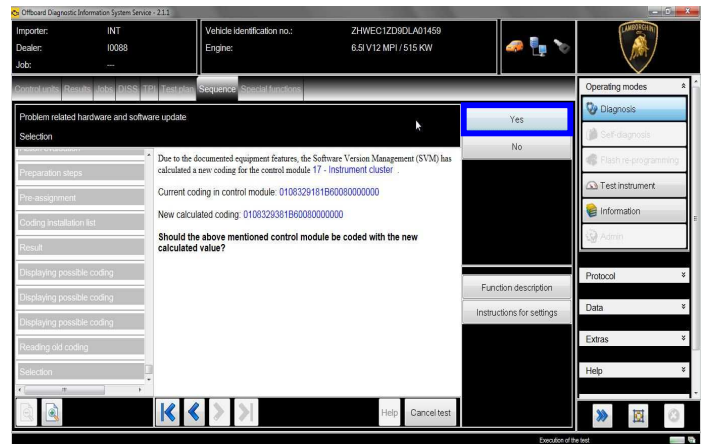
40. New coding has been calculated on execution control unit 17 – Instrument Cluster and it is necessary to write in the ECU.

Click “Yes”.

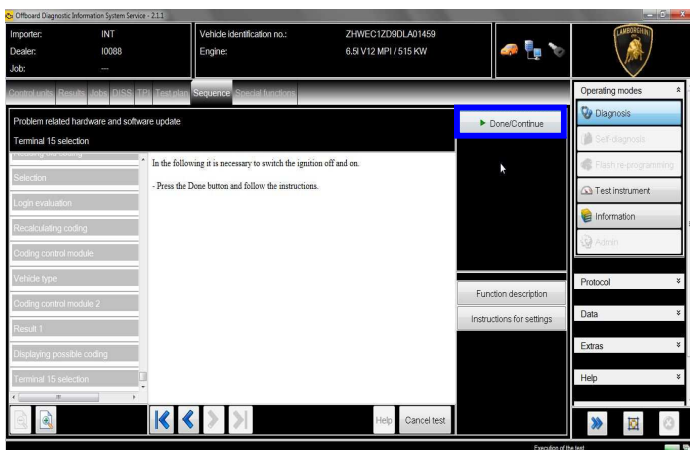
42. In the following an ignition OFF – ON cycle is necessary to restart both the ECUs.
Press “Done/Continue” to continue.

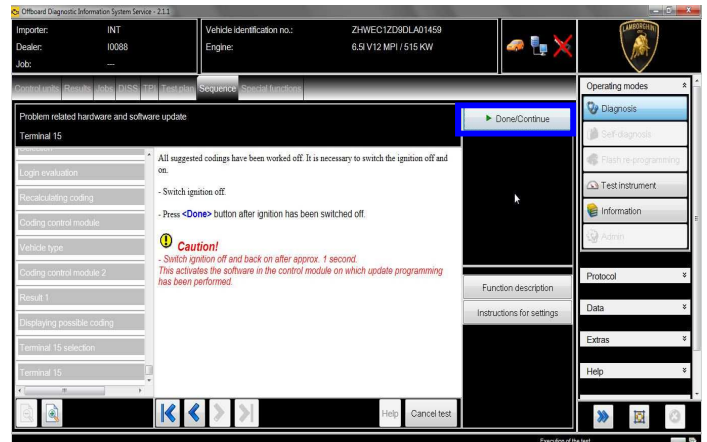
43. Switch the ignition OFF.
Press “Done/Continue”.

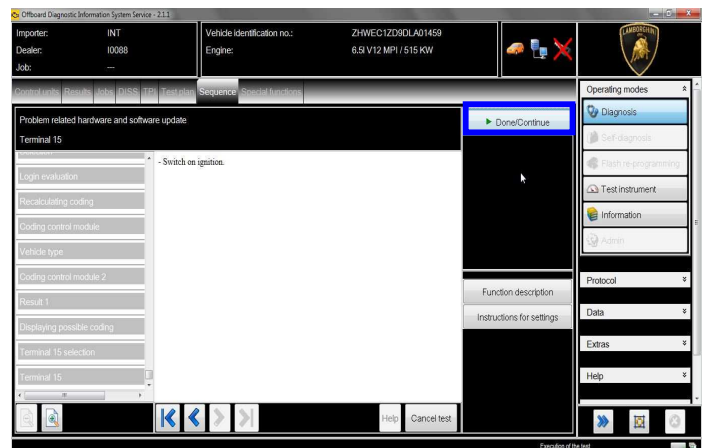
44. Switch the ignition ON.
Press “Done/Continue”.

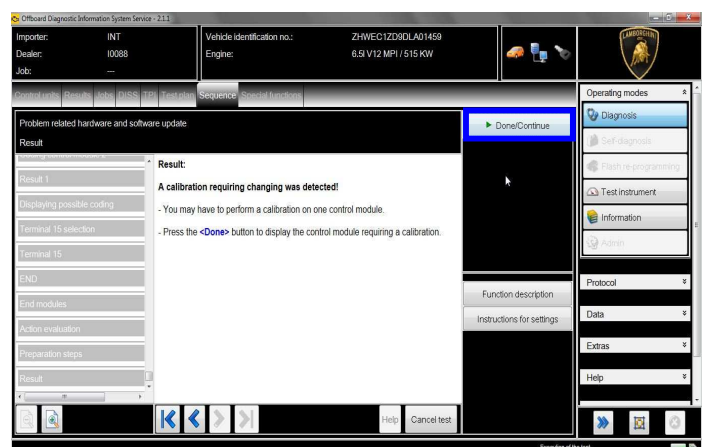
45. A calibration has been detected.
Click “Done/Continue”.

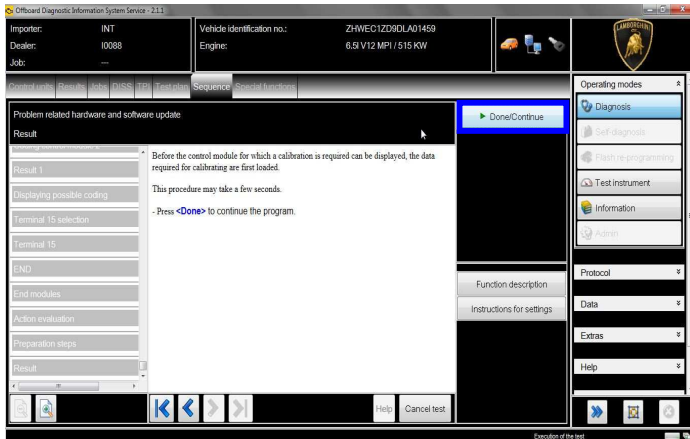
46. Wait few seconds in order to allow the download of all calibration data.

Click “Done/Continue”.

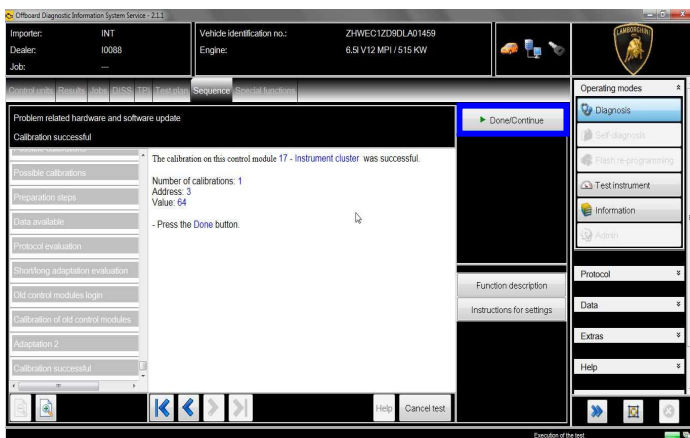
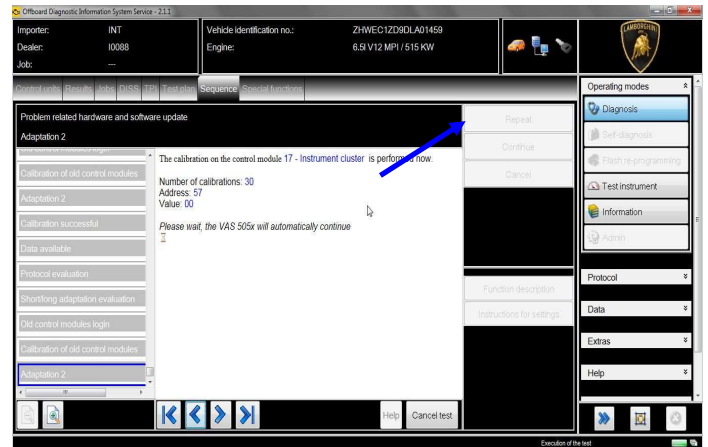
47. Continue with the calibration of the control unit 17 – Instrument Cluster.

Click “Done/Continue” to continue with the calibration of each parameter.

There are 41 parameters to be calibrated.

If the calibration update has not been completed or has been unsuccessful:

- turn the ignition OFF;
- wait 1 minute before turning the ignition ON again;
- if offered by the program: select “Repeat” to retry the update programming, otherwise repeat the procedure from step 46.

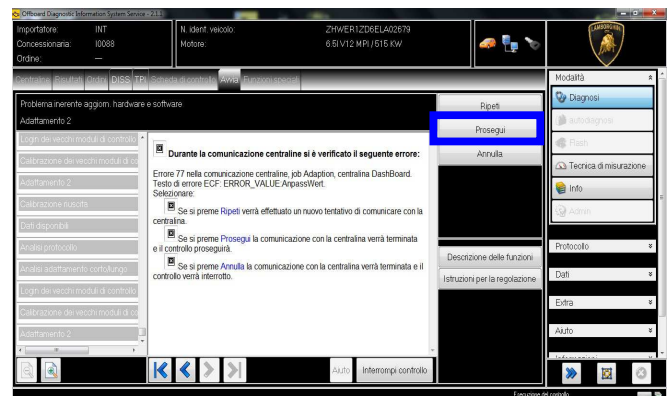
It is possible that the first time the update of the parameters 29 and 30 fails, with the following error in the figure:

In the case there was again the screen with the error of missing communication shown in figure,

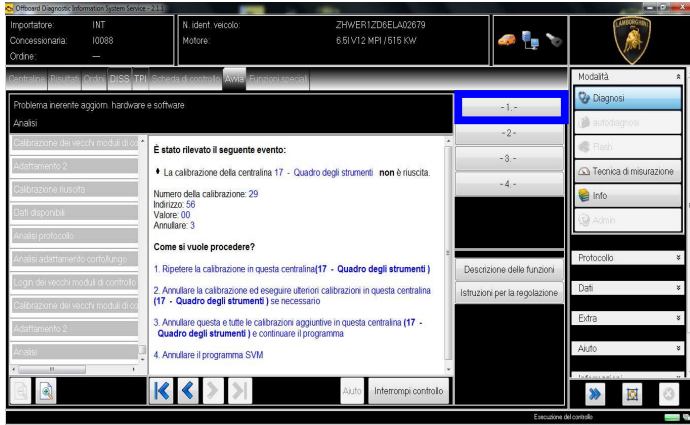
49. Select “1” to repeat the calibration of those parameters starting from step 47

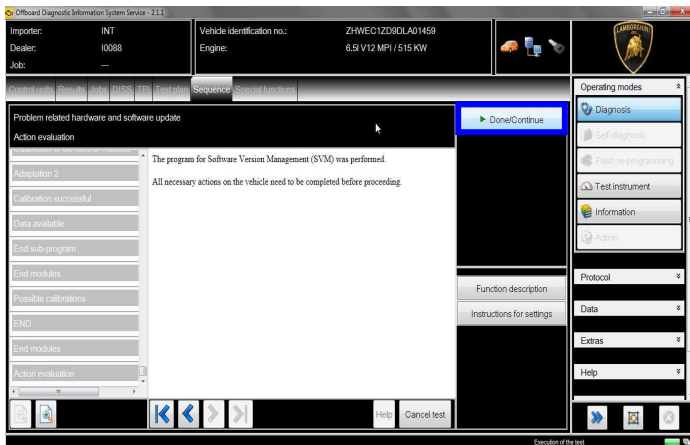
50. Click “Done/Continue” to end the SVM function.

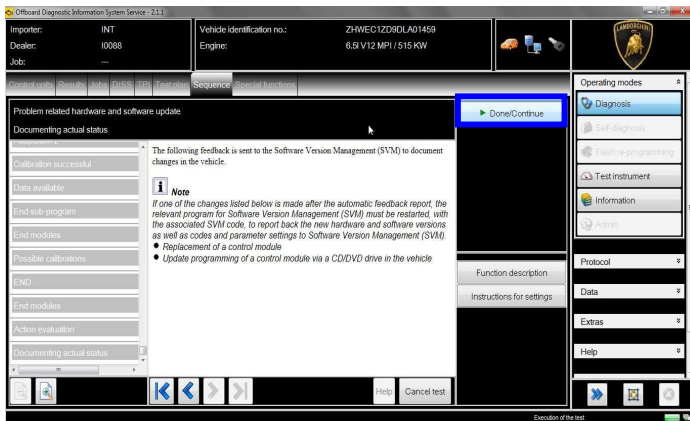
51. SVM can be completed after data acquisition from all ECUs.

Click “Done/Continue”.

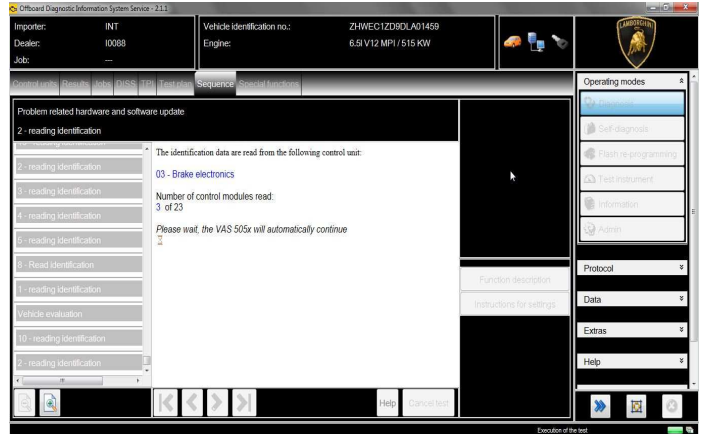
52. Wait until the data acquisition from all the control modules is completed.

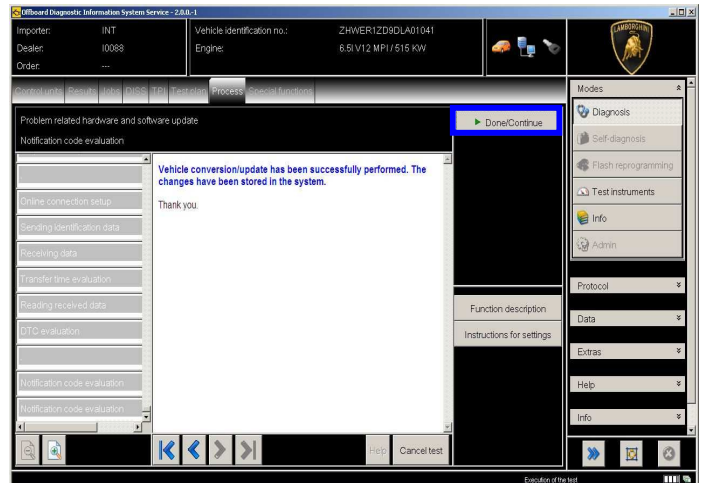
53. Once the data report has been sent to the servers a feedback as in the picture below is displayed.

The software update of engine, gearbox and instrument cluster ECUs has been completed successfully and all the information have been stored in the system.

Press “Done/Continue” to exit the program.

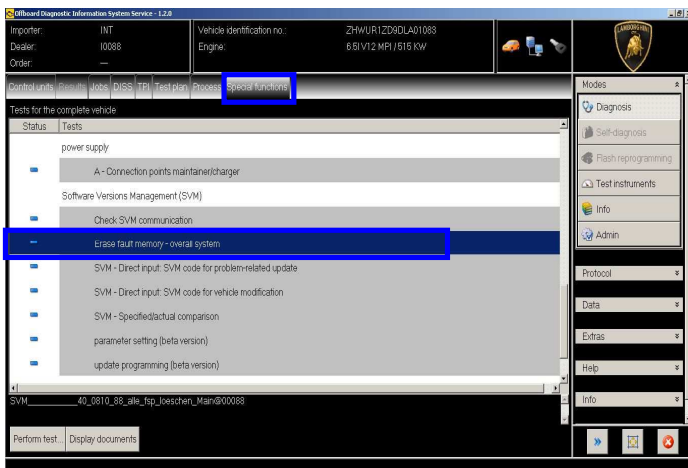
54. Go back to the tab “Special functions” and select “Erase fault memory – overall system” to clear all the faults stored because of the recent software update.

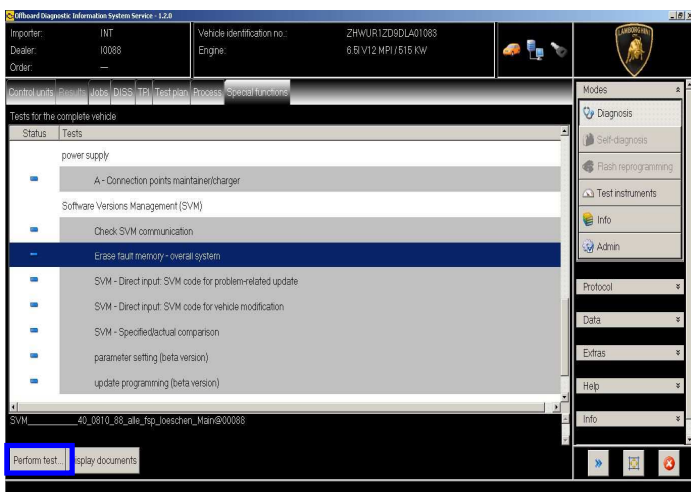
55. Execute the program “Erase fault memory – overall system” clicking on “Perform test...”

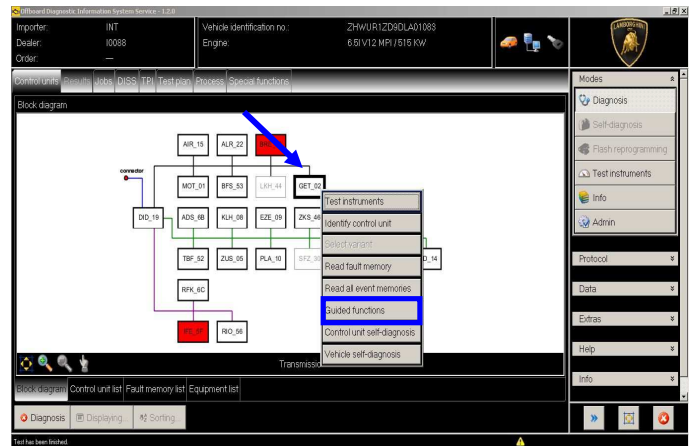
56. Go back to the Control Unit tab (block diagram or list view), to select the Transmission Electronics ECU GET_02 and its Guided Function.

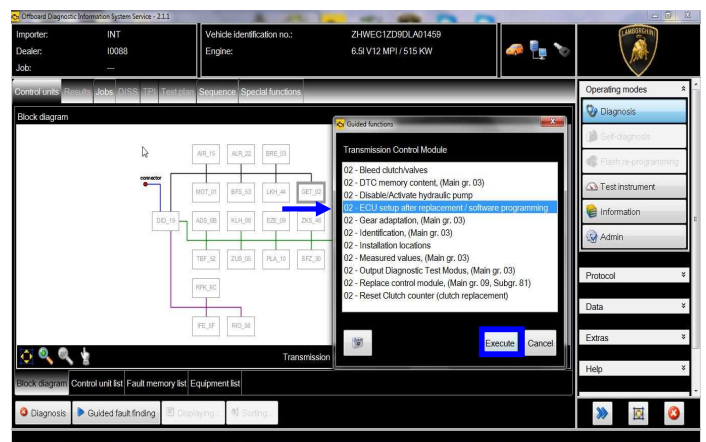
57. Select the function “02 – ECU setup after replacement / software programming” in order to initialize the gearbox ECU.

Click “Execute” to run the test.

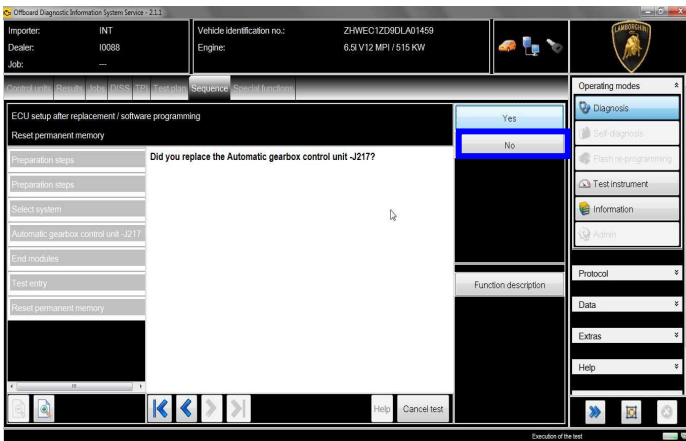
59. Select "NO"

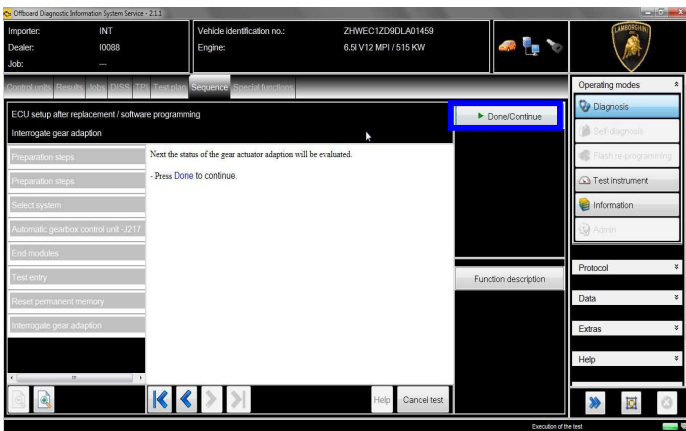
60. The status of the gear adaptation is evaluated.
Click "Done/Continue".

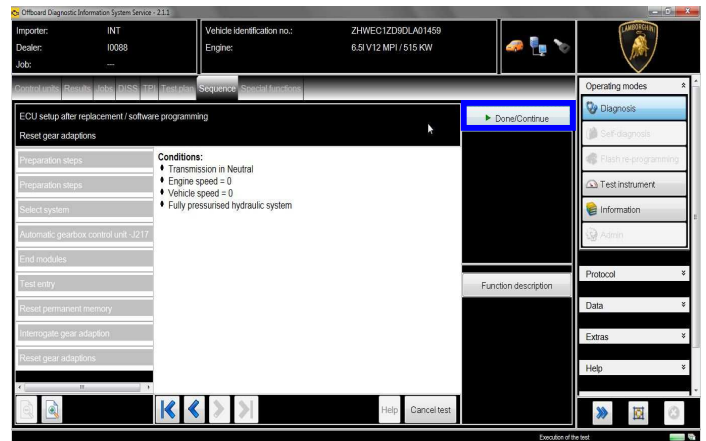
62. Click "Done/Continue" in order to execute the gear adaptation.

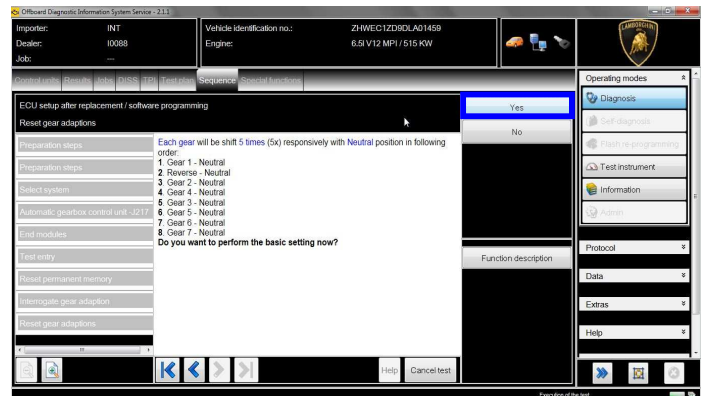
63. Gear adaptation.

Confirm clicking on "Yes".

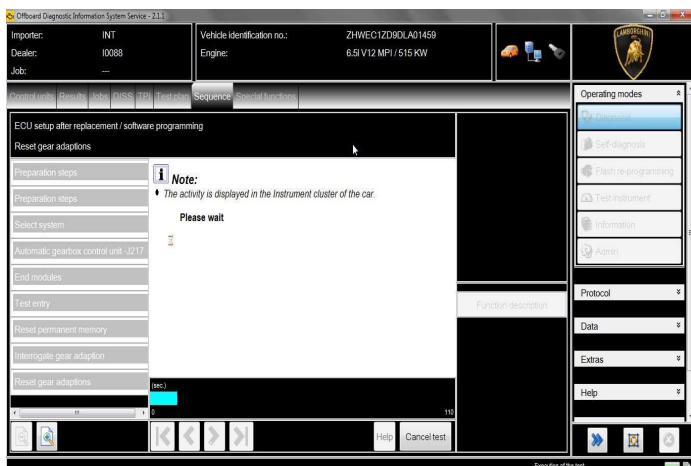
64. Wait until the gear adaption procedure is completed.

Gear engagements can be checked directly from the instrument cluster.

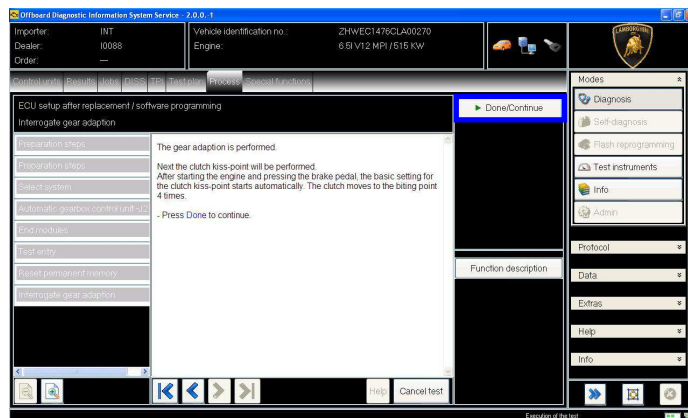
66. **Kiss point**

Click “Done/Continue” in order to perform the Kiss Point adaptation.

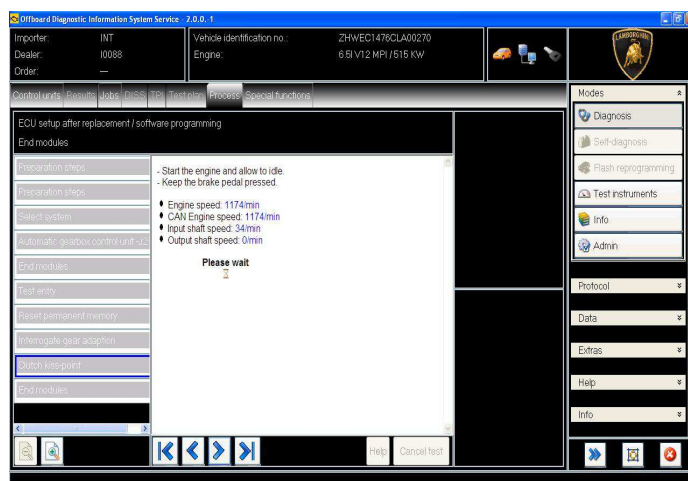
67. **Start the engine at idle and keep pressed the brake pedal for at least 1 minute.**

If the engine doesn't start:

- turn the ignition OFF;
- disconnect the diagnostic interface;
- wait at least 1 minute before turn the ignition ON again;
- reconnect the diagnostic interface and repeat the program from step 57.

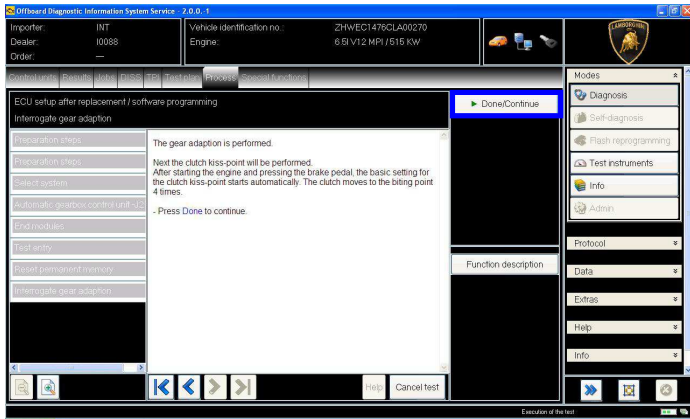
68. If the Kiss Point adaptation is completed successfully the screenshot below will be displayed.

Click on “Done/Continue” in order to exit from the program.

If the Kiss Point adaption is not completed successfully:

- turn the ignition OFF;
- disconnect the diagnostic interface;
- wait at least 1 minute before turn the ignition ON again;
- reconnect the diagnostic interface and repeat the program from step 57.

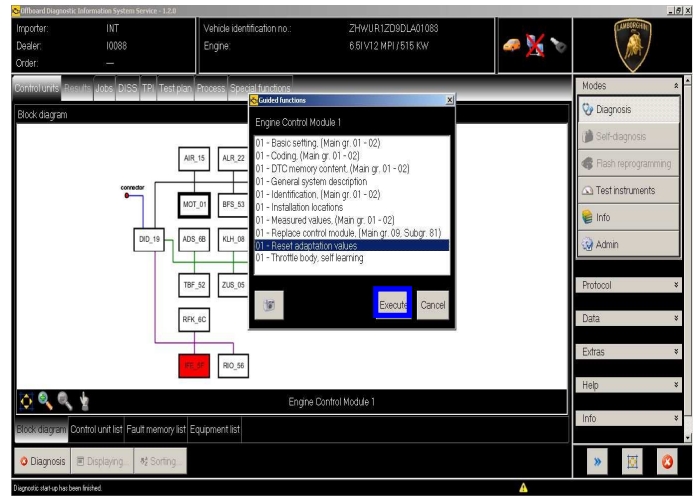
69. Go back to the Control Unit tab (block diagram or list view), to select the Engine ECU MOT_01 and the Guided Function:

01 – Reset adaptation values.

Click “Execute” to start the procedure for resetting the adaptation values (Basic Setting 254).

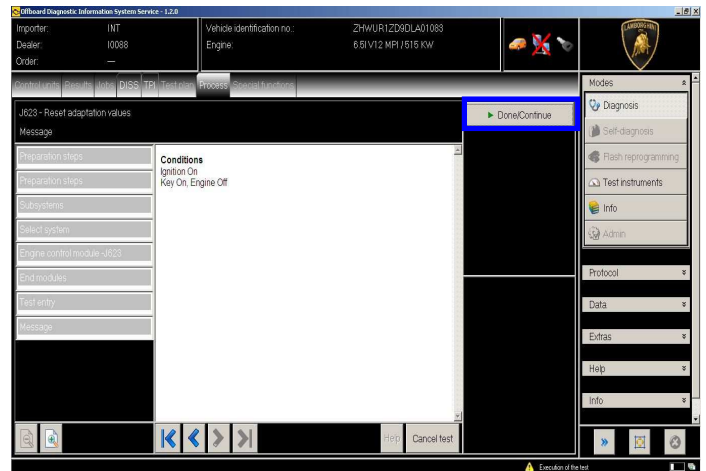
70. Be sure the activation conditions are respected:

- key ON;
- engine OFF;
- no faults stored in the Engine ECU’s memory;
- press “Done/Continue”.

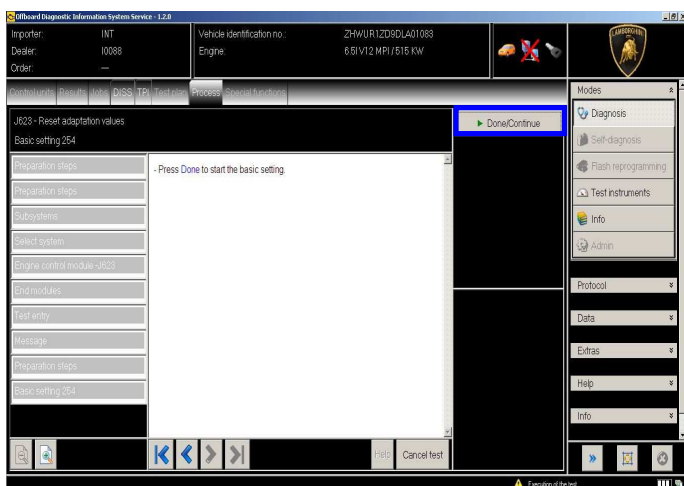
72. Click “Done/Continue” to perform the basic setting.

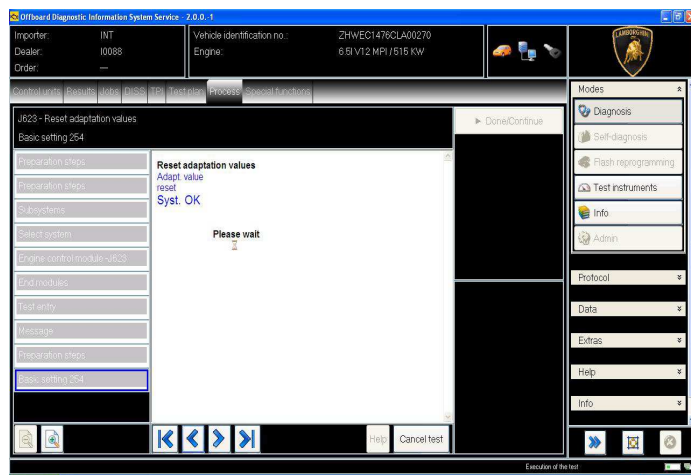
73. Wait until the feedback message is shown.

If the procedure has been performed successfully the message “Syst.OK” will appear, as shown in the picture below.

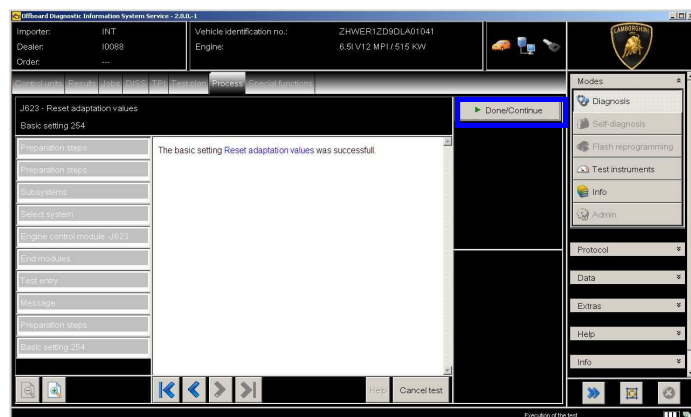
74. If the procedure has not been performed successfully:

- turn the ignition OFF;
- wait at least 1 minute before turn the ignition ON again;
- repeat the program from step 69.

Click “Done/Continue” to exit the basic setting.

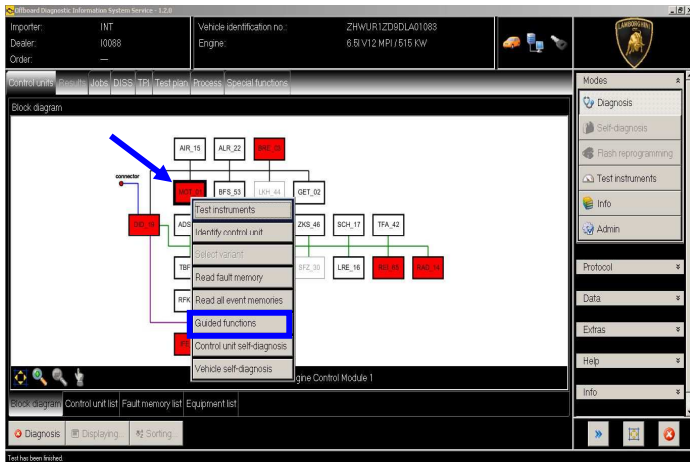
75. Go back to the Control Unit tab (block diagram or list view), to select the Engine ECU MOT_01 and the Guided Function.

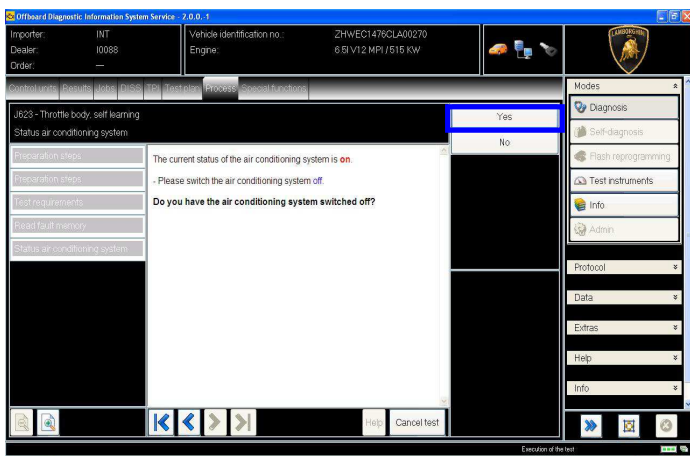
76. Select the program
 "01 – Throttle bodies, self learn-ing".
 And execute clicking on "Execute".

77. Be sure that Air Conditioning is OFF.
 Click "Yes";

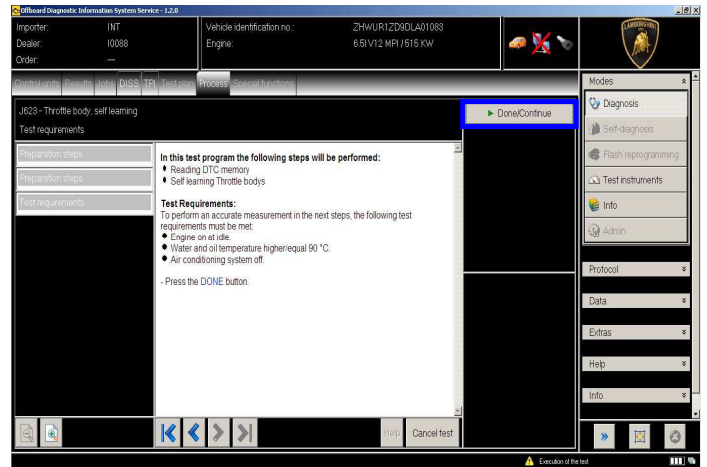
78. The prerequisites for the test are summarized.
 Press "Done/Continue";

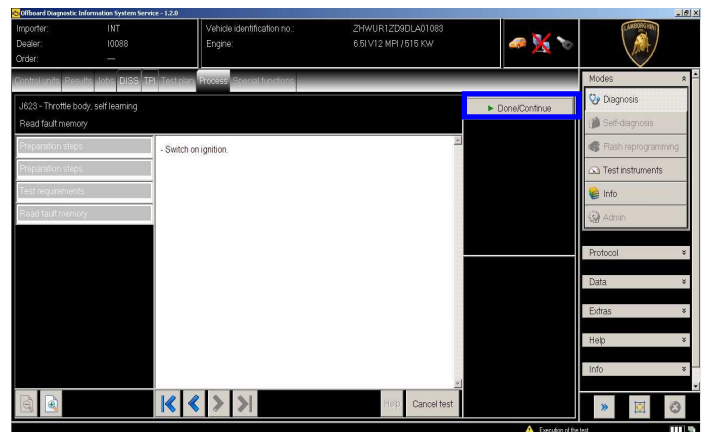
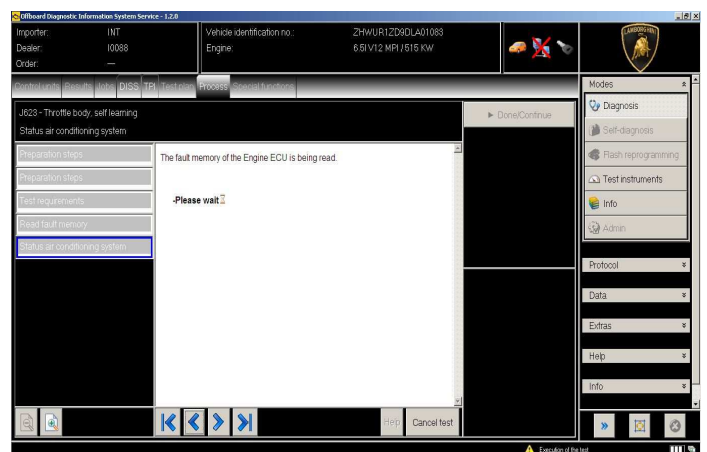
79. Switch the ignition ON.
 Click "Done/Continue".

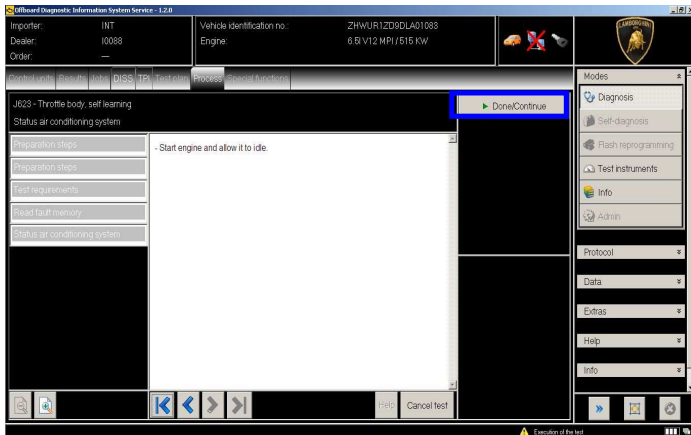
80. Start the engine at idle.
 Click "Done/Continue".

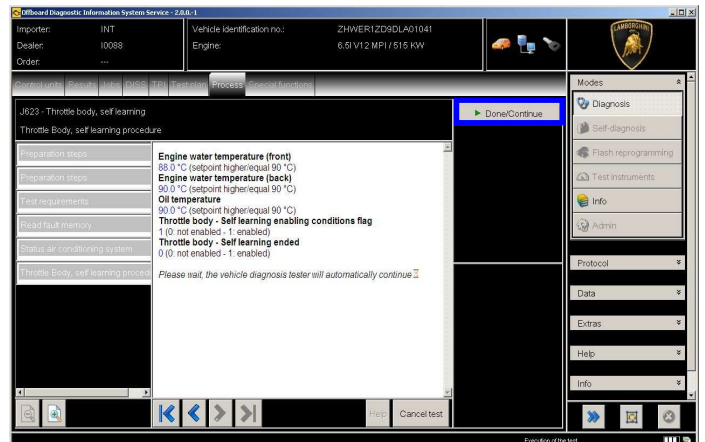
82. Once reached the activation conditions (water and oil temperatures major than 90°C) the “Throttle body – Self learning enabling conditions flag” changes from 0 to 1 indicating the start of the self-learning procedure.

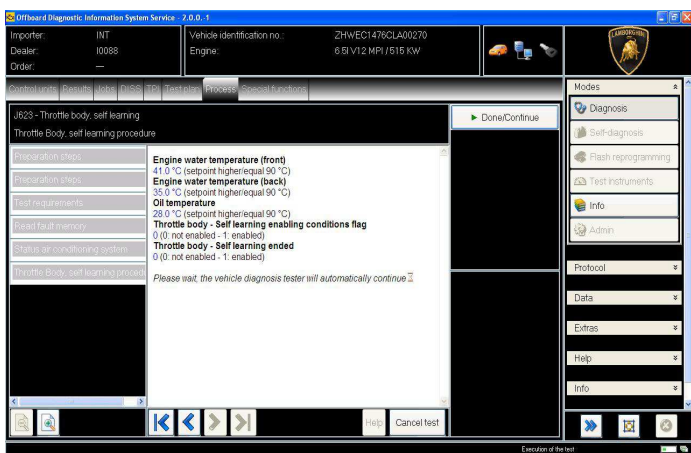
83. If the self-learning is completed successfully a screen as in the picture below is shown.

Click “Done/Continue” to display the ignition advance values.

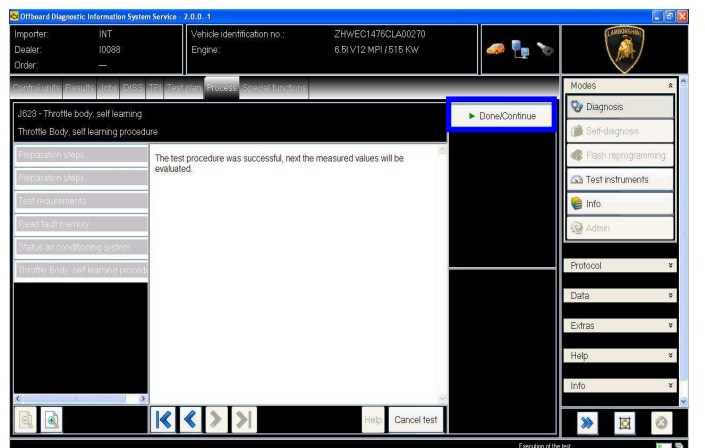
84. Have a look to the ignition advance values, that must be inside the range [-2° 3°].

In the case those values were out-side the range, restart the procedure from step 75 after an ignition switch OFF for at least 1 minute.

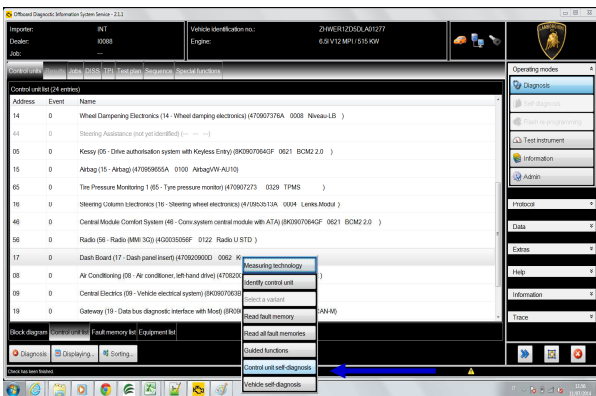
90. Restore the previously Service Intervals with following procedure:

- 1) Remain in Odis Service for diagnosis
- 2) From Control Units list, select “17 – Dashboard” and right click with the mouse
- 3) Select “Control unit self diagnosis”

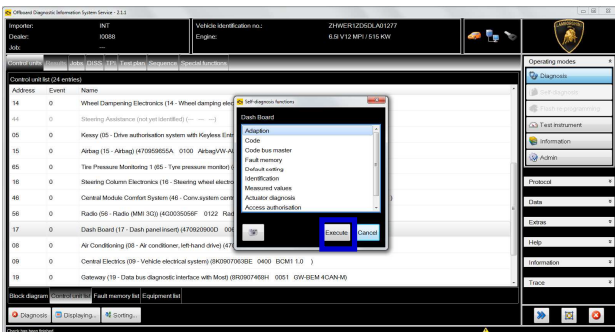
91. Select “Adaption” and click “Execute”:

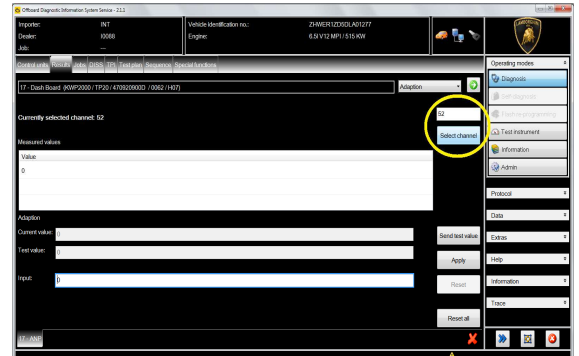
92. Type “52” in the upper right text box and click “Select Channel” button.

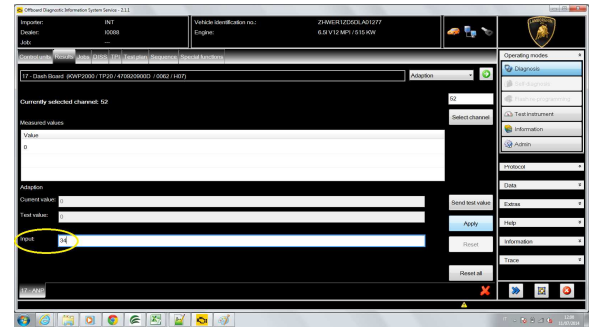
93. Insert the kilometers to the next service divided by 10 in the “Input” box (e.g if before the drivability package installation the remaining interval was 3400km, type “34”, that is 3400/100).

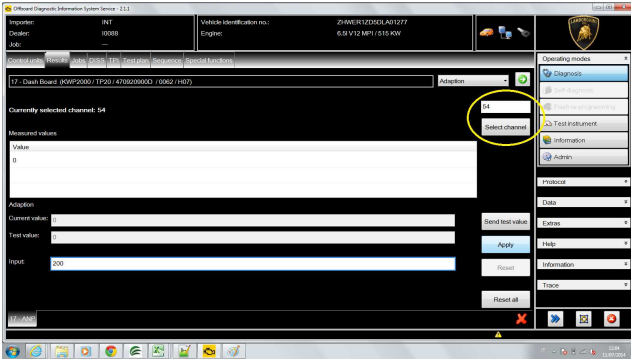
95. Select the channel “54”.

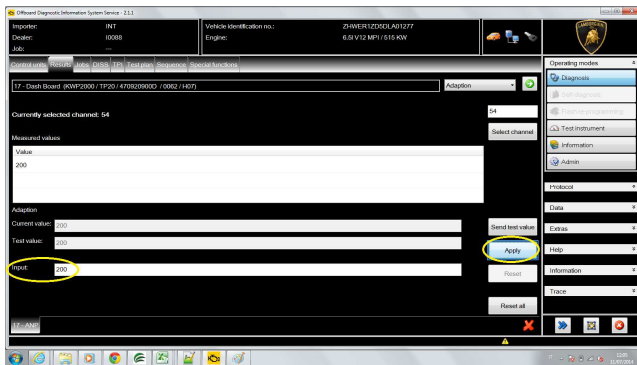
96. Insert the days till the next service in the “Input” box (e.g. 200 = 200 days) and click “Apply” button.

Now, the service interval values are restored as in the example figure of page3. The diagnosis tool can be closed.

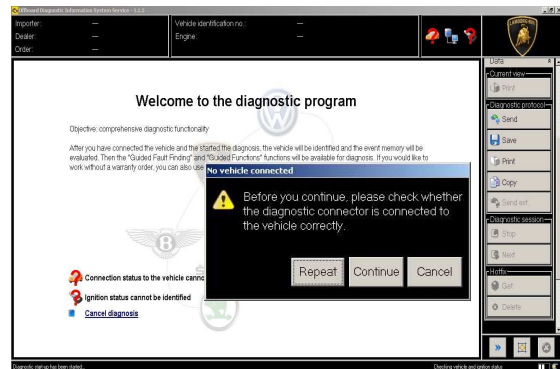
A. If the error message regarding the VAS5054 interface and the 2 icons for status of on board connection and key on are shown as in the picture below:

- Click “Cancel”;
- Repeat the VAS5054 HW interface installation following the procedure (*) “VCI Manager v2.0”, by entering in the menu “Extras” on the right side and clicking on “Diagnostic interface”.

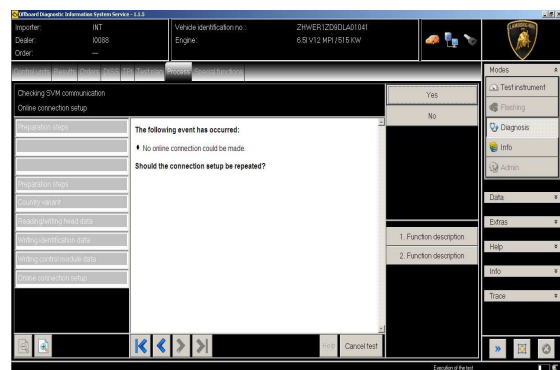
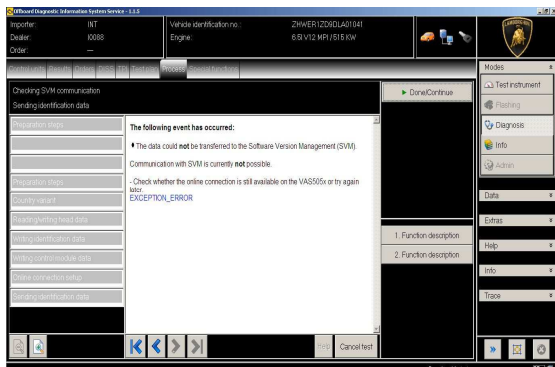
B. If one of the connection errors screens is shown as in the pictures below:

- it is not possible to establish a connection with the central server. Please check carefully that the diagnosis laptop is properly connected to the internet network and retry clicking “Yes” or “Done/Continue”.

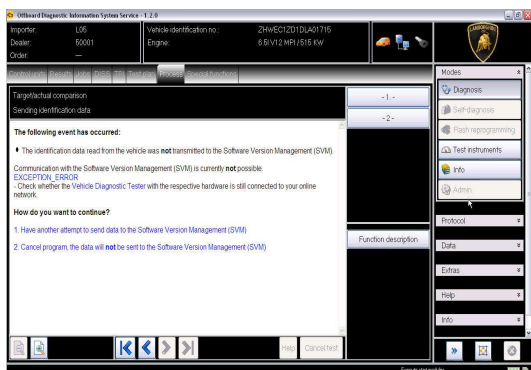
C. If the loss of connection happens during the target/actual comparison.

- It is not possible to connect to central server, check the working connection of internet and retry by clicking “1”.

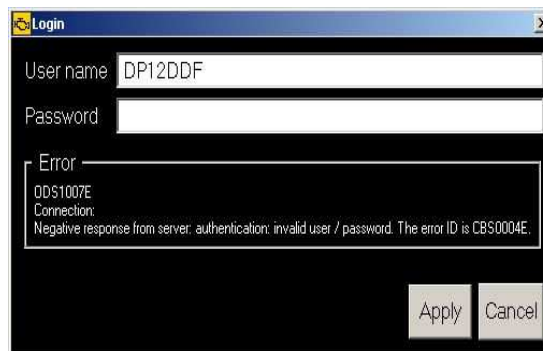
D. If the incorrect identification message is shown as in the picture below (error code: ODS1007E):

- be sure that your Geko account is valid;
- be sure that the label “Geko” is written on the token that you are using for the authentication;
- be sure the Password inserted is correct;
- click on Cancel and perform the application test (see document “ODIS_Checking_ConnectionServer_SVM_2.0” (*)).

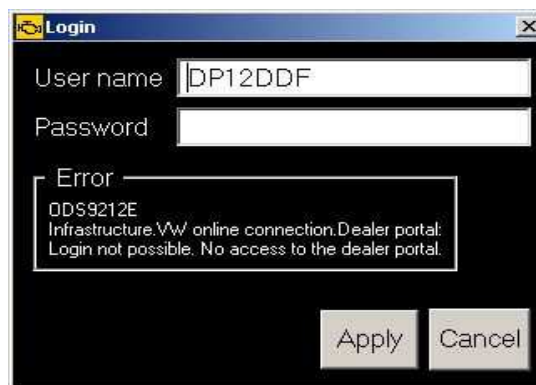
E. If the infrastructure error message is shown as in the picture below (error code: ODS9212E):

- be sure that your Geko account is valid
- be sure that the label “Geko” is written on the token that you are using for the authentication
- verify in ODIS settings you have “Internet” instead of “CPN” (see document “ODIS_Initial_Setup_2.0” (*))
- click on Cancel and perform the application test (see document “ODIS_Checking_ConnectionServer_SVM_2.0” (*))

If the same error was present during the application test, try following procedure:

- quit ODIS;
- Enter the folder C:\Program Files\Offboard_Diagnostic_Information_System_Service\automatic_sessions on your diagnosis laptop;
- delete the only file present in that folder.
