NUMBER: 08-028-16

GROUP: Electrical

RE2 RE6 RB5 RB6 Radio Software Enhancements

This bulletin involves updating the radio software and navigation if equipped.

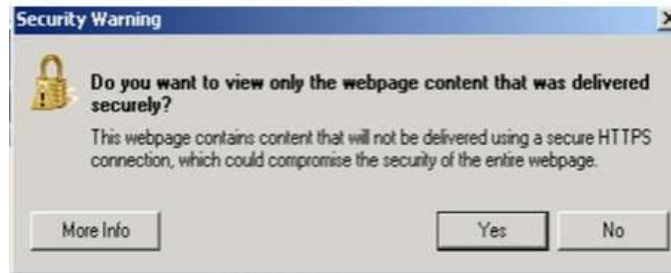
Fig. 1 Pop-up Security Message

1. Has a USB flash drive been created with the current software update?
 - a. YES >>> Proceed to [Step #6](#).
 - b. NO >>> Proceed to [Step #2](#).
2. Go to DealerCONNECT>Service>UCONNECT Information & Utilities> Uconnect Dealer software downloads to download the files.
3. If a security message appears "Do you want to view only the webpage content that was delivered securely?" See ([Fig. 1](#)). Press **No** to continue.

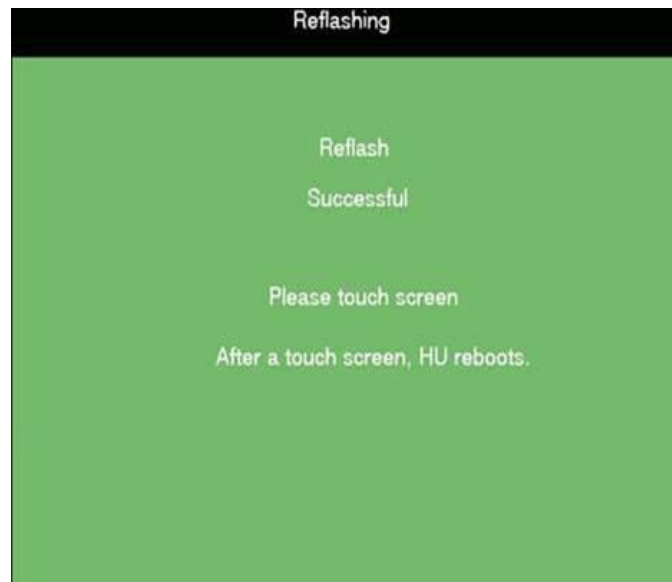
Fig. 3 Touch Screen Instruction

11. When the update is completed, the screen will read “Reflash Successful”. Remove the USB flash drive and touch the screen anywhere to initiate the radio to reboot. See (Fig. 3).

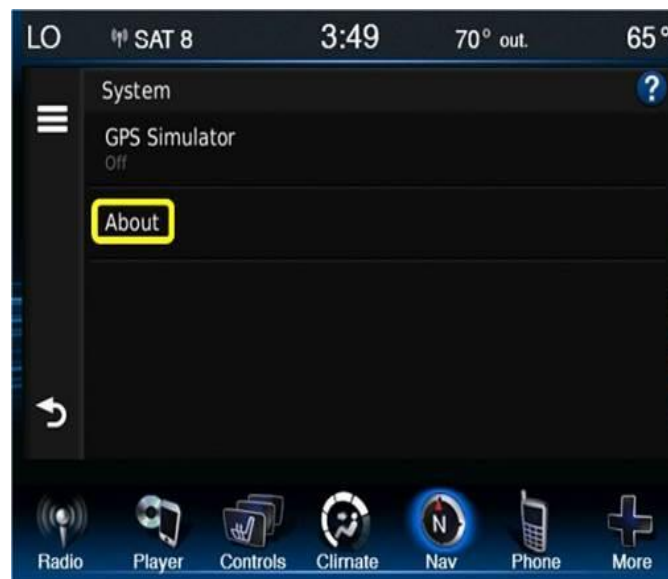
Fig. 7 About Screen Icon

17. Press the System Screen icon and then the About icon to display the Garmin System Information. See (Fig. 6) and (Fig. 7).

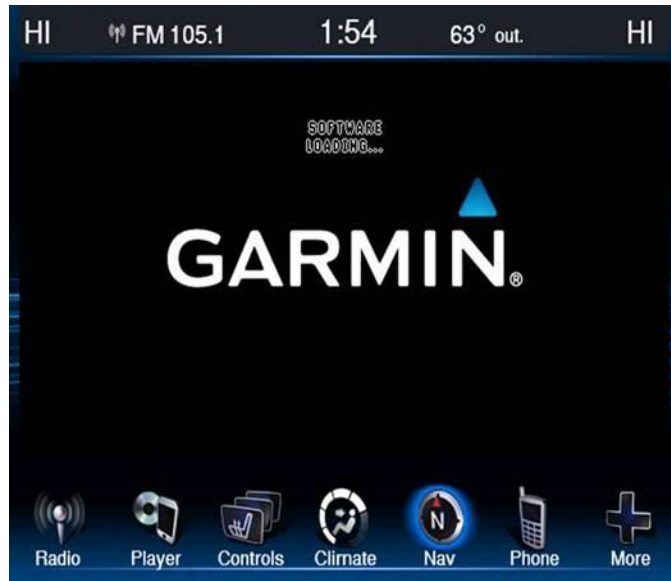
Fig. 8 Garmin Software Loading

21. Once the update has started the radio will change to the software loading screen. See (Fig. 8).

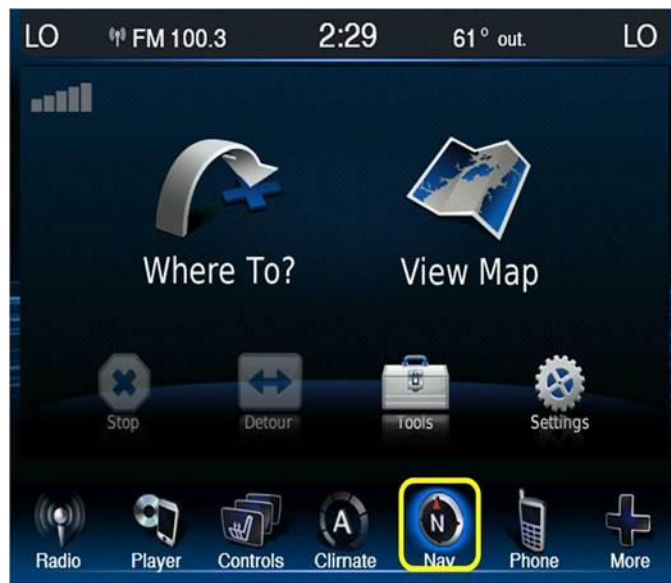
Fig. 9 Update Complete

22. Once the software update has completed down loading, the screen will automatically change to the Garmin main screen. See (Fig. 9).
