SERVICE BULLETIN

APPLICABILITY: 2014-15MY XV Crosstrek Hybrid Electric Vehicle (HEV) NUMBER: 16-94-15R

SUBJECT: Diagnosis and Repair of DTCs P172A and P0B0B

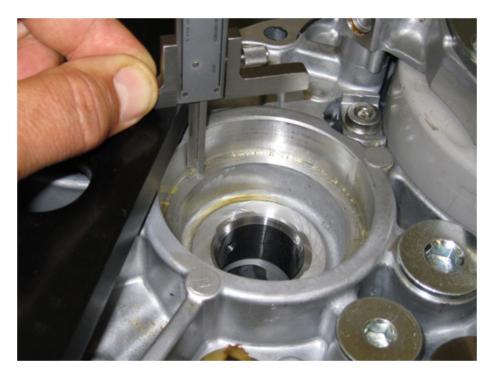
2) Measure the height "A" from the Gauge Block upper face to the ball bearing catch surface.

4) Obtain the thickness of reduction driven gear shim using the following formula to select zero to three reduction driven gear shims.
T (mm) = A - B - (0.05 — 0.25)
[T (in) = A - B - (0.002 — 0.01)
T: Shim thickness

A: Height from the Gauge Block upper face to the ball bearing catch surface

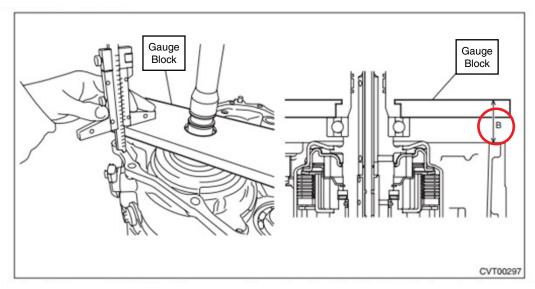
Steps 3:

3) Reinstall the output clutch assembly then measure the height "B" from the Gauge Block to the mating surface of the transmission case.

B: Height from Gauge Block to transmission case mating surface

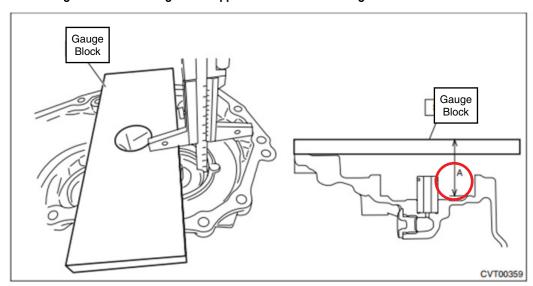
Step 1:

1) Measure the height "A" from the Gauge Block upper face to the ball bearing catch surface.

- 3) Obtain the thickness of transfer driven gear shim using the following formula to select zero to three transfer driven gear shims.
- T (mm) = A B (0.05 0.25)[T (in) = A B (0.002 0.01)
- T: Shim thickness
- A: Height from the Gauge Block upper face to the ball bearing catch surface
- B: Height from Gauge Block to transmission case mating surface
- 0.05 0.25 mm (0.002 0.01 in): Clearance

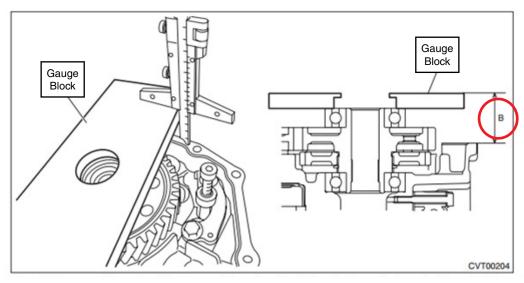
Steps 2 and 3:

2) Measure the height "B" from the Gauge Block to the mating surface of the transmission case.

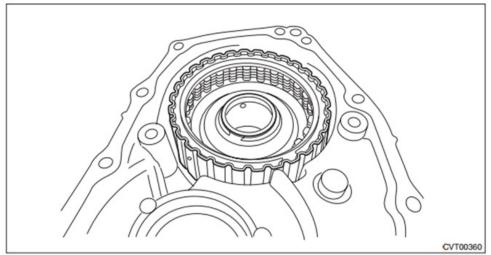
Step 1:

1) Install the transfer clutch assembly to the extension case with the transfer driven gear shims and thrust bearings removed.

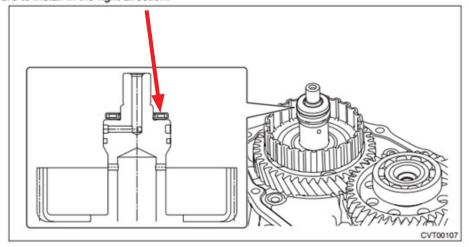
2) Install the thrust bearing to the transfer driven gear.

Make sure to install in the right direction.

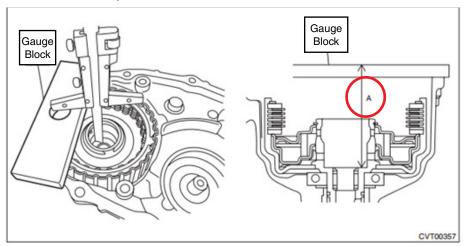
3) Using the Gauge Block, measure the height "A" from the ST end face to the thrust bearing catch surface of the transfer clutch assembly.

A: Height from the Gauge Block end face to the transfer clutch assembly thrust bearing catch surface

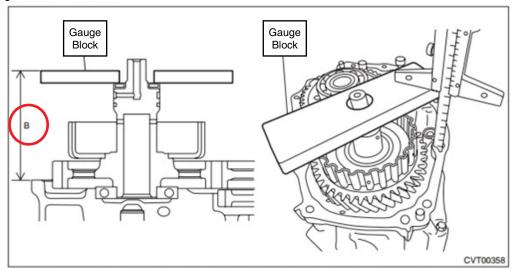
4) Using the Gauge Block, measure the height "B" from the transmission case mating surface to the end of the Gauge Block

B: Height from mating surface of the transmission case to the end of the Gauge Block

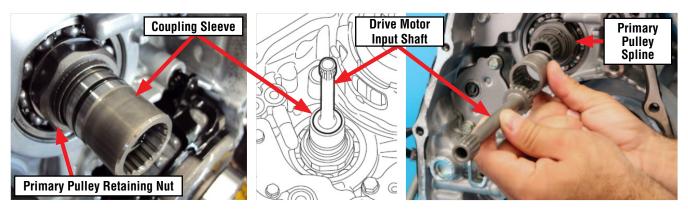
IMPORTANT: <u>BEFORE</u> applying any sealer to the cases, always trial fit them together to confirm proper spline alignment between the coupling sleeve, the drive motor input shaft and the primary pulley. The cases are too close together to facilitate turning the primary pulley retaining nut to get the splines aligned properly, especially when there is fresh sealer applied.

• Once proper spline alignment is confirmed, use some CVT fluid to hold the 6 o-rings in place between the cases during reassembly.
