PRODUCT CAMPAIGN BULLETIN

APPLICABILITY: 2018 Model Year Legacy, Outback, and BRZ Vehicles

NUMBER: WTZ-85R

SUBJECT: Harman Kardon Head Unit FMVSS 111 Noncompliance Recall

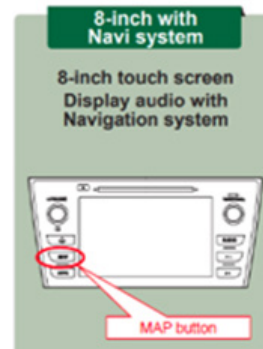
Multimedia System Type	Descriptive Features
8.0 Inch Audio / Navigation System	Map Button in Top Row Center

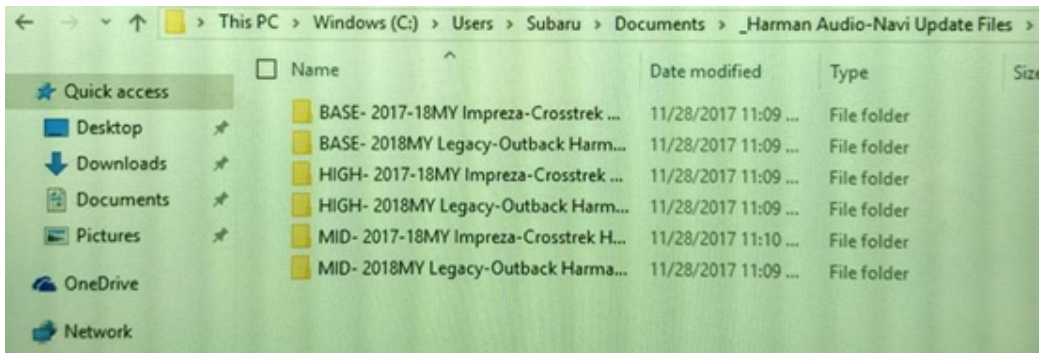
- Go to My Documents on the GUI screen to display the list of available update files shown below.
- Sort by Date Modified to bring the most recent files to the top of the list. The folder is named: _Harman Audio-Navi Update Files. It contains the six folders shown in the EXAMPLE photos below.

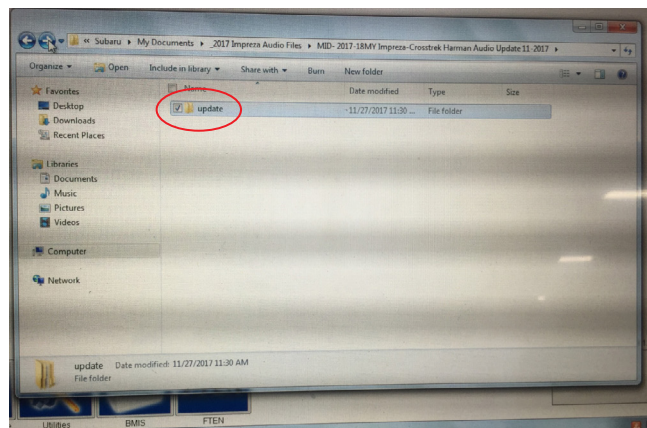
- Double-click on the required file (for this example, select the file entitled “HIGH-17-18 Impreza-18 Crosstrek-18-Legacy-Outback-18-BRZ-HARMAN AUDIO UPDATE-NOVEMBER 2018”) and the Update file will display as shown.

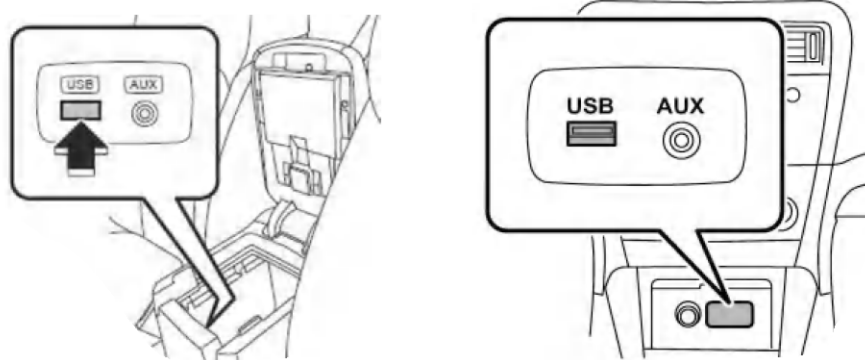
- With the engine idling (or GR8 connected), plug the flash drive into the USB Port.

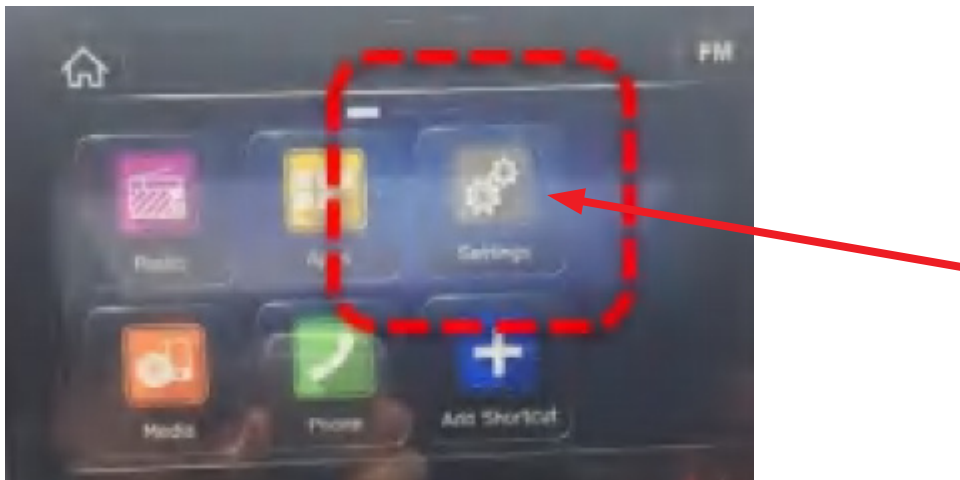
- Turn the ignition back ON. The STARLINK screen should be displayed. If the STARLINK screen is not displayed, perform **Step 5** again and be sure to **WAIT AT LEAST 3 MINUTES** before proceeding.
- In some cases, the radio presets may not appear initially.
- From the HOME screen, touch “Settings”.

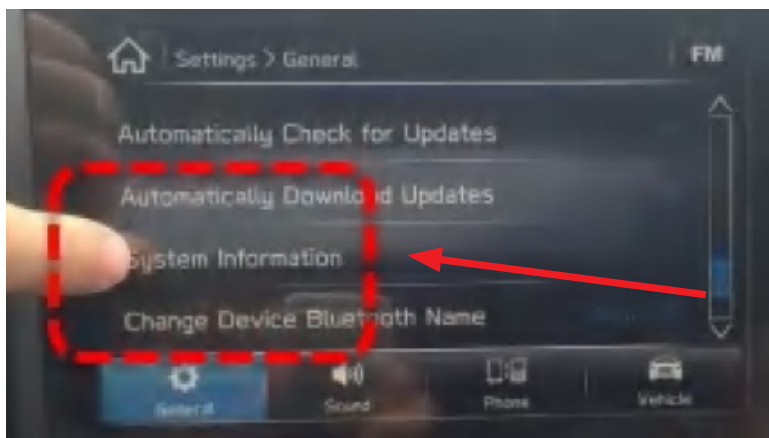
- From the Settings > General screen, scroll down to and then touch “System Information”.

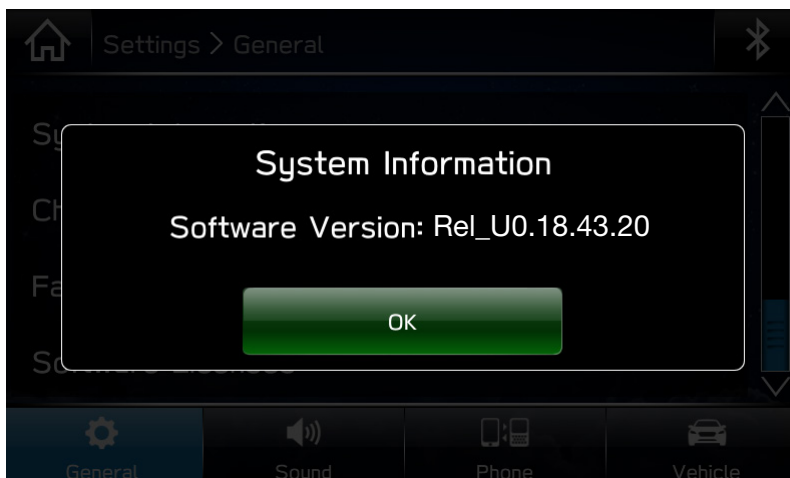
- Confirm Software Version is now “Rel_UO.18.43.20”.
