SERVICE INFORMATION BULLETIN

NUMBER: 15-205-16R

SUBJECT: Reprogramming File Availability to Address
Operational Concerns with “Gen 2.0” and “Gen 2.1”
Fujitsu-TEN (F10) / Denso-TEN (D10) Navigation and
7” Display Audio Units

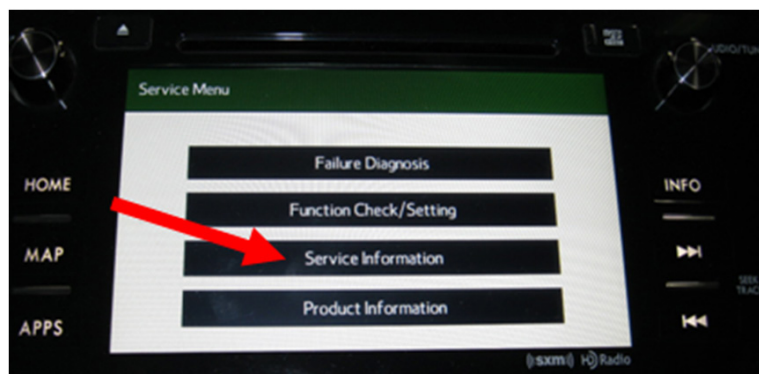
- Switch the unit into “Diagnosis Mode” by pressing and holding the HOME button while pressing the “AUDIO/TUNE” button 5 (five) times.

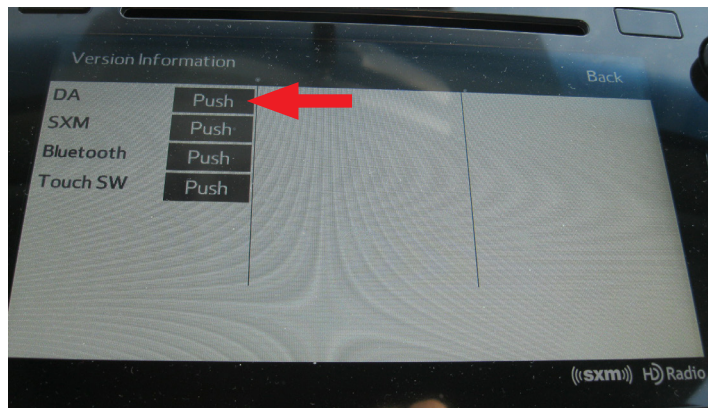
- Press “Version Information”

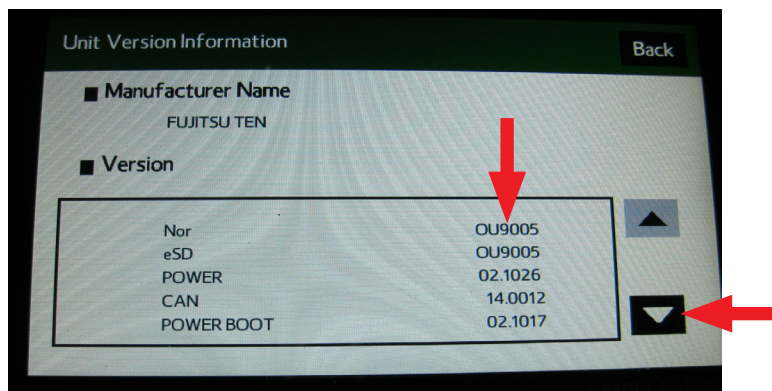
- Press “Push” next to DA (or AVN for Navigation units)

- Verify the current versions according to the Update File Applicability / Information table shown table shown on page 7. Use the down arrow to scroll to the bottom of the list for complete verification.
- If the software version is current, press and HOLD the HOME button to exit the Diagnostic Mode and complete the procedure as no updates are necessary. If no updates are necessary, continue your diagnosis of the customer concern. If the Version ID numbers are prior to (lower than) those shown in the table above, proceed with **Step 2**, preparing the USB memory (Flash Drives) then **Step 3**, the software update procedure.

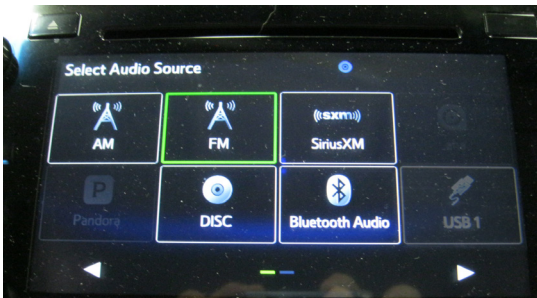
- Turn the ignition / key (ACC) “ON”.

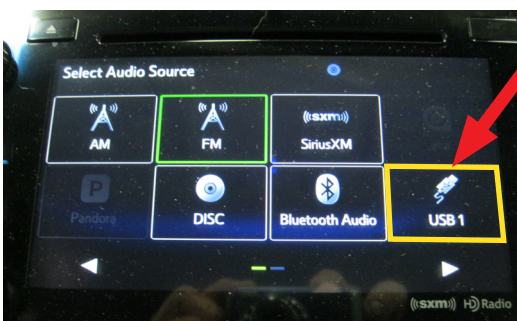
- Press the “AUDIO/TUNE” button.
- The Select Audio Source screen will appear.

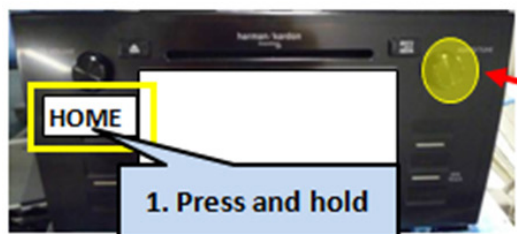
- Once the USB icon is illuminated, switch the unit into “Diagnosis Mode” by pressing and holding the HOME button while pressing the “AUDIO/TUNE”

2. Press "AUDIO/TUNE" button 5 times

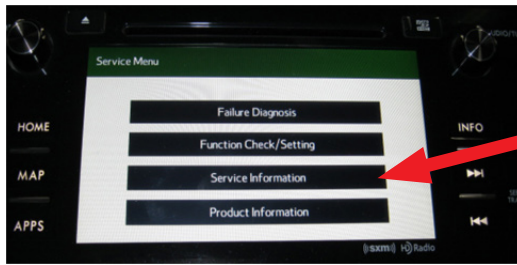
• Press “Service Information”

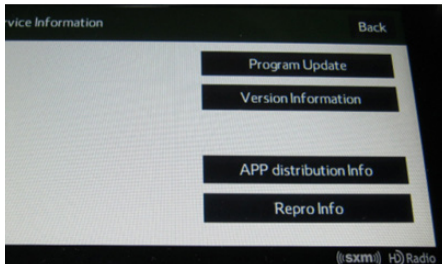
• Press “Program Update” then follow the sequence shown in the screen shots on the next page

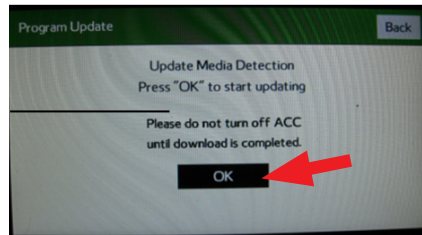
Press “OK”

Wait for “OK” to activate
(turn black)

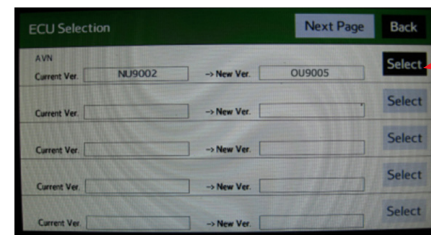
Press “SELECT”

CAUTION: Confirm the intended new version is displayed before clicking Select.

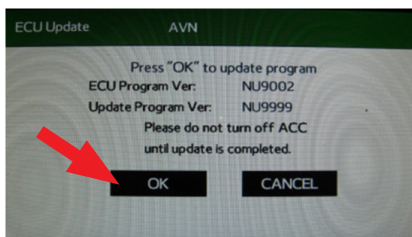
Press “OK”

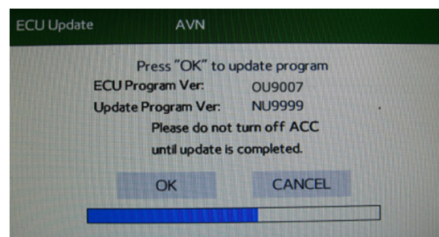
Once the updating starts, the status bar may need to complete more than once and could take up to about 15 minutes.

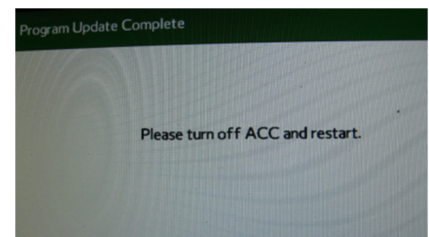
Turn off ACC

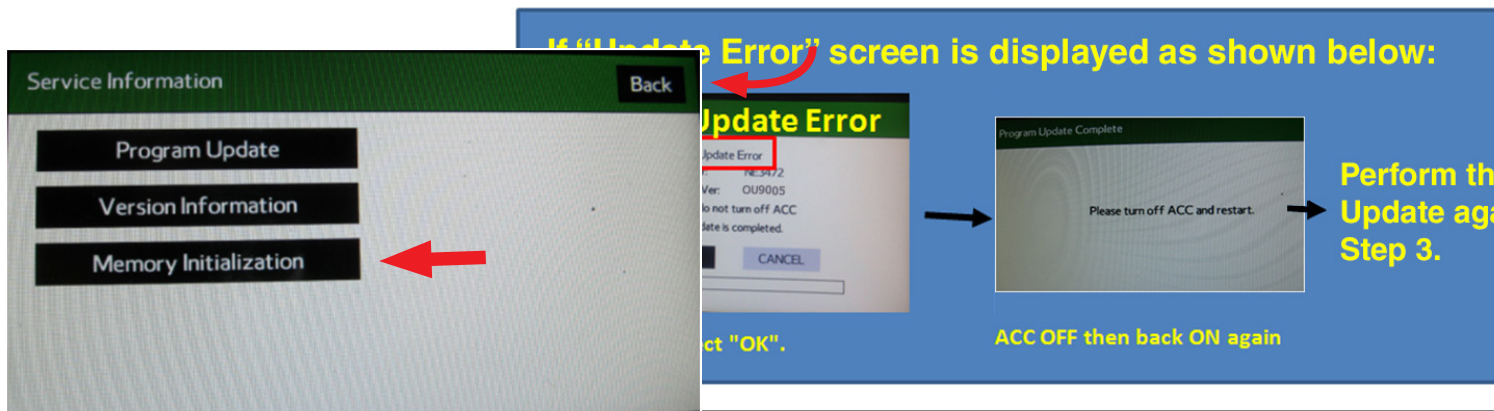
If the progress bar stops, please wait 15 minutes. If the progress bar does not move after 15 minutes, turn ACC OFF and back ON again then, restart the update procedure.

IMPORTANT: Do not turn the ACC (ignition / key) off or disconnect the flash drive from the USB port during updating.

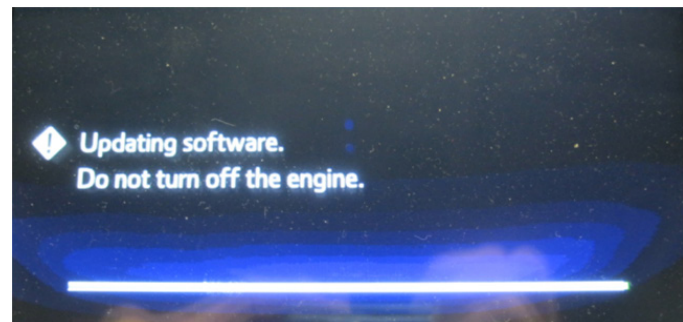
- Once the update completes successfully, turn the ACC off.
- **CRITICAL: WAIT AT LEAST 60 SECONDS.** If the ignition is turned back on before waiting **AT LEAST 60 SECONDS**, the data may be corrupted and the unit damaged.
- After the unit boots back up, the "Updating software" screen and its status bar will be displayed. This update may take up to 5 minutes to complete.

When the Software Updates complete, the unit will restart automatically. Once the STARLINK opening screen is displayed, remove the flash drive from the USB port and turn the ignition off. **CRITICAL STEP:** Before proceeding further, perform **Step 1** (Version Check Procedure) again to confirm the updated software installation from Drive "1" was successful. When the update is successful, the new software version number will be displayed. If OK, proceed with installation of the Drive "2" update (repeat **Step 4**, Update Software Installation). If the updated versions are not displayed, **Step 4** using Drive "1" must be repeated. Once the software and CAN version updates are confirmed, insert Drive "2" and repeat **Step 4**.

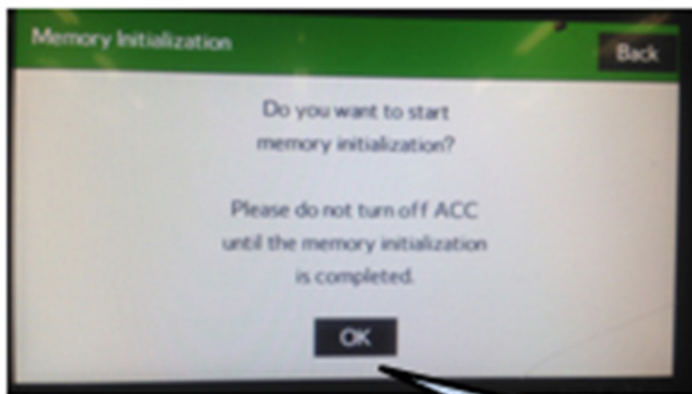
NOTE: All presets will likely be lost and will need to reset after performing this procedure. After pressing “Back”, the following screen will be displayed:

- Press “Memory Initialization”

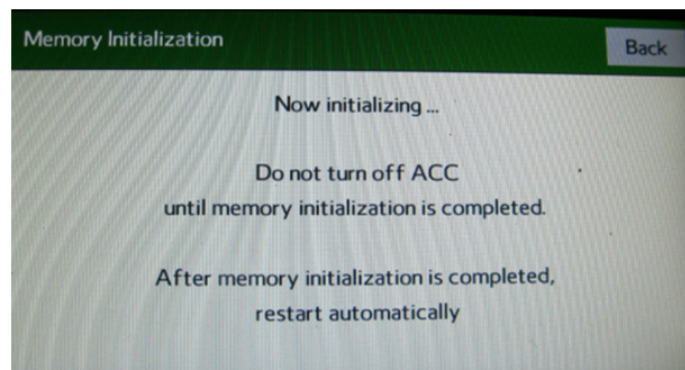
Press and Hold

- Press and **HOLD** the “OK” button until the screen shown below is displayed (5 to 10 seconds).

This screen will be displayed for about 1 minute while the unit restarts. After restart, the Loading screen and its status bar will be displayed. After the status bar completes, the Main Menu screen will be displayed. To complete the updating procedure, you must go through the series of Initial Setup screens, reset the radio station presets and re-pair any mobile devices (where applicable).

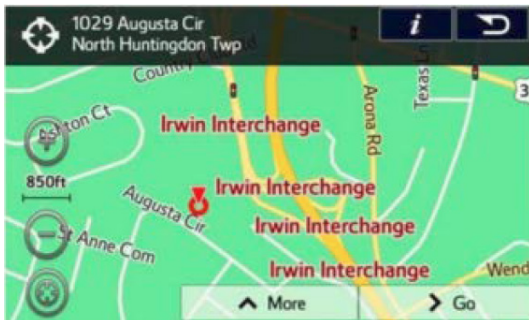
- Audio output is lost after a few minutes when listening to Sirius/XM satellite radio.
- Bluetooth feature becomes inoperative.
- HD Radio “freezes” after a few minutes of play.
- Back-Up Camera “help lines” do not appear.
- Map location is inconsistent between Navigation display and iPhone when using the iPhone’s Google Maps with the phone connected to the USB port in console.
- Roads or interchanges have the same name displayed multiple times.

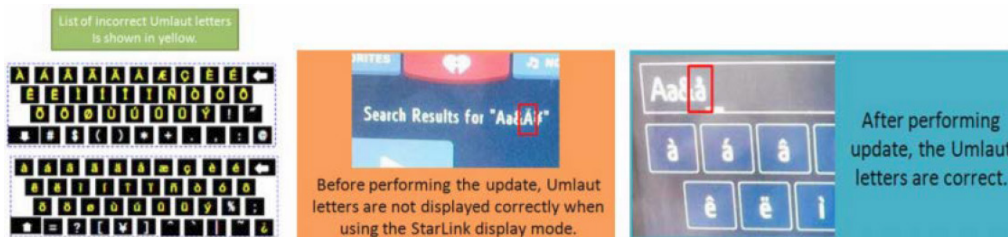
- Navigation function is slow to start when selected.
- No map display with key or ignition in “ACC” (accessory) position.
- No voice guidance provided from Navigation system after selecting a route unless the ignition is cycled off and back on again.
- Steering wheel switch controls are inoperative with an iPod (MP3) player connected to the USB.
- Incorrect Umlaut characters are shown on StarLink display.

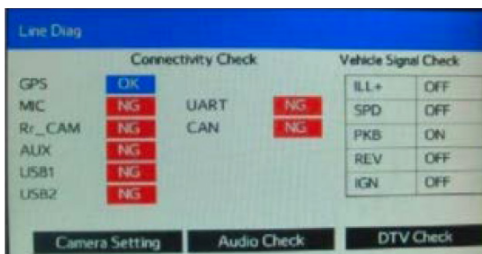
- No response from the soft touch keys on display.
- Back-Up Camera is displayed when shifter is in positions other than Reverse.
- “Line Diag” screen is displayed intermittently while driving.

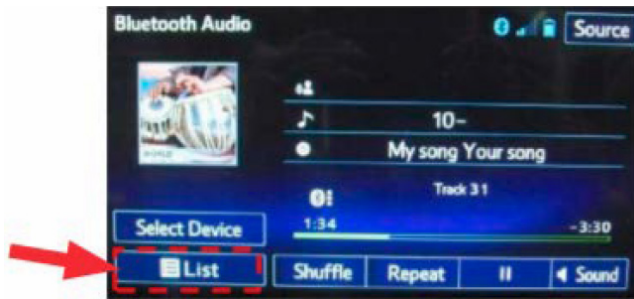
- “LIST” soft touch key is not displayed on Bluetooth Audio screen while using Bluetooth audio feature with an Apple device utilizing iOS8 software version.

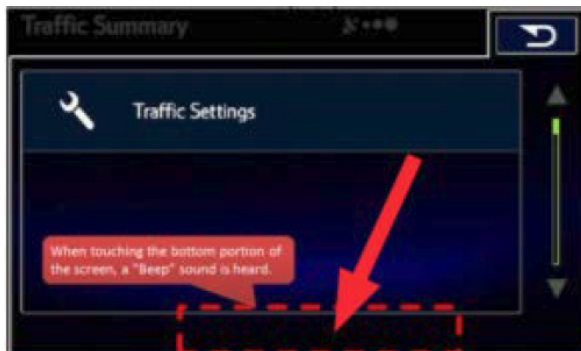
- “Beep” sound heard when touching the bottom of the display screen where no function soft touch keys are displayed.

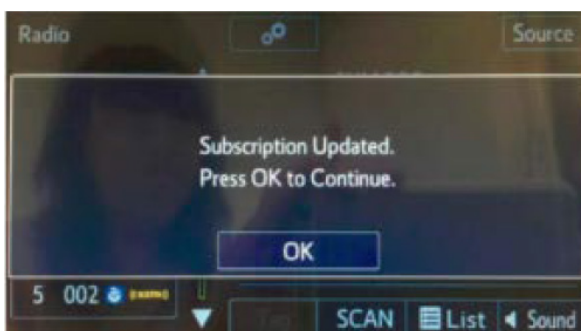
- SXM caution message screen is displayed in English even when French language operation settings are selected.

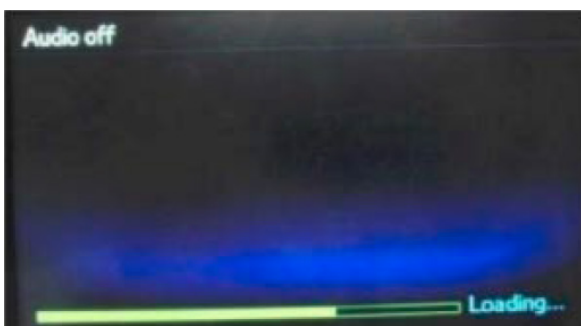
- The following symptoms are all related to the inability of the software to properly load. One or all of these 5 conditions may occur at the same time:
 - Repeated display of the “Loading” screen at initial unit start-up

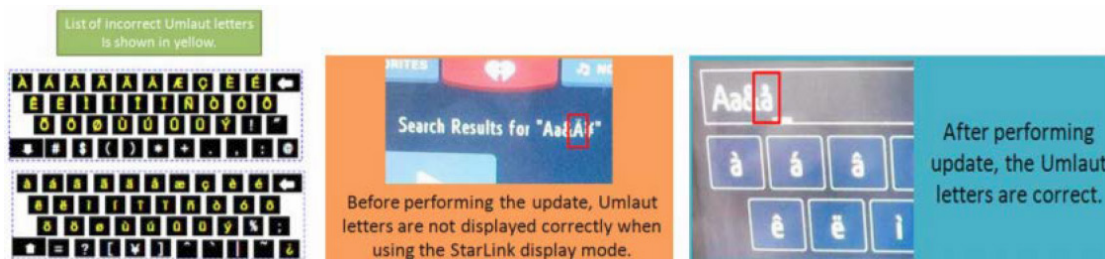
- Audio output is lost after a few minutes when listening to Sirius/XM satellite radio.
- Bluetooth feature becomes inoperative.
- HD Radio “freezes” after a few minutes of play.
- Back-Up Camera “help lines” do not appear.
- Incorrect Umlaut characters are shown on StarLink display.

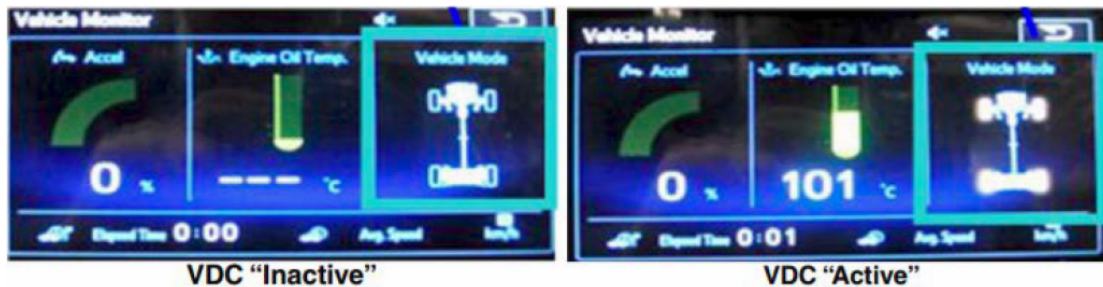
- Logic change to provide a “_” (underscore) character on the keyboard.
- Logic change to match the engine oil maintenance remaining mileage on the maintenance reminder screen to the odometer meter value on the combination meter when mileage unit is set to read in “KM”.
- Logic change to insure the Vehicle Mode indicator on the Vehicle Monitor screen matches the actual vehicle status. Example: The wheel indicators on the vehicle monitor screen no longer stay illuminated indicating VDC is “active” after VDC activation is complete.

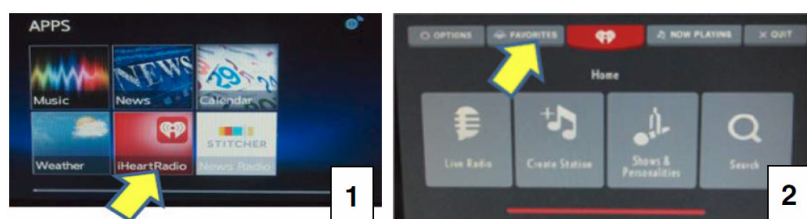
- SXM Channel numbers higher than 256 cannot be set using voice recognition.
- Characters may appear garbled to the right of the input characters when entering an e-mail address or password using the software keyboard within the iHeart Radio app.

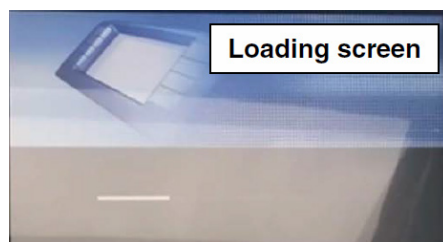
- The Navigation system freezes when re-routing while using traffic information supplied by SXM.
- The Navigation system re-boots from the Loading screen when utilizing the remote engine starter (RES) feature (if equipped).
