December 04, 2020

Version 1

2019-21 HR-V: *Bluetooth*[®] HandsFreeLink[®] Freezes After Calls; Voice Tags Are Missing at Startup

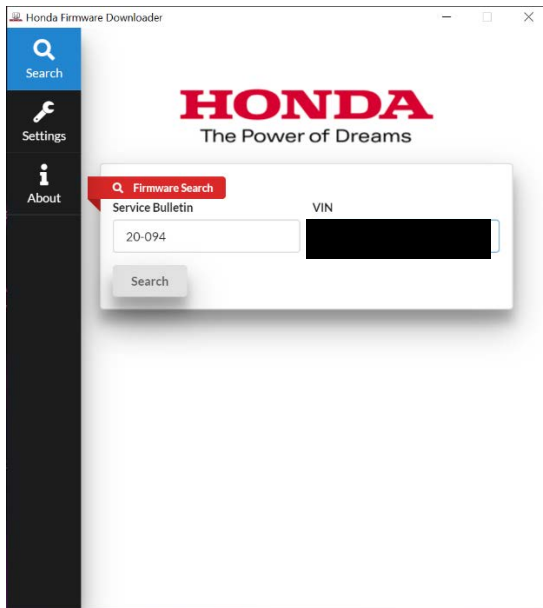
- Before updating the software, write down the customer's audio unit presets.
 - Connect a fully charged battery jumper to the vehicle, and leave it connected during the entire procedure to maintain steady voltage.
 - Apply the parking brake to keep the headlights off during the update.
1. From your computer's desktop, open Honda Firmware Downloader. Refer to job aid *Honda Firmware Downloader* for additional information. Make sure to use an empty USB flash drive that is formatted to FAT 32.
 2. Enter the service bulletin number and the VIN. This is important, as the software can be different depending on the trim level. Select the download icon when the correct software is found.

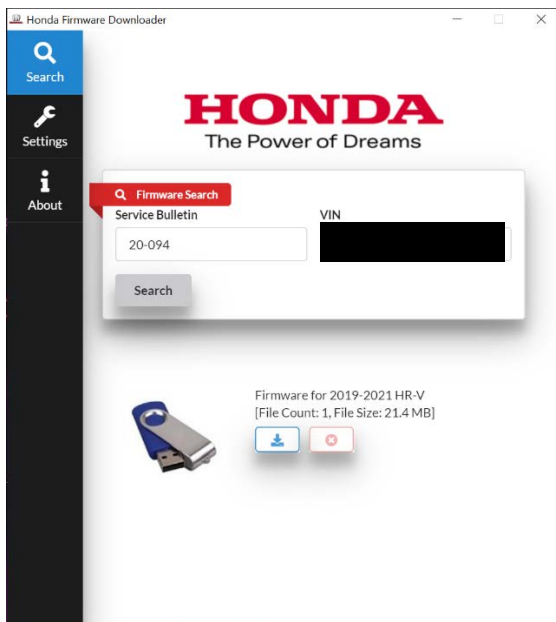
The software download may take up to **10-15 minutes**, depending on the size of the file.

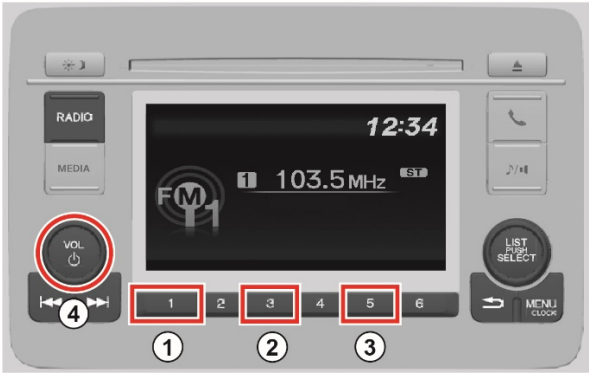
5. With the audio unit OFF, press and hold the buttons in sequential order as shown. This will let you view the **Version display** screen.

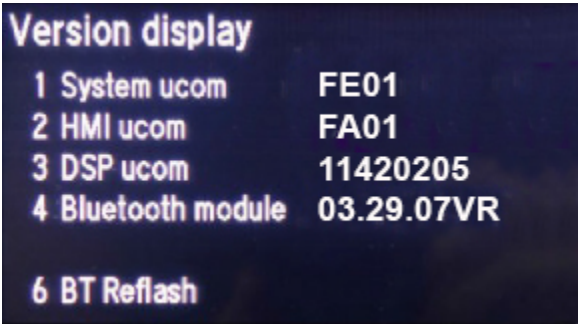
The image below is an example.

If any of the software versions do not match the ones listed in the table below, do not update the audio unit because you can damage it.

Software Details	Affected Software Versions
	2019-21 HR-V
System ucom	FE01
HMI ucom	FA01
DSP ucom	11420205
Bluetooth module	03.29.07VR

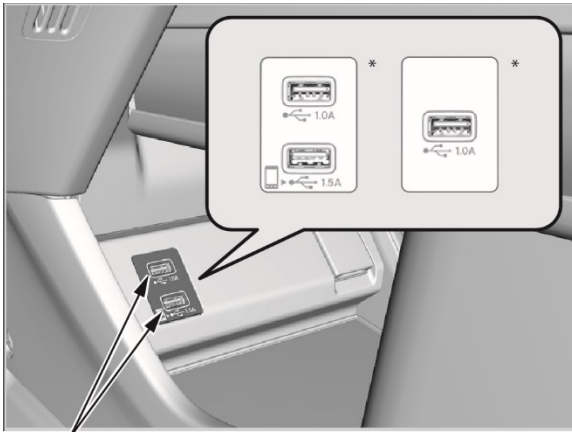
USB PORTS

8. Plug the USB flash drive into the USB port to start the update. The audio unit will automatically detect the USB flash drive and start the update process.

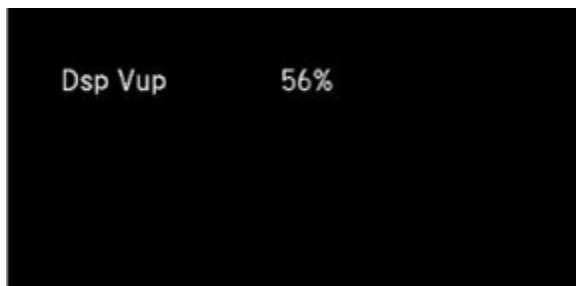
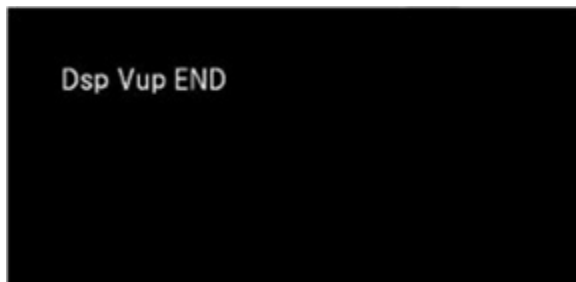
- Dsp Vup

You will see the following screens as the update runs.

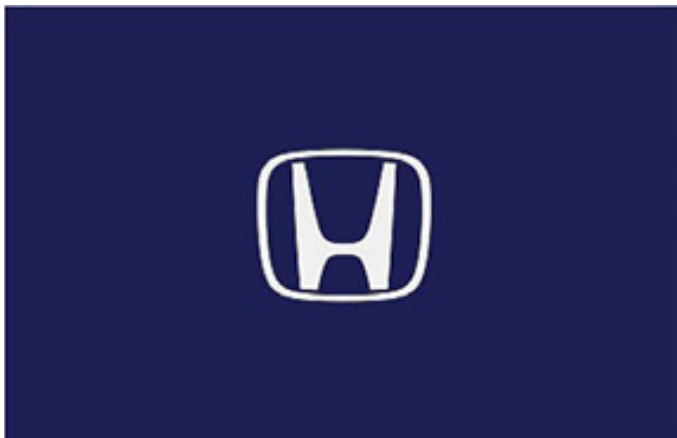
- The screen will go black and the buttons will begin blinking. The blinking will speed up and you will hear a beep every 10% of progress.
- When the software update is complete, you will hear a long beep, then the Honda logo will appear, and the audio unit will turn off.

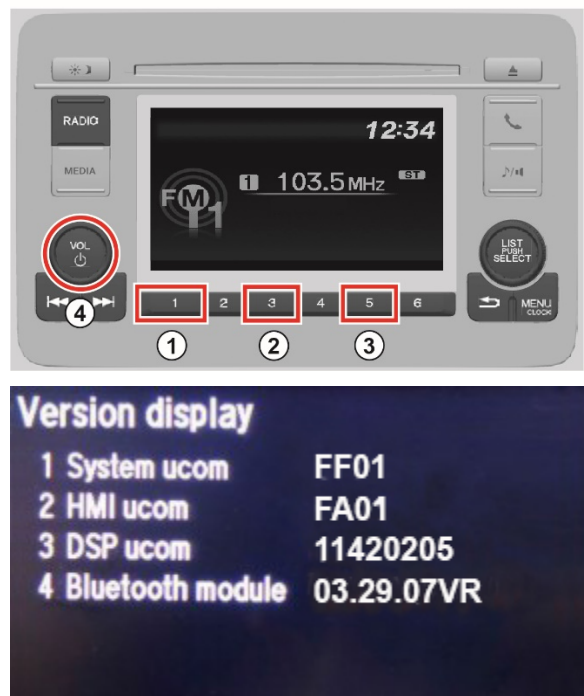
1. With the audio unit turned OFF, press and hold the buttons in sequential order as shown. This will let you view the **Version display** screen and verify the software version was updated.

Software Details	Affected Software Versions
	2019-21 HR-V
System ucom	FF01
HMI ucom	FA01
DSP ucom	11420205
Bluetooth module	03.29.07VR

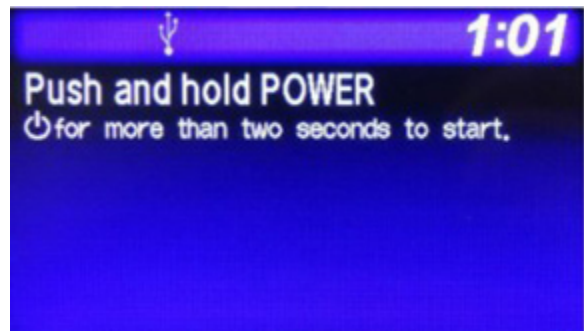
2. Press the VOL/Power button to exit the **Version display** screen.
3. Remove the USB flash drive.
4. Press and hold the VOL/Power button to sync the security code.
