SERVICE INFORMATION BULLETIN

APPLICABILITY: 2015-2017MY Legacy and Outback
 2015-2016 Impreza
 2015-2017 Crosstrek
 2016-2018MY Forester
 2016-2018MY WRX

NUMBER: 15-205-16R

SUBJECT: Reprogramming File Availability to Address Operational Concerns with “Gen 2.0” and “Gen 2.1” Fujitsu-TEN (F10) / Denso-TEN (D10) Navigation and 7” Display Audio Units

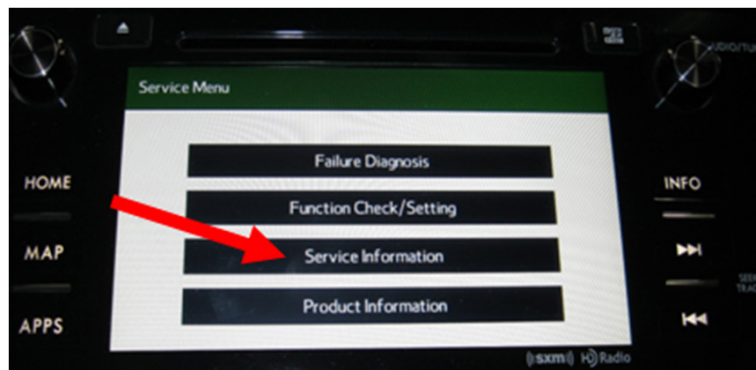
- Switch the unit into “Diagnosis Mode” by pressing and holding the HOME button while pressing the “AUDIO/TUNE” button 5 (five) times.

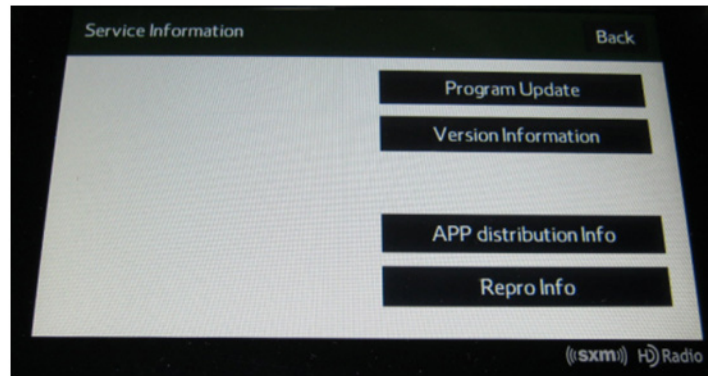
- Press “Service Information”

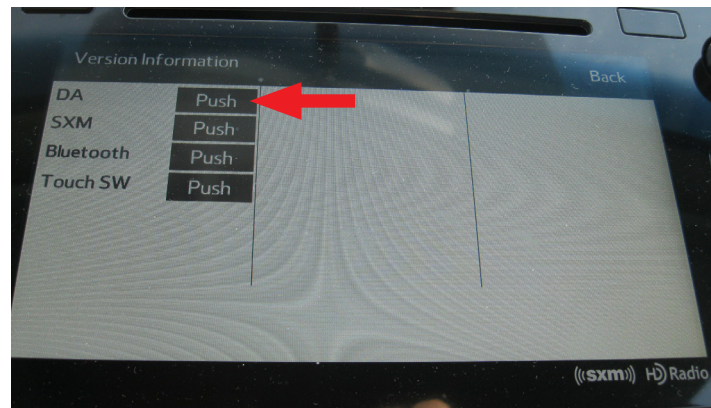
- Press “Version Information”

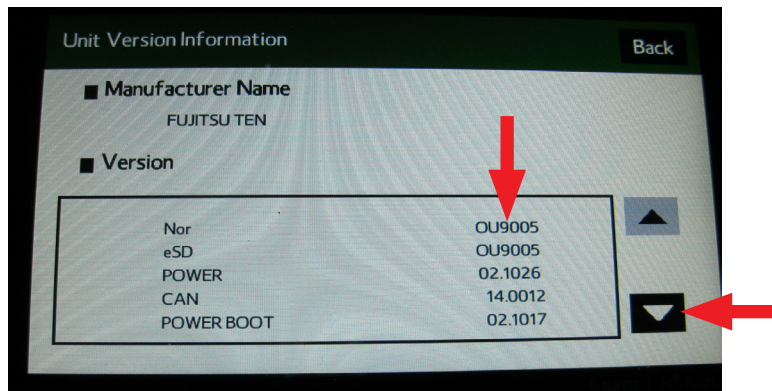
- Press “Push” next to DA (or AVN for Navigation units)

- Verify the current versions according to the Update File Applicability / Information table shown table shown on page 7. Use the down arrow to scroll to the bottom of the list for complete verification.
- If the software version is current, press and HOLD the HOME button to exit the Diagnostic Mode and complete the procedure as no updates are necessary. If no updates are necessary, continue your diagnosis of the customer concern. If the Version ID numbers are prior to (lower than) those shown in the table above, proceed with **Step 2**, preparing the USB memory (Flash Drives) then **Step 3**, the software update procedure.

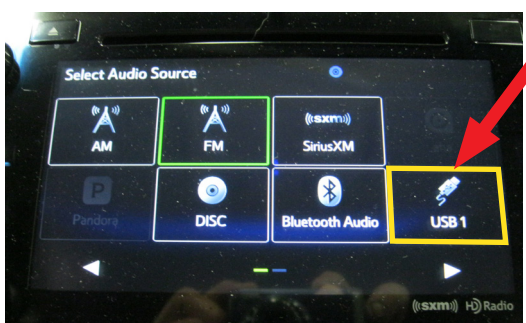
Install Drive “1” (or Drive “2” after successful installation of Drive “1” update is confirmed) into the vehicle’s USB port. After the flash drive is recognized, the USB icon will illuminate.

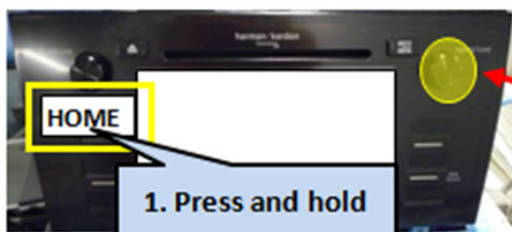
2. Press "AUDIO/TUNE" button 5 times

into “Diagnosis Mode” by pressing and holding the HOME button while pressing the “AUDIO/TUNE” button 5 (five) times.

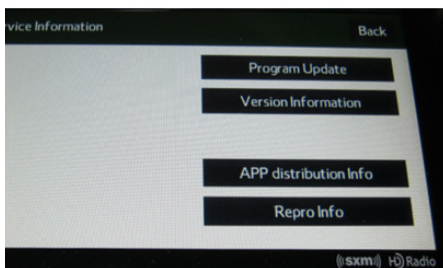
- Press “Program Update” then follow the sequence shown in the screen shots on the next page

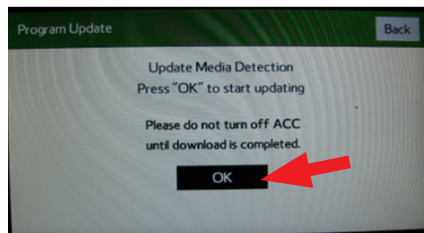
Press “OK”

NOTE: The “OK” button will not activate (turn black) if the wrong Update File(s) are on the flash drive. Re-format the flash drive and reload the proper Update Files starting from the beginning of Step 2.

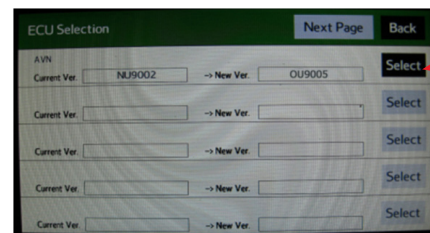
Press “SELECT”

CAUTION: Confirm the intended new version is displayed before clicking Select.

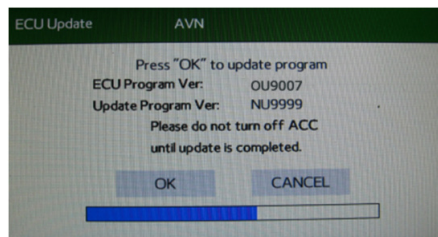
Once the updating starts, the status bar may need to complete more than once and could take up to about 15 minutes.

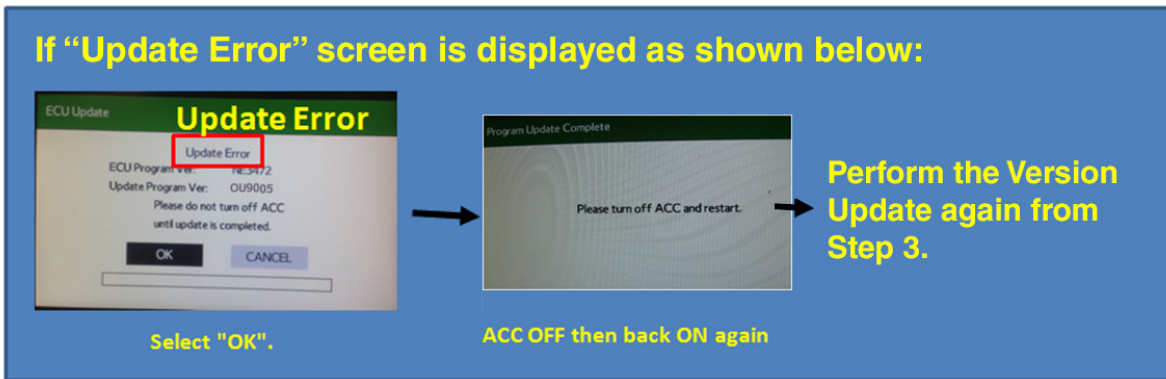
If the progress bar stops, please wait 15 minutes. If the progress bar does not change even if after 15 minutes, turn ACC OFF and back ON again then, restart the update procedure from **Step 4**.

IMPORTANT: Do not turn the ACC (ignition / key) off or disconnect the flash drive from the USB port during updating.

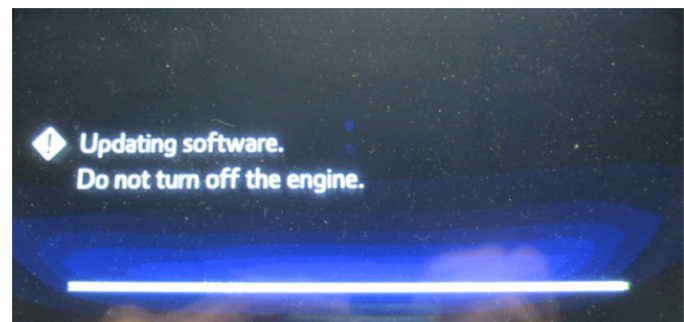
- Once the update completes successfully, turn the ACC off.
- **CRITICAL: WAIT AT LEAST 60 SECONDS.** If the ignition is turned back on before waiting **AT LEAST 60 SECONDS**, the data may be corrupted and the unit damaged.
- After the unit boots back up, the "Updating software" screen and its status bar will be displayed. This update may take up to 5 minutes to complete.

When the Software Updates complete, the unit will restart automatically. Once the STARLINK opening screen is displayed, remove the flash drive from the USB port and turn the ignition off. **CRITICAL STEP:** Before proceeding further, perform **Step 1** (Version Check Procedure) again to confirm the updated software installation from Drive "1" was successful. When the update is successful, the new software version number will be displayed. If OK, proceed with installation of the Drive "2" update (repeat **Step 4**, Update Software Installation). If the updated versions are not displayed, **Step 4** using Drive "1" must be repeated. Once the software and CAN version updates are confirmed, insert Drive "2" and repeat **Step 4**.

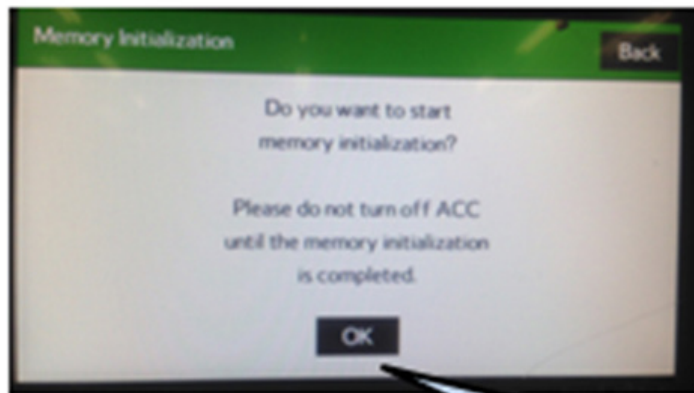
NOTE: All presets will likely be lost and will need to reset after performing this procedure. After pressing "Back", the following screen will be displayed:

- Press "Memory Initialization"

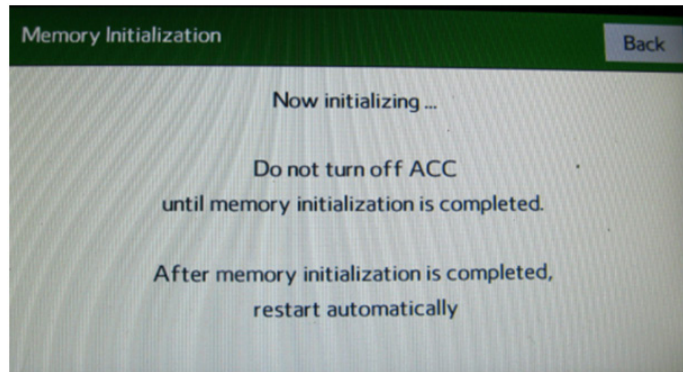
- Press and **HOLD** the "OK" button until the screen shown below is displayed (5 to 10 seconds).

This screen will be displayed for about 1 minute while the unit restarts. After restart, the Loading screen and its status bar will be displayed. After the status bar completes, the Main Menu screen will be displayed. To complete the updating procedure, you must go through the series of Initial Setup screens, reset the radio station presets and re-pair any mobile devices (where applicable).
