# Service Bulletin

Bulletin No.: 20-NA-212

**Subject: IPC Gauges Inoperative or Fluctuate, No Crank, Start then Stall**

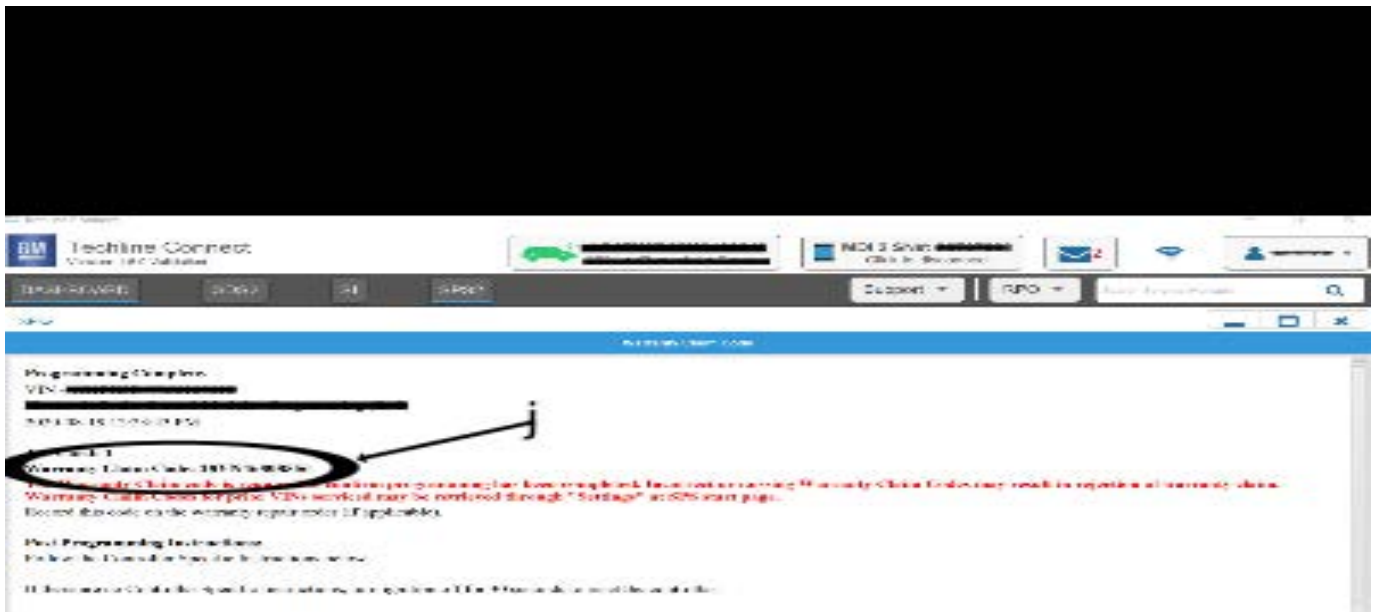
5431209

1. Reprogram the K56 Serial Data Gateway Module: Programming and Setup. Refer to *K56 Serial Data Gateway Module: Programming and Setup* in SI.
