Service Bulletin

Bulletin No.: 20-NA-238

Subject: Radio Software Version V153 Update

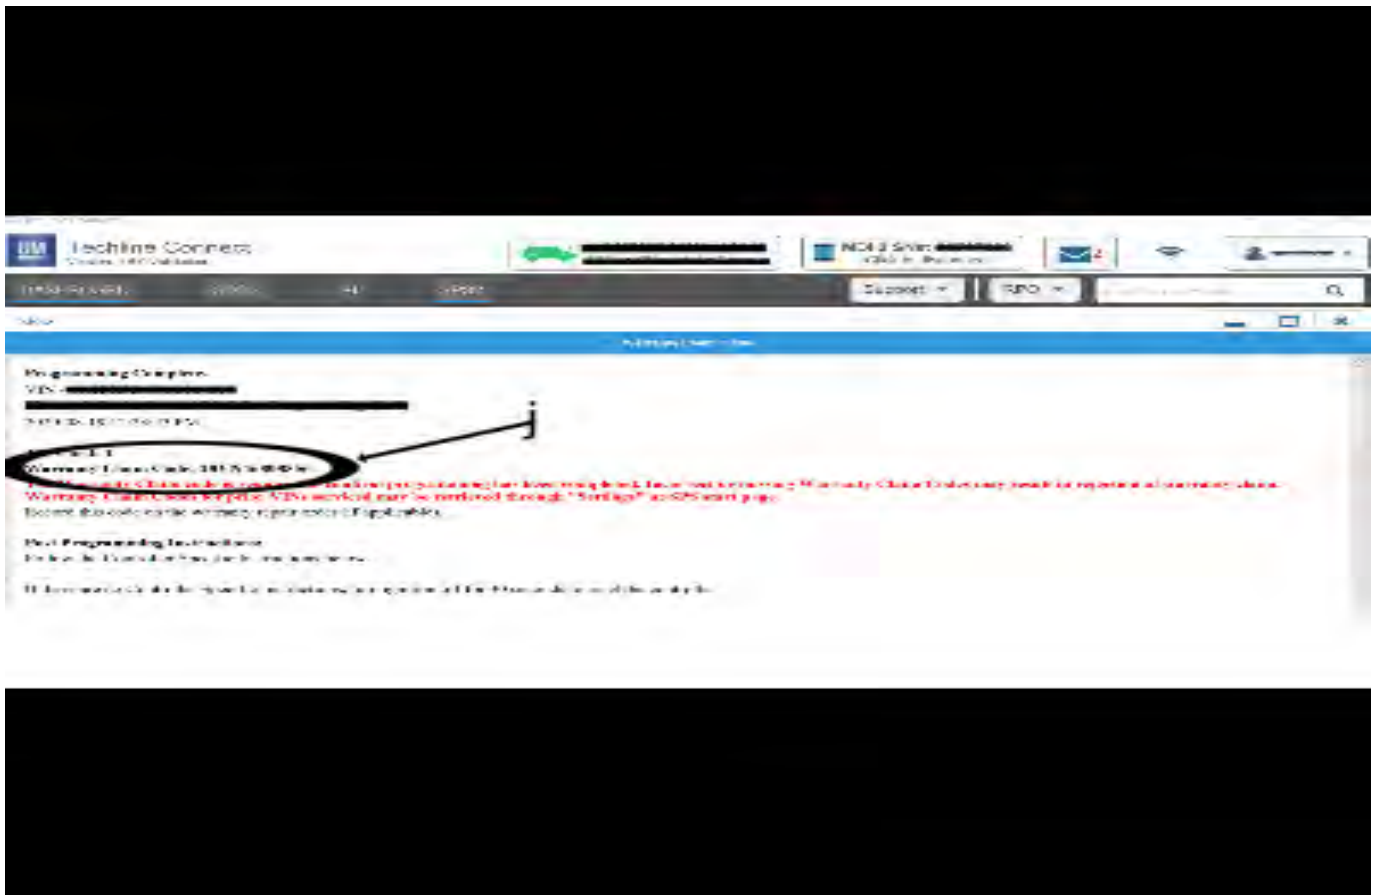
5431209

2. Install the software update via USB. Refer to *A11 Radio: Programming and Setup* in SI.
