May 15, 2021

Version 2

## Product Update: 2018 Odyssey Front Control Box OTA Software Update

Update the audio unit software.

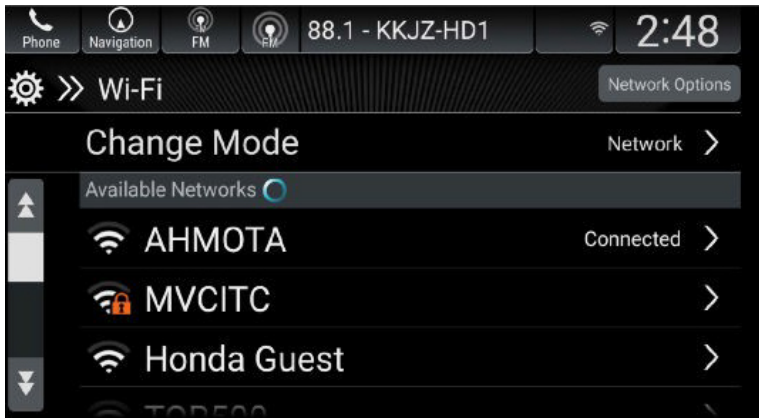
1. Make sure the vehicle is located in range of the dealership's Wi-Fi network with the engine running.
2. Park the vehicle outside in a well-ventilated area, or attach an exhaust hose to it.
3. From the Home screen, select **Settings, Connections**, then **Wi-Fi**. Make sure the vehicle is connected to **AHMOTA**. If **AHMOTA** is not listed, contact your IT Administrator. See Over the Air (OTA) Resources, located in the Service Bay on the iN.

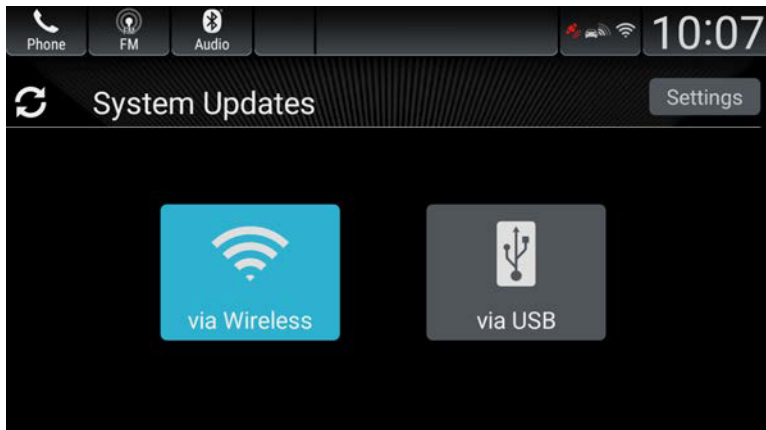
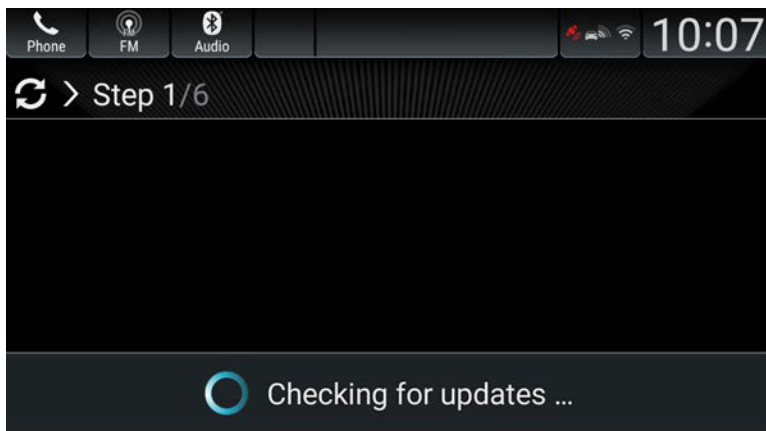
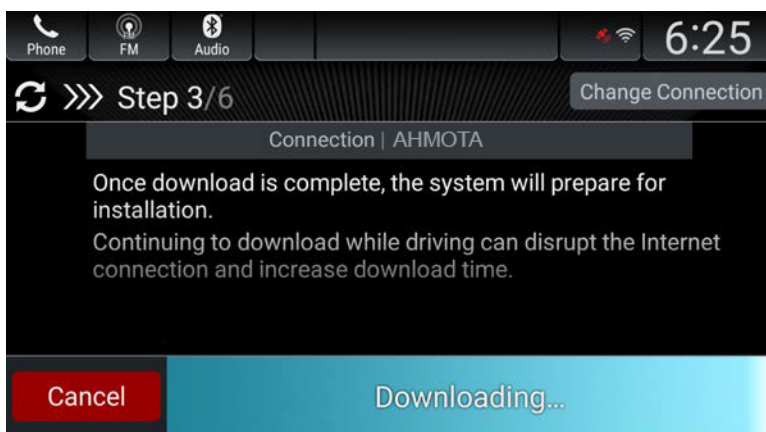
5. Once you have confirmed the vehicle is connected to AHMOTA, and the **Honda SW Version** reads lower than **B.1.3.4**, return to the Home screen. From there, select **System Updates**, then **via Wireless**.

- In some instances, you might not see the following screens on the display.
- If you see **Code 6382**, make sure your dealer AHMOTA network is properly set up.

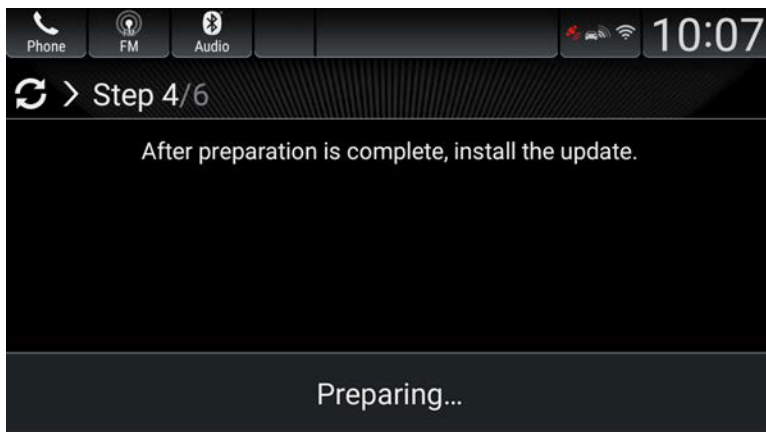
- The download will only complete with the ignition turned to ON. If you turn the ignition to OFF before it is complete, or the Wi-Fi connection is lost, the download will resume once you turn the ignition to ON and the Wi-Fi connection is restored within 2 weeks. If it takes longer than 2 weeks, you must start the process again and it will reset to 0% complete.

- If the download completes, go to step 6.

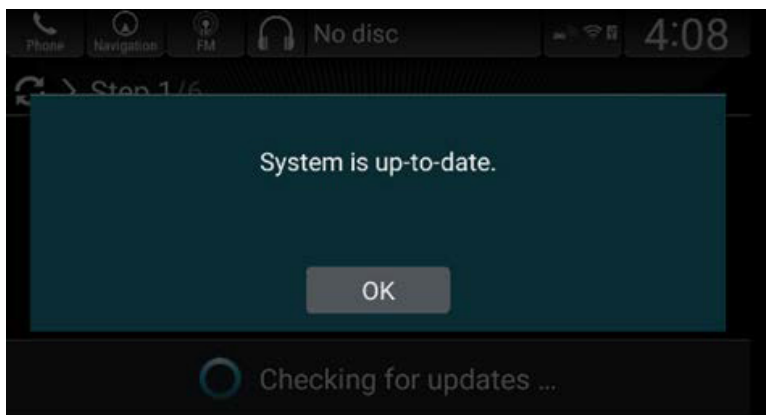
- If the download does not complete after several attempts, and you see an error message, call Tech Line.
- If the download does not complete, and you see the message below, go to REPAIR PROCEDURE - USB FLASH DRIVE.

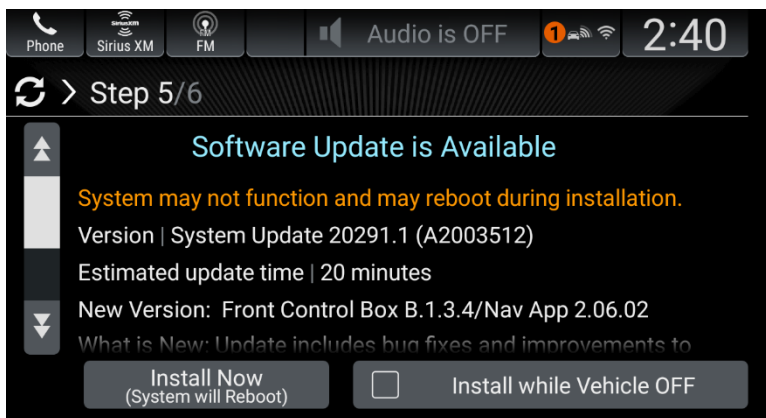
6. When you see this screen, select **Install Now**.

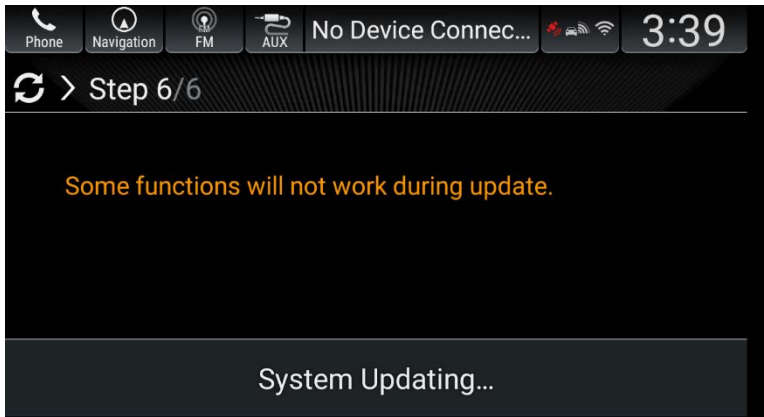
- The system will reboot several times during the installation.
- You may see this screen twice if the vehicle has navigation.

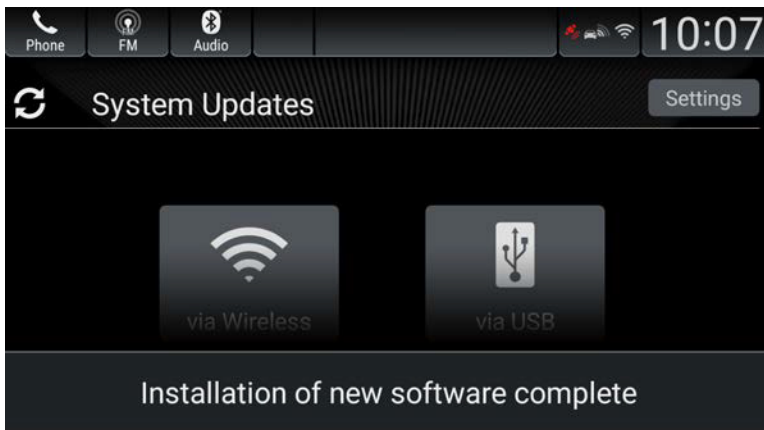
7. Once the installation is complete, you will see this screen. Keep in mind the message **Installation of new software complete** will appear for only **5 seconds**.

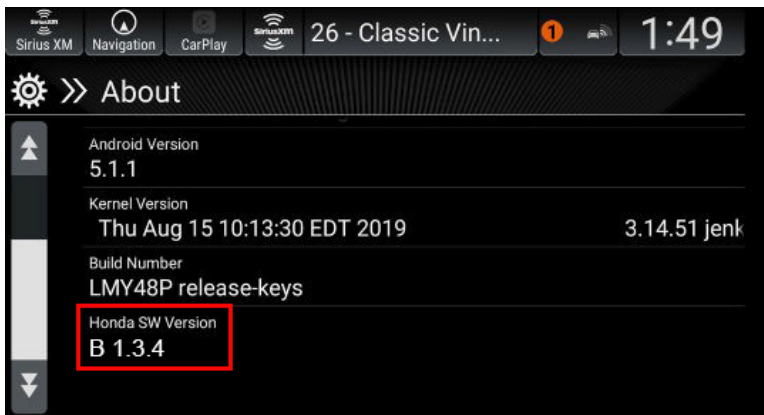
8. Go to the Home screen select **Settings, System, About**, and make sure the Honda SW Version reads B.1.3.4 or later. If it does, this repair is complete.

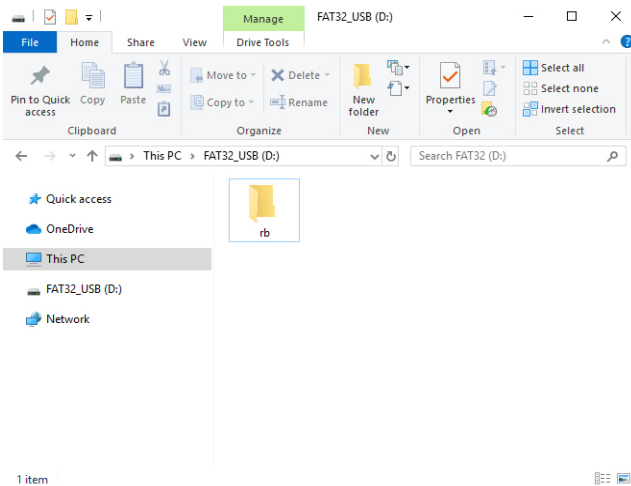
6. Create a folder on the flash drive, and name it **rb**.

NOTE: The flash drive should already be formatted to FAT 32.

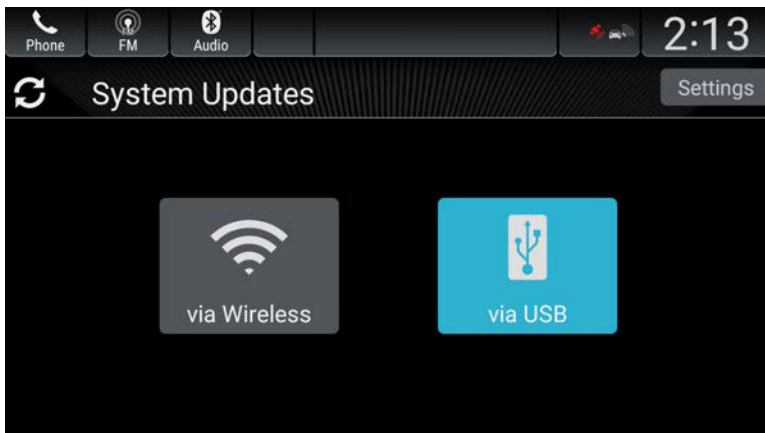
8. Once the file is on the flash drive, return to the vehicle. From the Home screen, select **System Updates**, then **via USB**.

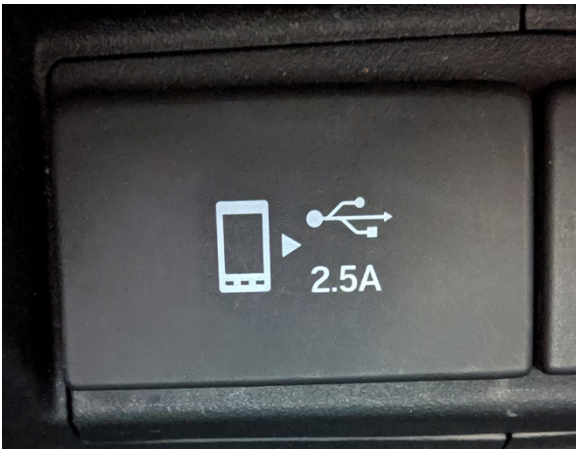
9. Plug the flash drive into the vehicle's USB Data port identified with this symbol.

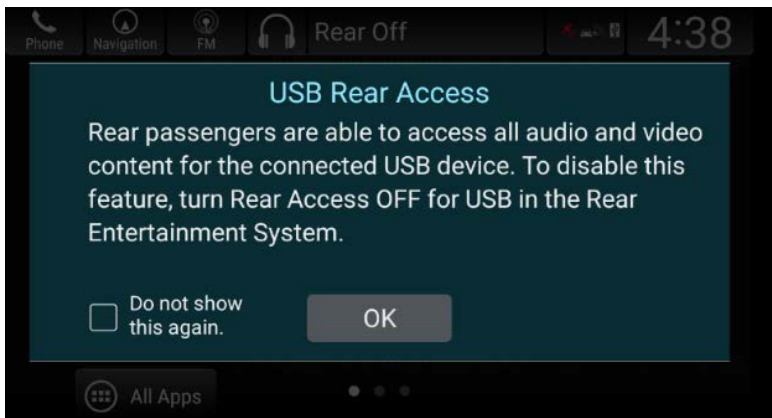
NOTE: If the vehicle has an RES, you may see this screen. If you do, select **OK** and continue.

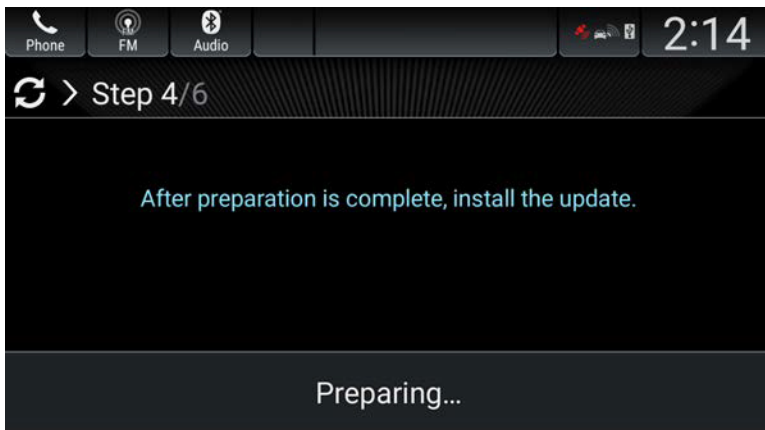
You will then see this screen telling you the system is automatically copying and preparing the update files. Keep in mind this may take some time depending on the file sizes.

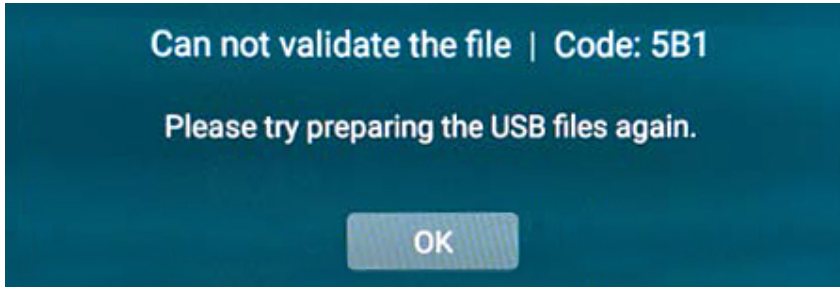
- If the preparation fails to complete, you will see this screen. If you do, try preparing the files again. For support, contact Tech Line.

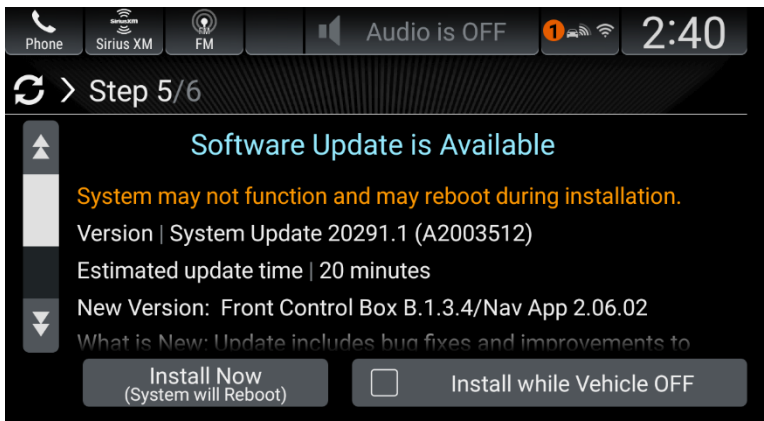
10. Once the software has been prepared, select **Install Now**. The system will reboot several times during the installation.

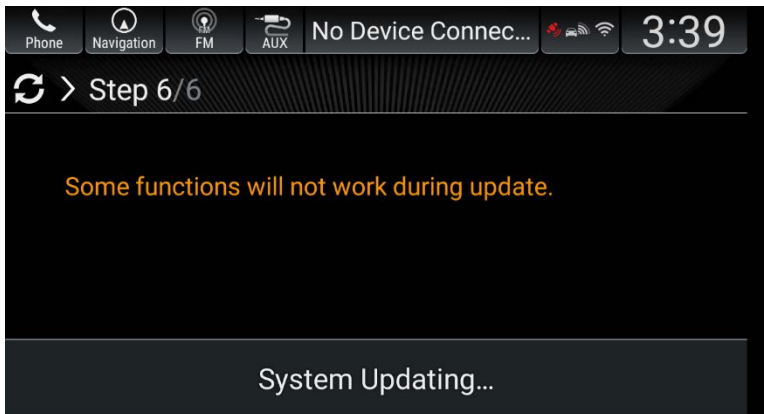
- The system will reboot several times during the installation.
- You may see this screen twice if the vehicle has navigation.

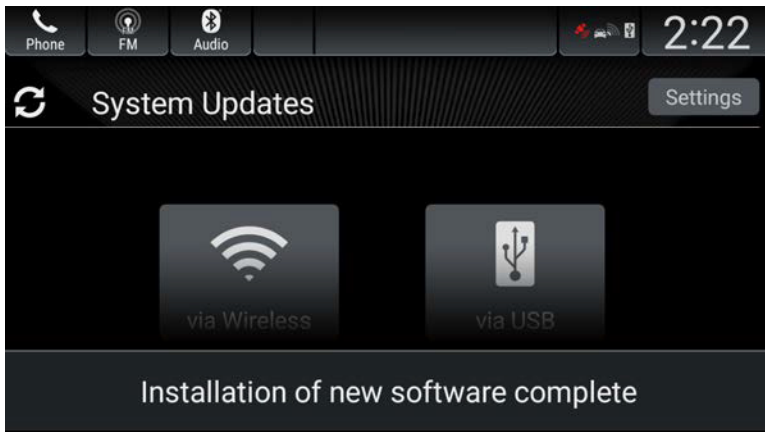
Once the installation is complete, you will see this screen.

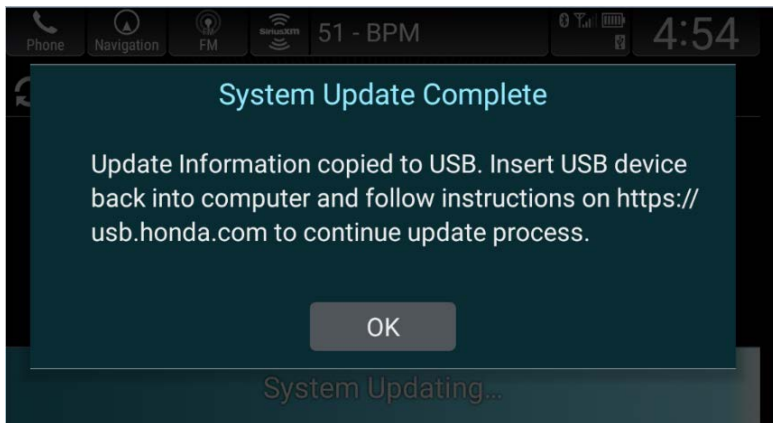
- If the System Update Complete screen is displayed, you will need to manually report the status of the update. Return to your PC and insert the USB drive into your computer. Go to <https://usb.honda.com>. Select Report Upload. Navigate to the RB folder on your USB drive and choose the XXXXXREPORT.JSON file.

Under REPAIR PROCEDURE – USB FLASH DRIVE, a note and image were added under step 10.

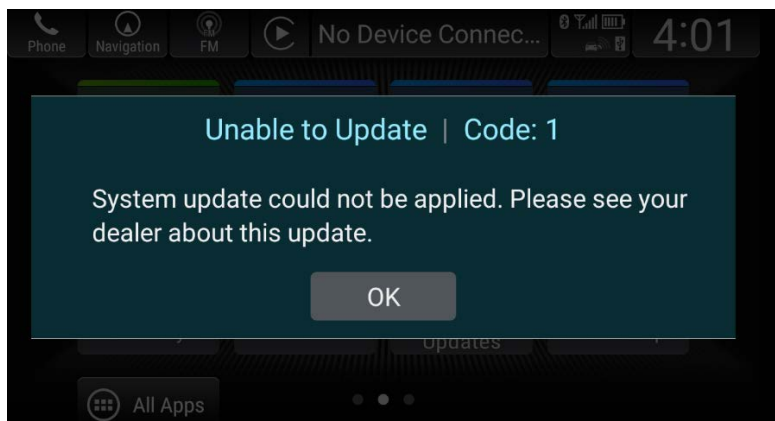
- If you encounter a message **Unable to Update | Code: 1** after seeing the image above, press OK and cycle the ignition.

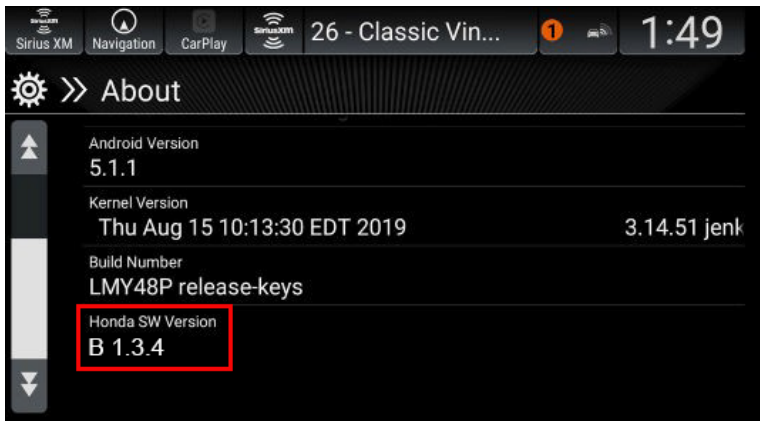
11. Make sure the Honda SW Version reads B.1.3.4 or later.
