WARRANTY BULLETIN

Campaign no.: 2019-0008

Subject: **Large Panoramic 7.8" Wide LCD Display - Software Update**

No. **2019-5**

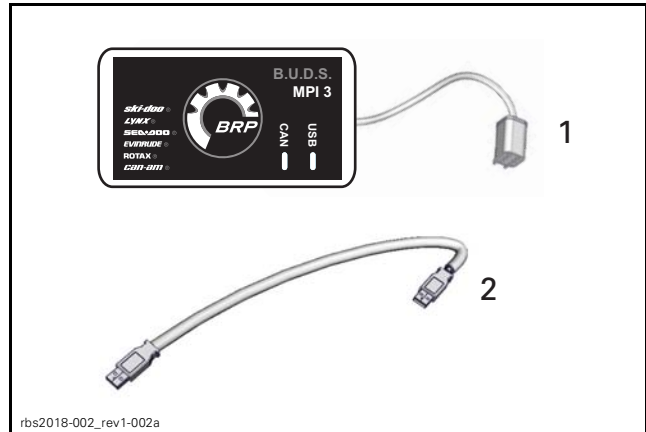
NOTE: Both diagnostic cable and USB cable are required to do the update.

- 1. MPI Diagnostic Cable
- 2. USB Cable

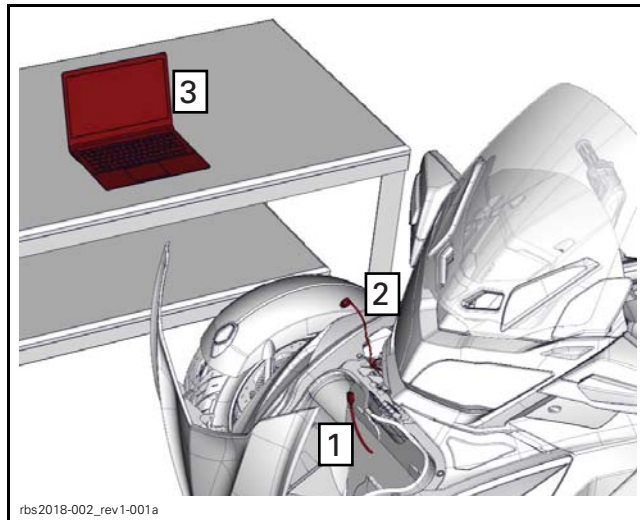
- SHOWING RT MODELS
- 1. Vehicle USB cable
 - 2. BRP diagnostic software cable
 - 3. Computer

- 1. Access the vehicle USB connector.
- 2. Connect the USB cable between the computer and the vehicle.
- 3. Connect the vehicle to the BRP diagnostic software (BUDS2) using the *MPI DIAGNOSTIC CABLE*.
- 4. Logon as administrator by doing a right click on the BUDS2 icon and select the *RUN AS ADMINISTRATOR* option.

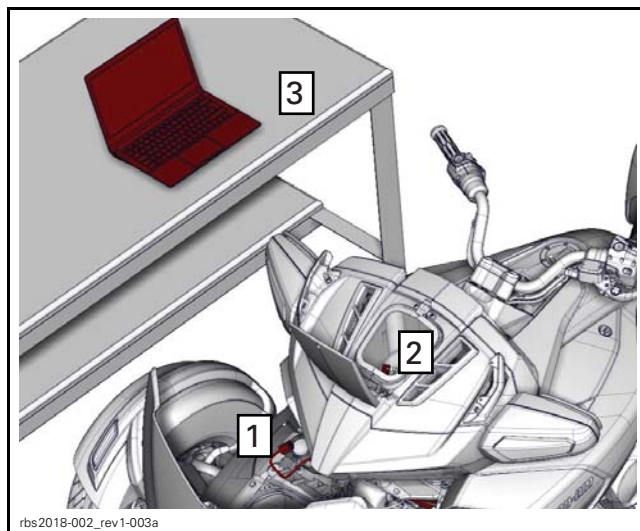
- SHOWING F3 MODELS
- 1. BRP diagnostic software cable
 - 2. Vehicle USB cable
 - 3. Computer

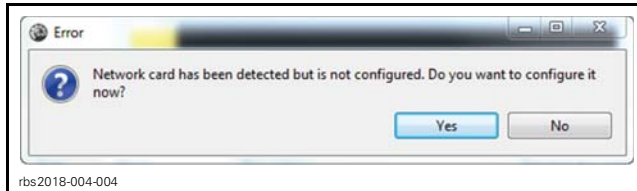
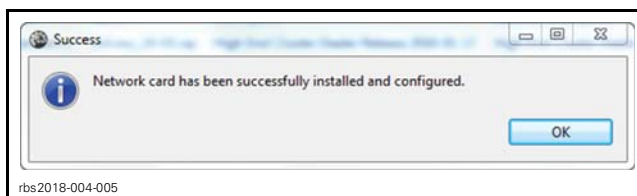
The first time an update is done with a computer, 2 dialog boxes will appear.

7. Click **YES** on the first one, and **OK** on the second.

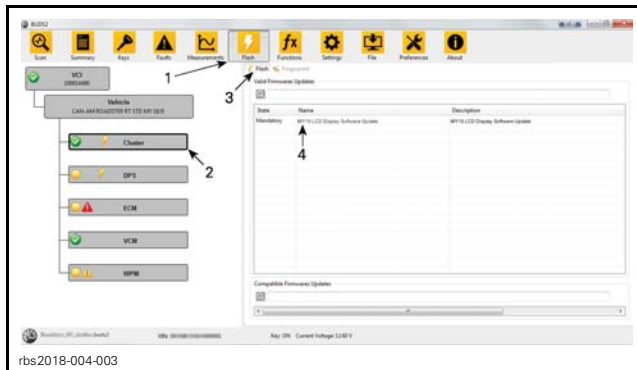
6. In BUDS2, select:

- Flash page
- Cluster button
- Flash tab.

- TYPICAL**
1. Flash page
 2. Cluster button
 3. Flash tab
 4. Update files
