Product Update: Electric Power Steering (EPS) Software Update

Supersedes 15-055, dated September 28, 2018; See Revision Summary

AFFECTED VEHICLES

Year	Model	Trim Level	VIN Range
2013-14	Accord	ALL	Check the iN VIN status for eligibility.
2014	Accord Plug-In Hybrid	ALL	Check the iN VIN status for eligibility.
2014	Accord Hybrid	ALL	Check the iN VIN status for eligibility.

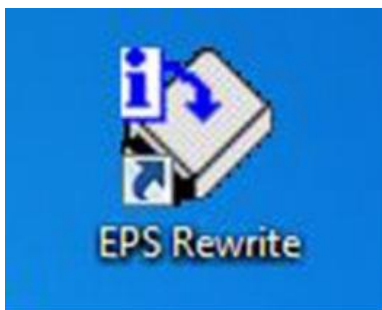
- Make sure you have the latest software loaded to your PC. Run the Honda Download Manager to confirm the latest software.
 - During the software update, DO NOT turn off the ignition to OFF. Doing so during the update will damage the control unit.
1. Connect a jumper battery to the vehicle and leave it connected during the entire procedure to maintain a steady voltage.
 2. Connect the Mongoose Pro / Plus Honda Interface Tool between the PC and the vehicle's DLC.
 3. Select the EPS Rewrite Icon on your PC.

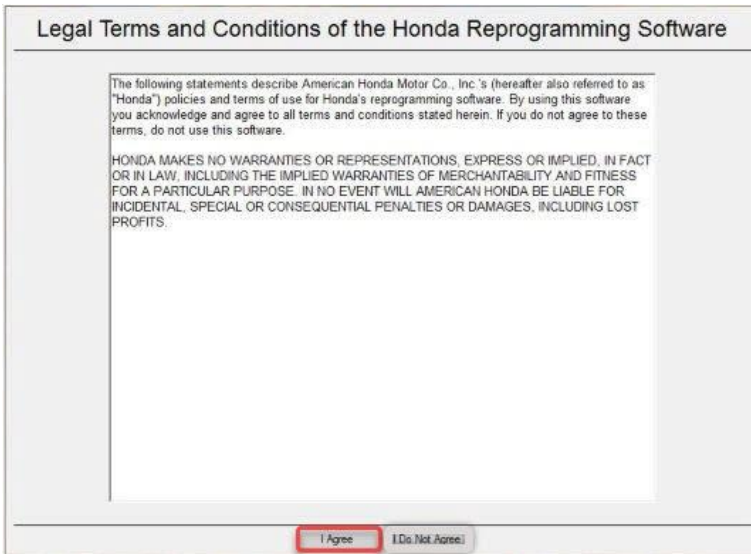
4. Select **I Agree**.

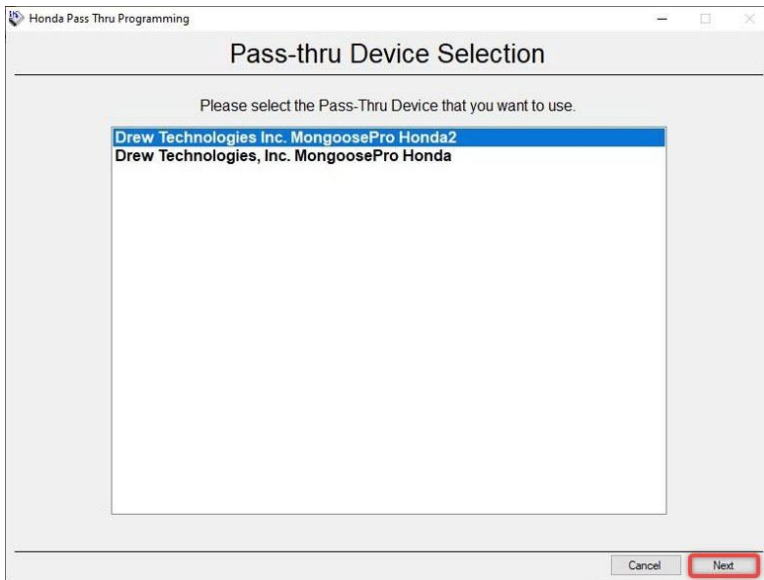
5. Select **Next** in the Pass-thru Device Selection screen.

NOTE: If you are using the Mongoose Plus Interface Tool, be sure to select "Drew Technologies, Inc. MongoosePro Honda2" or the interface tool will not connect.

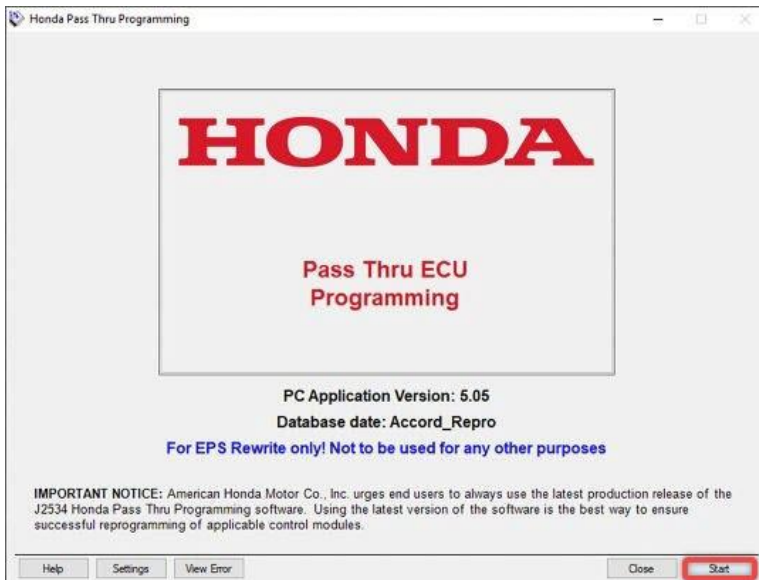
6. Select **Start**.

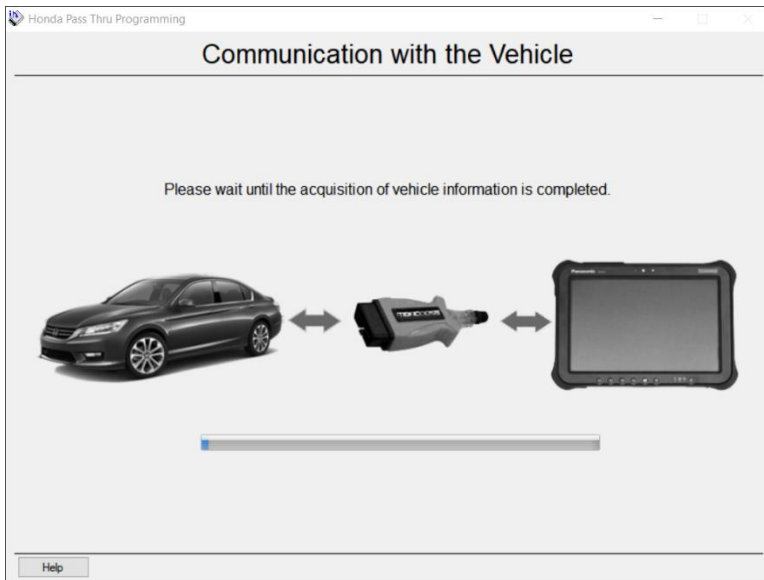
8. You will see the **Communication with the Vehicle** screen.
