## SERVICE BULLETIN

**APPLICABILITY:** All 2019-**22MY** Vehicles with Gen 2 Telematics      **NUMBER:** 15-219-18R  
**SUBJECT:** Error Code 202 and / or 204 Generated During      **DATE:** 06/21/18  
 Gen 2 Telematics Subscription Process      **REVISED:** **11/02/21**

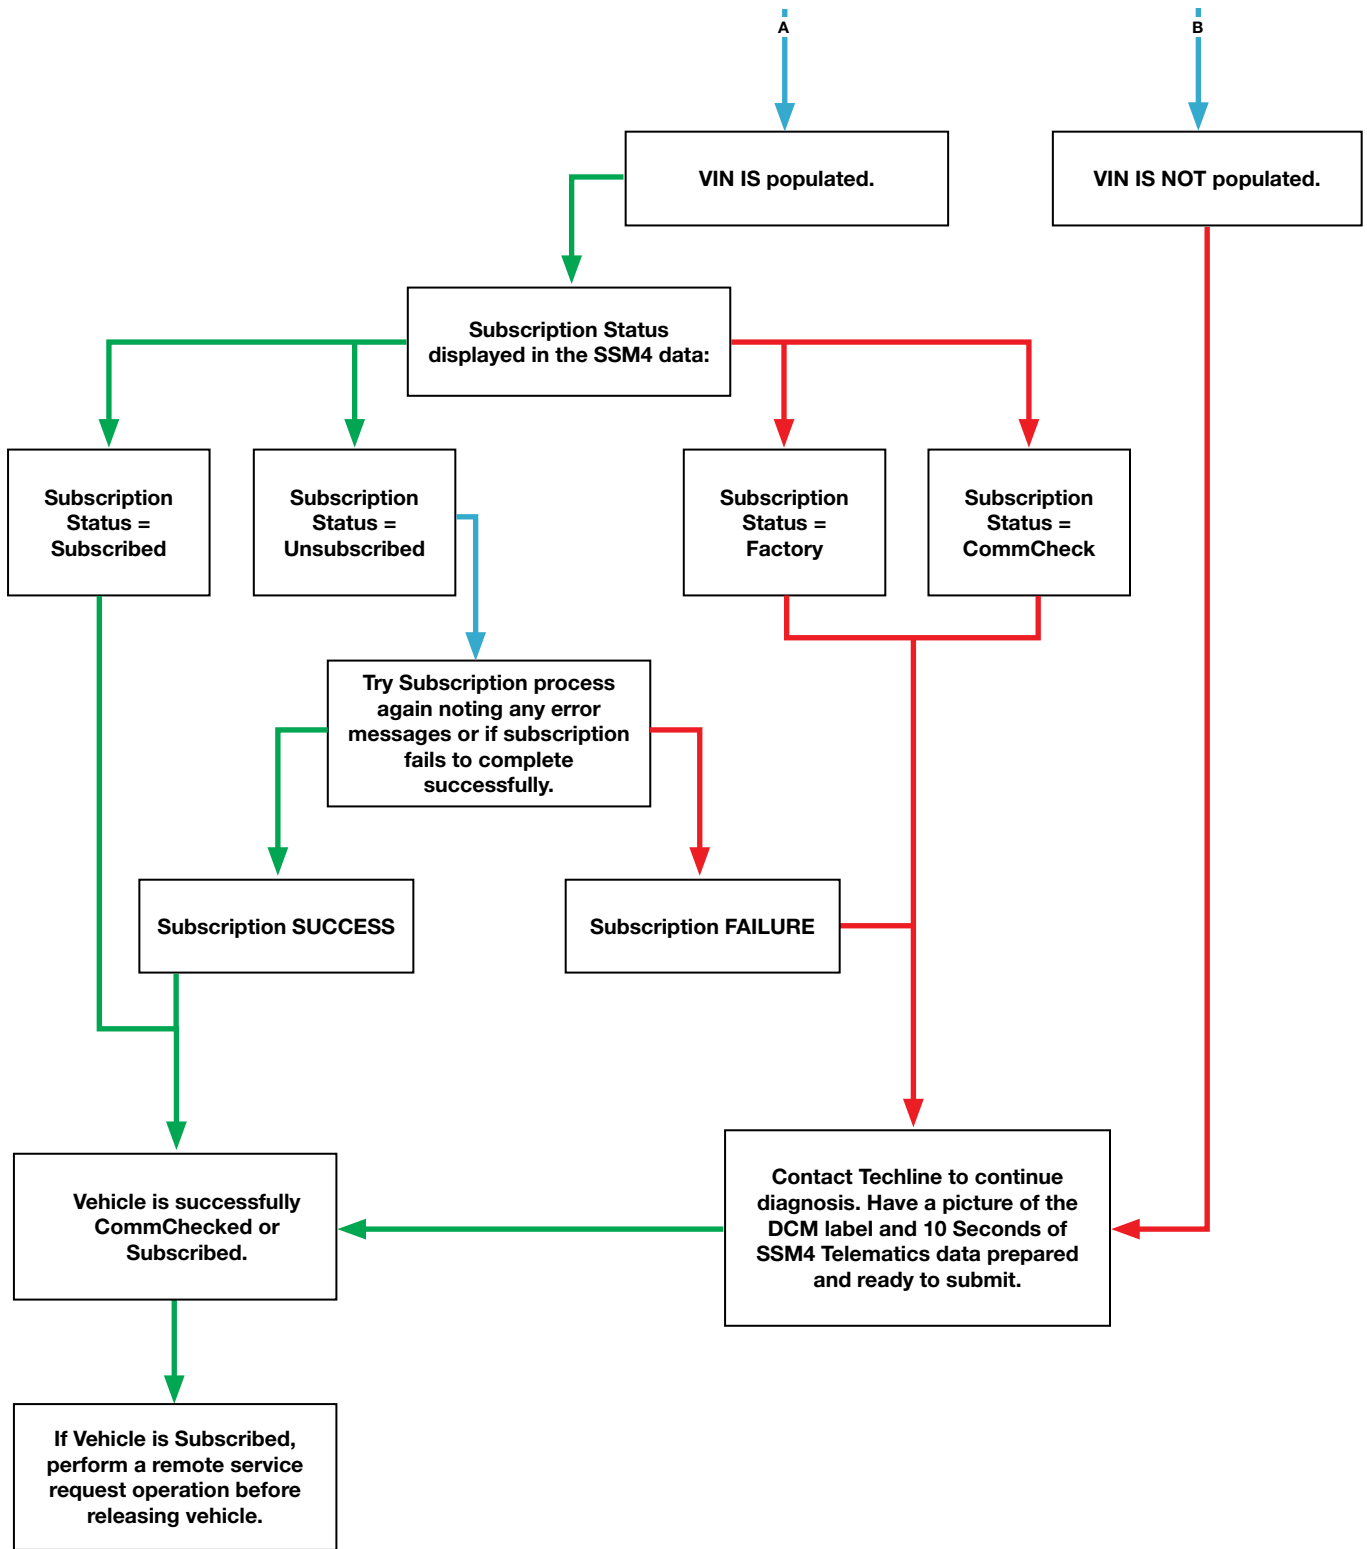
# “Appendix A”

**NOTE:** A flow chart to use as an additional diagnostic reference tool has been provided in “APPENDIX A” beginning on pg. 5.
