SERVICE BULLETIN

APPLICABILITY: 2015-20MY Legacy & Outback
 2015-20MY Forester
 2015-20MY WRX
 2019-20MY Ascent

NUMBER: 07-207-22R

SUBJECT: Subaru Battery Drain Product Liability Litigation

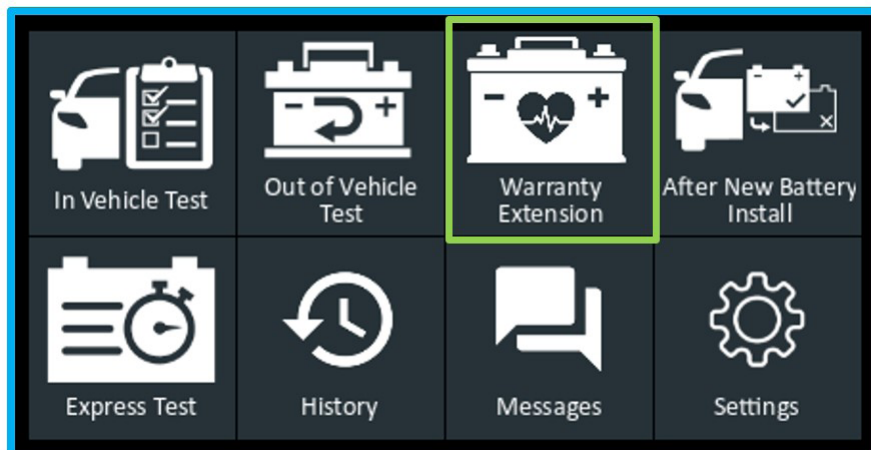
1. Carefully connect the testing equipment to the vehicle and press the Warranty Extension icon to continue.

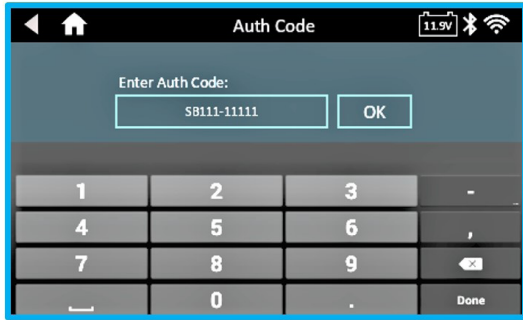
DCA-8000

- The Authorization Code or the QR scan code (if testing is started with the DSS-5000) is required at this point. Enter the required information.

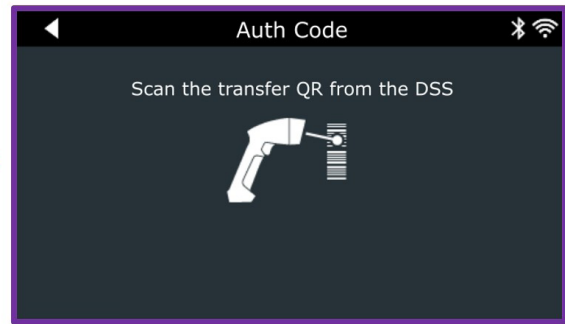
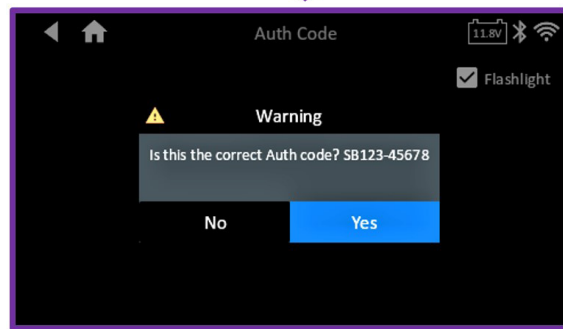
DSS-5000 to DCA-8000

NOTE: In a case when the QR Code is entered from the DSS-5000, a confirmation will display to confirm the Authorization Code for the vehicle being tested. Click “Yes” if the code is correct.

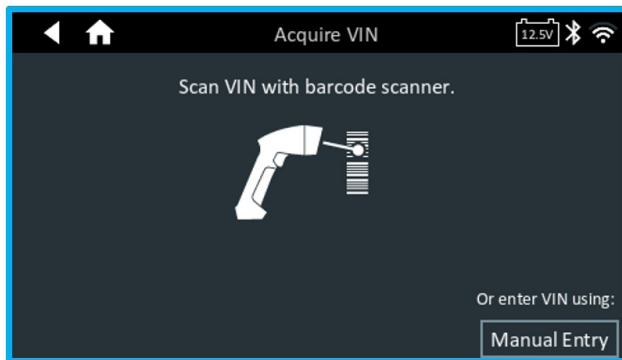
- Verify the VIN using the scan tool.

NOTE: In a case where the scan tool option is unavailable the VIN can be entered by using the manual entry function.

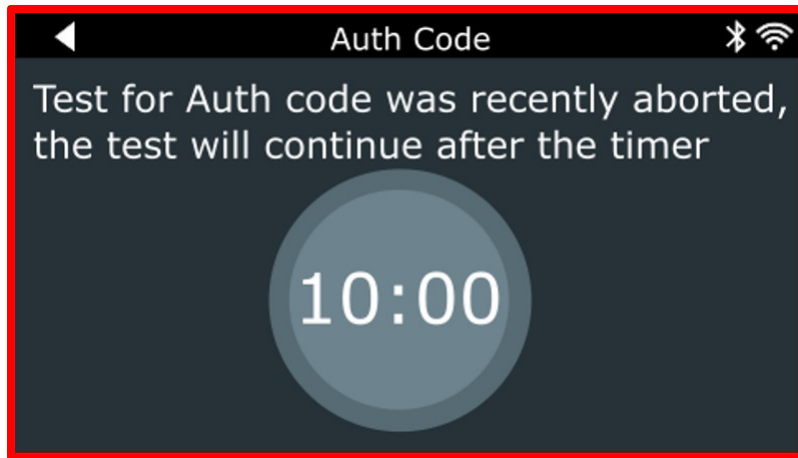
Once the battery information is confirmed and entered, continue with the battery testing.

CAUTION: In the event of a test or charge being aborted for any reason, a ten-minute time window is displayed. After ten minutes has elapsed, the test will have to be restarted from the beginning.
