Service Bulletin

Bulletin No.: 22-NA-189

Subject: Non-Operating Remote Start with DTCs P31DB/P31E8 Set

Brand:	Model:	Model Year:		VIN:		Engine:	Transmission:
		from	to	from	to		
Chevrolet	Corvette	2021	2022	—	—	—	—

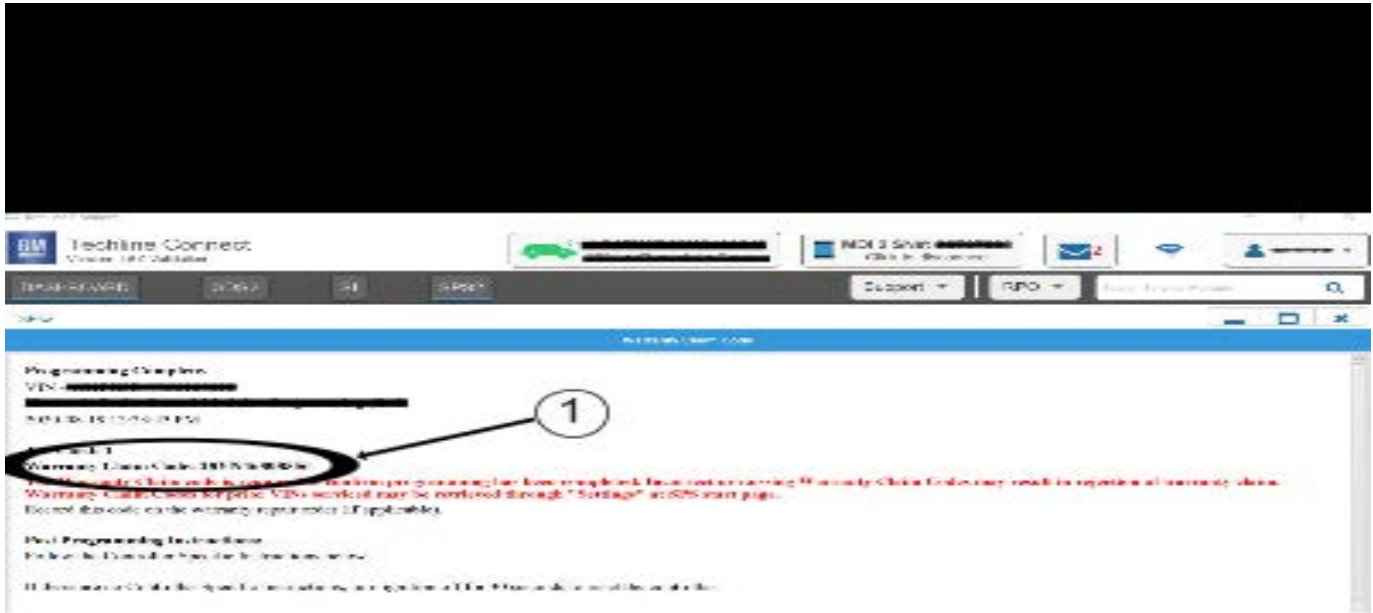
5644478

Note: The screenshot above is an example of module programming and may not be indicative of the specific module that is being programmed. Module selection and VIN information have been blacked out.

Important: If the same calibration/software warning is noted on the TLC or SPS Summary screen, select OK and follow screen instructions. After a successful programming event, the WCC is located in the Service Programming System dialogue box of the SPS

Summary screen. Document the WCC on the job card. No further action is required. Refer to the Warranty Information section of this bulletin.
