SERVICE BULLETIN

Subaru Battery Drain Product Liability Litigation

APPLICABILITY: 2015-20MY Legacy & Outback

NUMBER: 07-207-22R

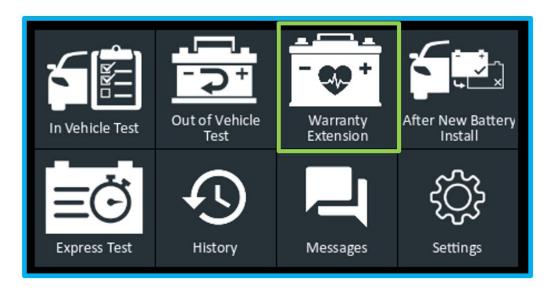
1. Carefully connect the testing equipment to the vehicle and press the Warranty Extension icon to continue.
