SERVICE BULLETIN

APPLICABILITY: 2015-20MY Legacy & Outback
 2015-20MY Forester
 2015-20MY WRX & WRX STI
 2019-20MY Ascent

NUMBER: 07-207-22R

SUBJECT: Subaru Battery Drain Product Liability Litigation

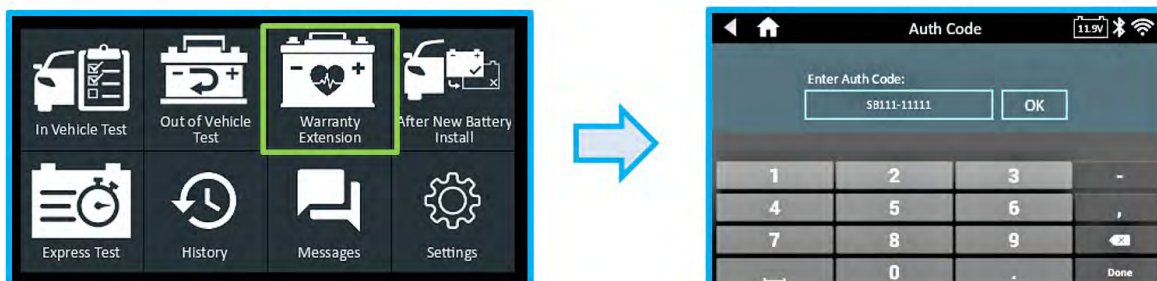
DSS-5000 TESTING:

The DSS-5000 can be used for initial testing or testing when charging is not required. The Authorization Code will be needed prior to testing. This code will be requested after the testing equipment is properly connected and the Warranty Extension icon is pressed. If the test requires charging, the DSS-5000 cannot meet the testing requirements as it does not have charging capabilities.

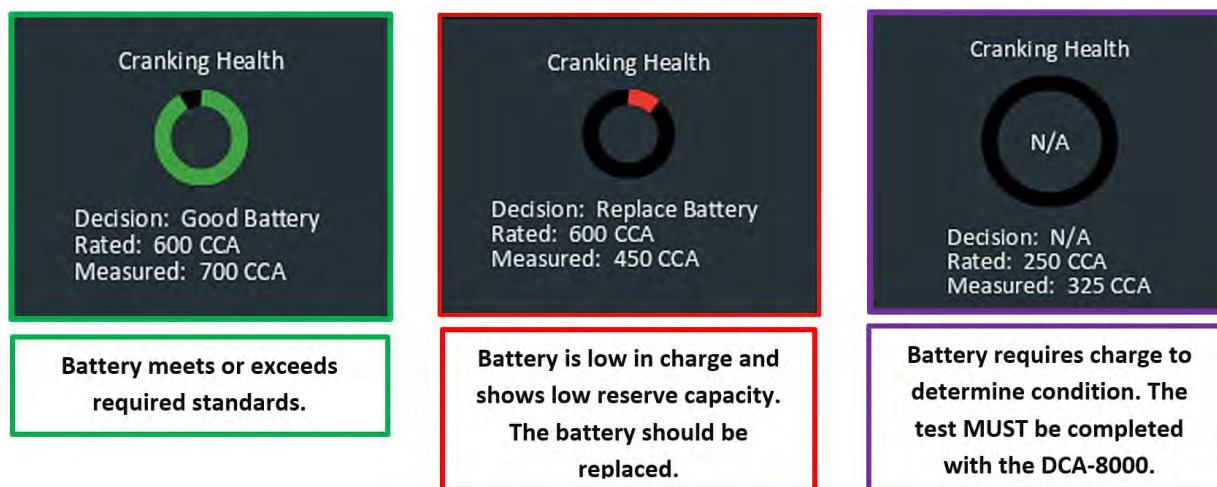
Continue with the normal test procedures. The possible test results given from the DSS-5000 are “Good Battery”, “Replace Battery”, or the battery requires a further charge.

If the DSS-5000 determines the battery requires replacement or does not require replacement, no further testing equipment will be required. A 21-digit Warranty Extension Test Code will be generated and clickable icon will be displayed on the screen **ONLY** if testing was completed. When pressed, the Warranty Extension Code will be displayed. **This code must be retained and attached to the repair order as it will be required for claim submission.**

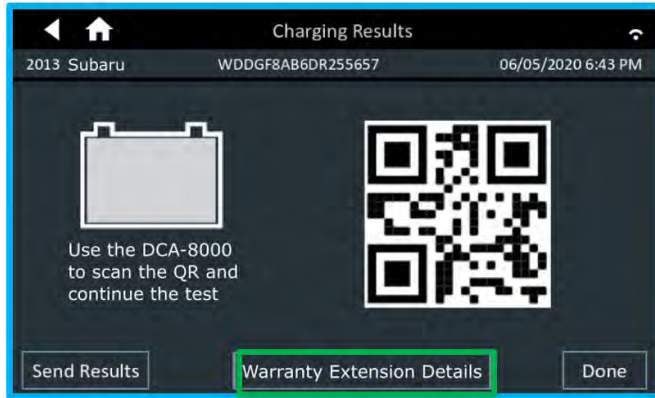
If the DSS-5000 determine charging will be needed for further diagnostic measures, the DCA-8000 will be needed to continue. When test results determine further charging is needed, a transfer QR code will be displayed on the screen. This code can be used to transfer vehicle information and charging requirements to the DCA-8000.

The following information is encrypted into the QR Code:

- Battery Information
- Vehicle Information
- Authorization Code
- Test Timestamp
- Warranty Extension Code (if applicable)
- Test Index

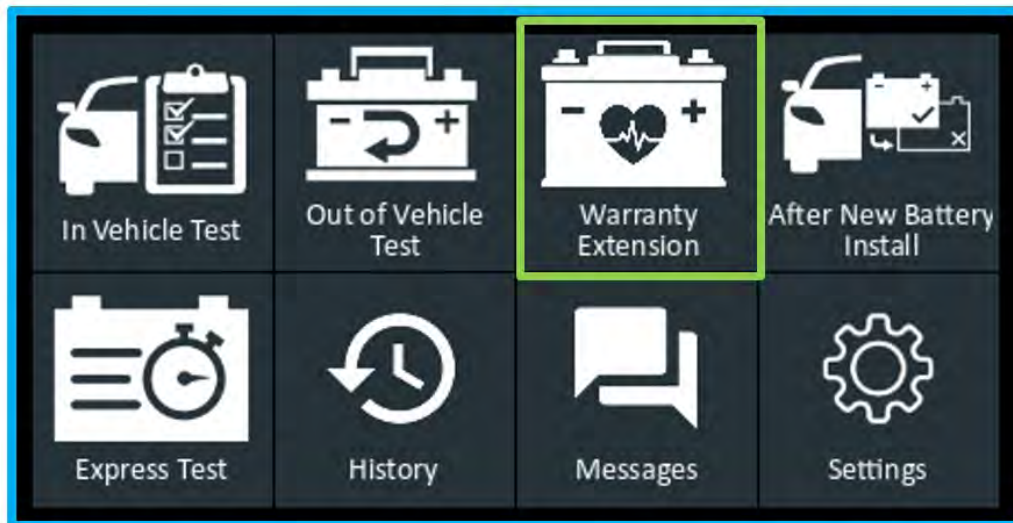
1. Carefully connect the testing equipment to the vehicle and press the Warranty Extension icon to continue.

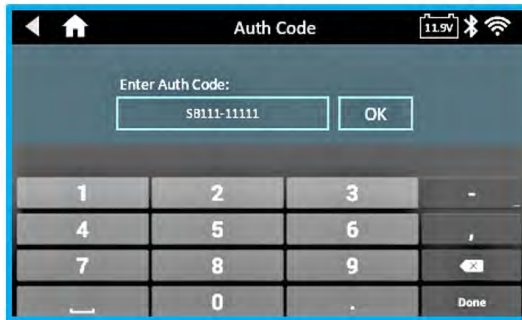
DCA-8000

- The Authorization Code or the QR scan code (if testing is started with the DSS-5000) is required at this point. Enter the required information.

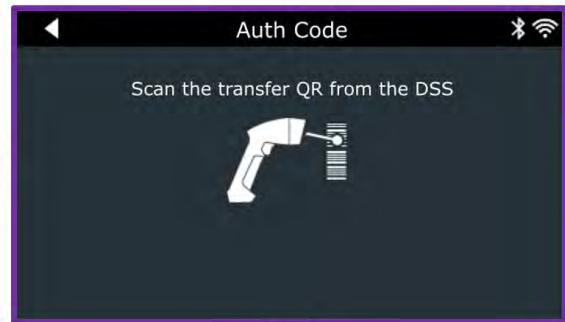
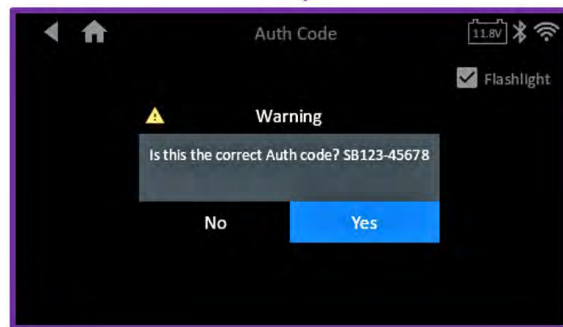
DSS-5000 to DCA-8000

NOTE: In a case when the QR Code is entered from the DSS-5000, a Warning screen will display to confirm the Authorization Code for the vehicle being tested. Click “Yes” if the code is correct.

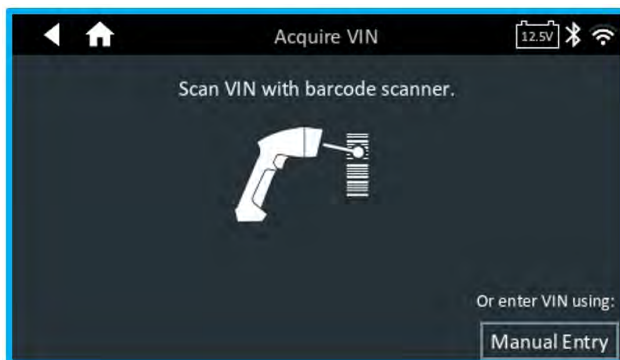
- Verify the VIN using the scan tool.

NOTE: In a case where the scanner option is unavailable the VIN can be entered by using the manual entry function.

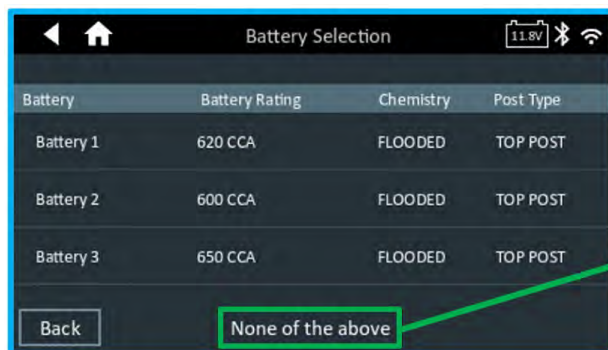
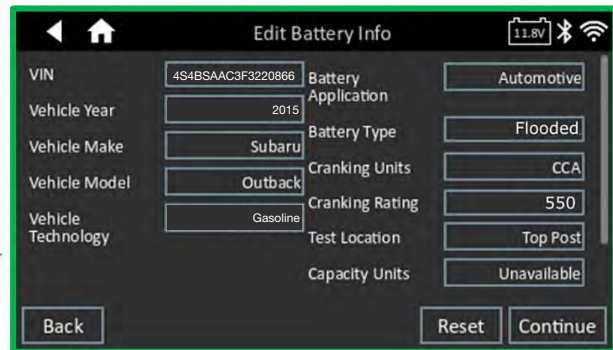
- Select the battery type being tested. If the “None of the above” button is selected, the Edit Battery Info menu will be displayed requiring manual entry into the required fields.

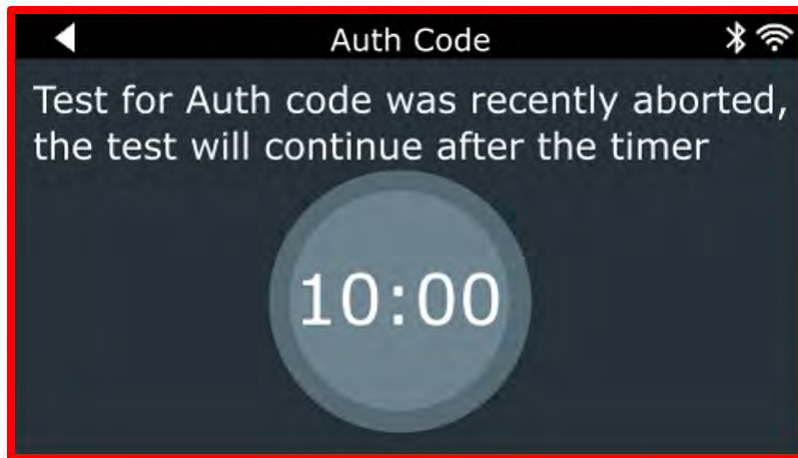
Once the battery information is confirmed and accurately entered, select “Continue” to proceed with the battery testing.

CAUTION: In the event of a test or charge being aborted for any reason, a ten-minute time window is displayed. After ten minutes have elapsed, the test must be restarted from the beginning.

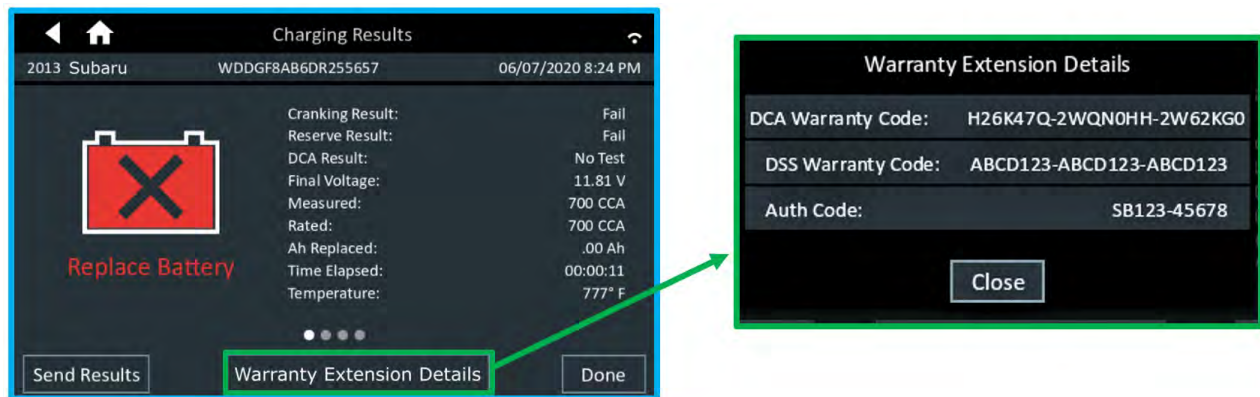
5. The DCA-8000 will display the testing results when complete. A 21-digit Warranty Extension Code will be generated. A Warranty Extension Details clickable icon will be displayed on the screen. When pressed, both the Authorization Code and the Warranty Extension Code are displayed in detail. These codes are to be retained and attached to the repair order and will be required for claim submission.
