SERVICE BULLETIN

APPLICABILITY: 2015-20MY Legacy & Outback
 2015-20MY Forester
 2015-20MY WRX & WRX STI
 2019-20MY Ascent

NUMBER: 07-207-22R

SUBJECT: Subaru Battery Drain Product Liability Litigation

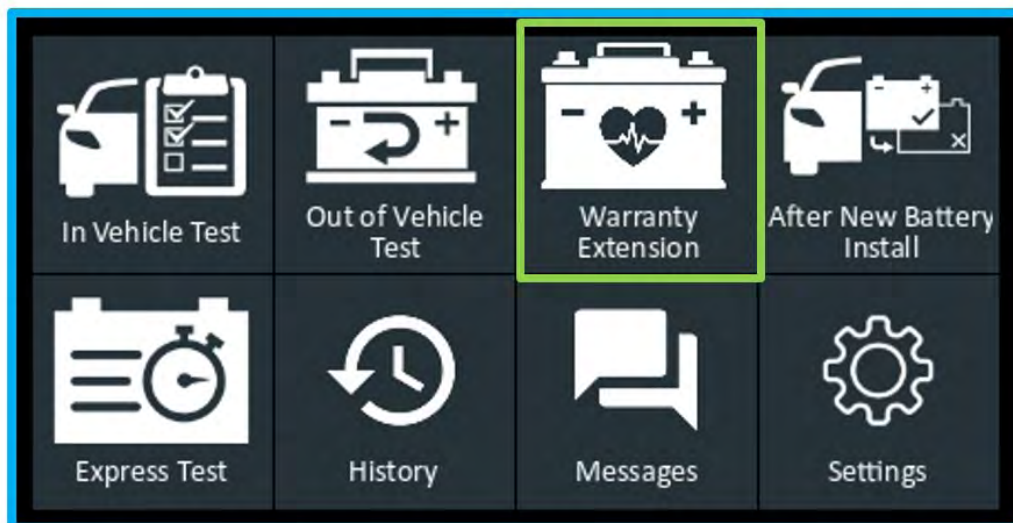
1. Carefully connect the testing equipment to the vehicle and press the Warranty Extension icon to continue.

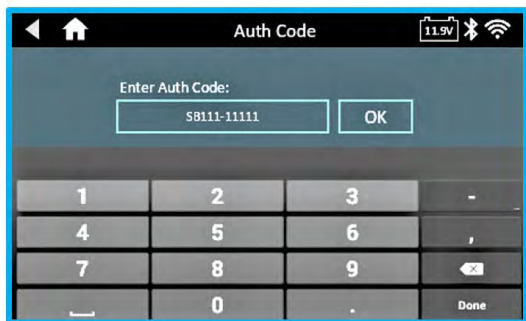
DCA-8000

- The Authorization Code or the QR scan code (if testing is started with the DSS-5000) is required at this point. Enter the required information.

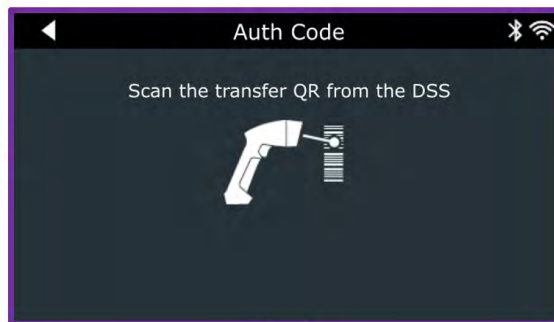
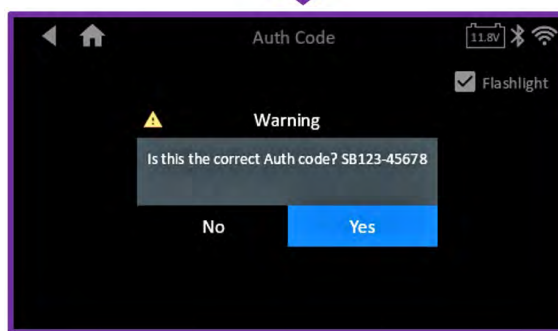
DSS-5000 to DCA-8000

NOTE: In a case when the QR Code is entered from the DSS-5000, a Warning screen will display to confirm the Authorization Code for the vehicle being tested. Click “Yes” if the code is correct.

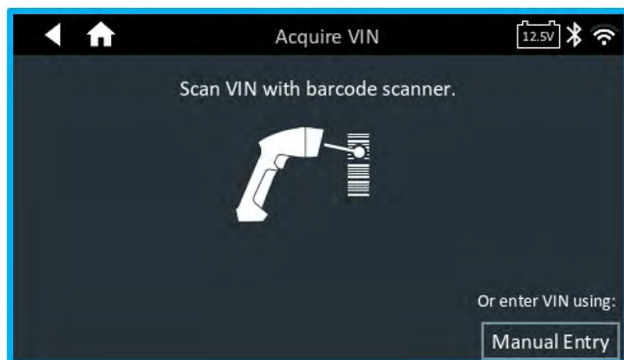
- Verify the VIN using the scan tool.

NOTE: In a case where the scanner option is unavailable the VIN can be entered by using the manual entry function.

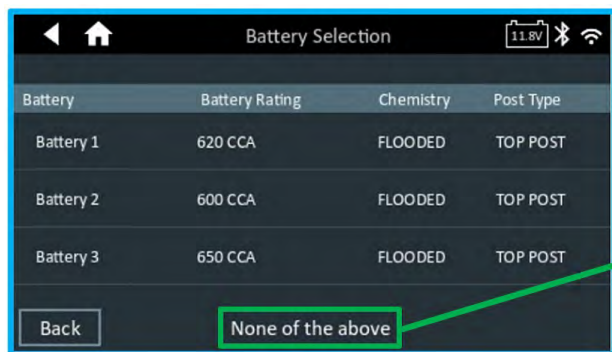
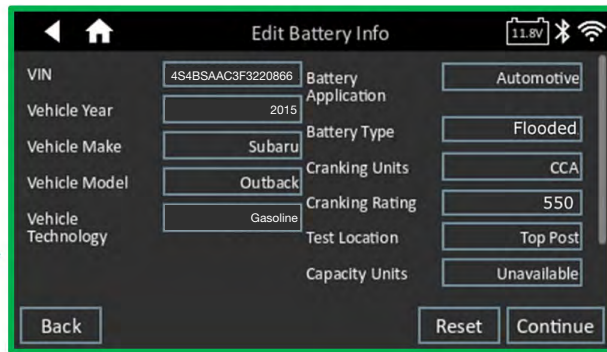
- Select the battery type being tested. If the “None of the above” button is selected, the Edit Battery Info menu will be displayed requiring manual entry into the required fields.

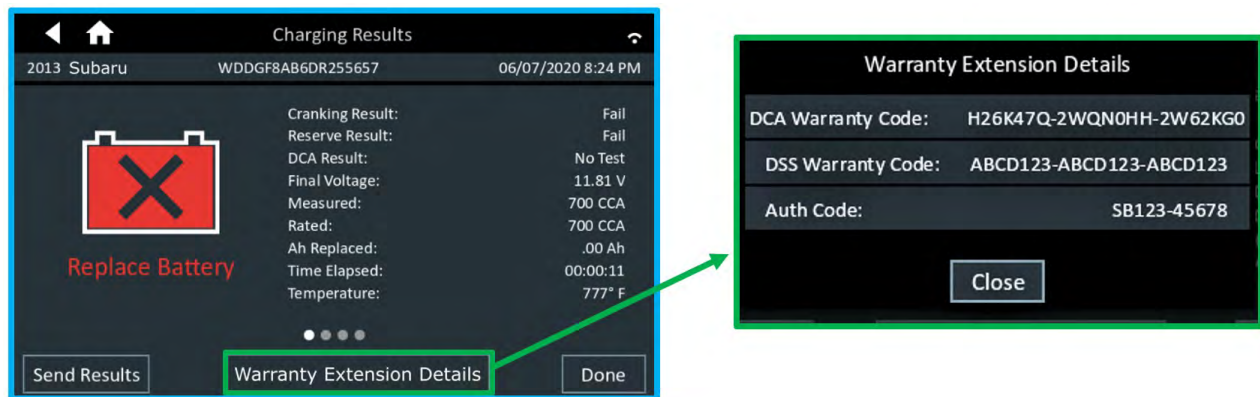
5. The DCA-8000 will display the testing results when complete. A 21-digit Warranty Extension Code will be generated. A Warranty Extension Details clickable icon will be displayed on the screen. When pressed, both the Authorization Code and the Warranty Extension Code are displayed in detail. These codes are to be retained and attached to the repair order and will be required for claim submission.
