SERVICE BULLETIN

APPLICABILITY: 2022-23MY Forester with Driver Monitoring System

NUMBER: 07-222-23R

SUBJECT: Climate Control Settings / Undesired Changes

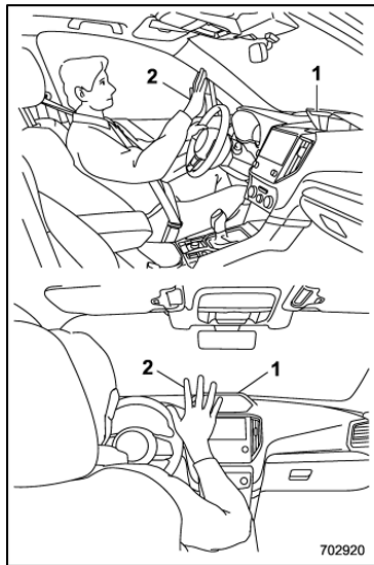
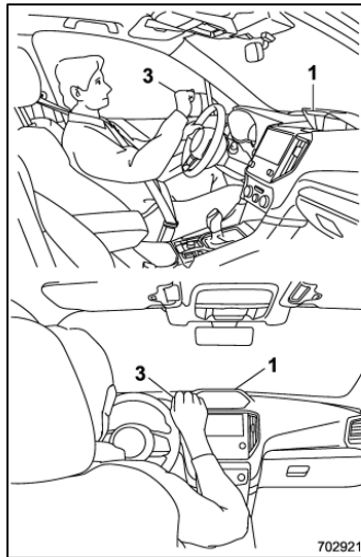
1: Camera

2: When the gesture is an open palm, the set temperature rises.

3: When the gesture is a closed fist, the set temperature lowers.

Gesture control allows you to operate the climate control system without taking your eyes off the road and reduces the time you take your hand off the steering wheel.
