# SERVICE BULLETIN

EC13-012c

August 25, 2016

## VERSA SEDAN AND VERSA NOTE; ENGINE TURNS OFF OR HESITATES WHEN ACCELERATING FROM A STOP DURING HOT AMBIENT TEMPERATURES (+100°F)

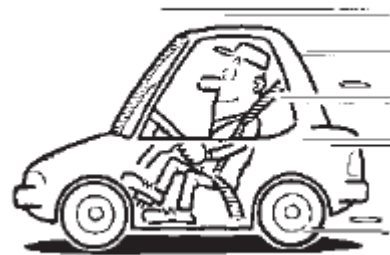
Figure A

- For 2013 Versa Sedan only: This procedure may require reprogramming of the **ECM and TCM** which means most steps in this procedure may need to be done twice.
- Most instructions for reprogramming with CONSULT-III plus (C-III plus) are displayed on the CONSULT PC screen.
- If you are not familiar with the reprogramming procedure, click here. This will link you to the "CONSULT- III plus (C-III plus) Reprogramming" general procedure.
- Take the vehicle for a 10 minute drive in order to meet the following Idle Air Volume Learn (IAVL) conditions:
  - Engine coolant temperature: 70 -100°C (158 -212°F)
  - Battery voltage: More than 12.9V (At idle)
  - Transmission: Warmed up

- After reprogramming is complete, you will be required to perform Throttle Valve Closed Position, Idle Air Volume Learn, Accelerator Closed Position, and DTC erase.

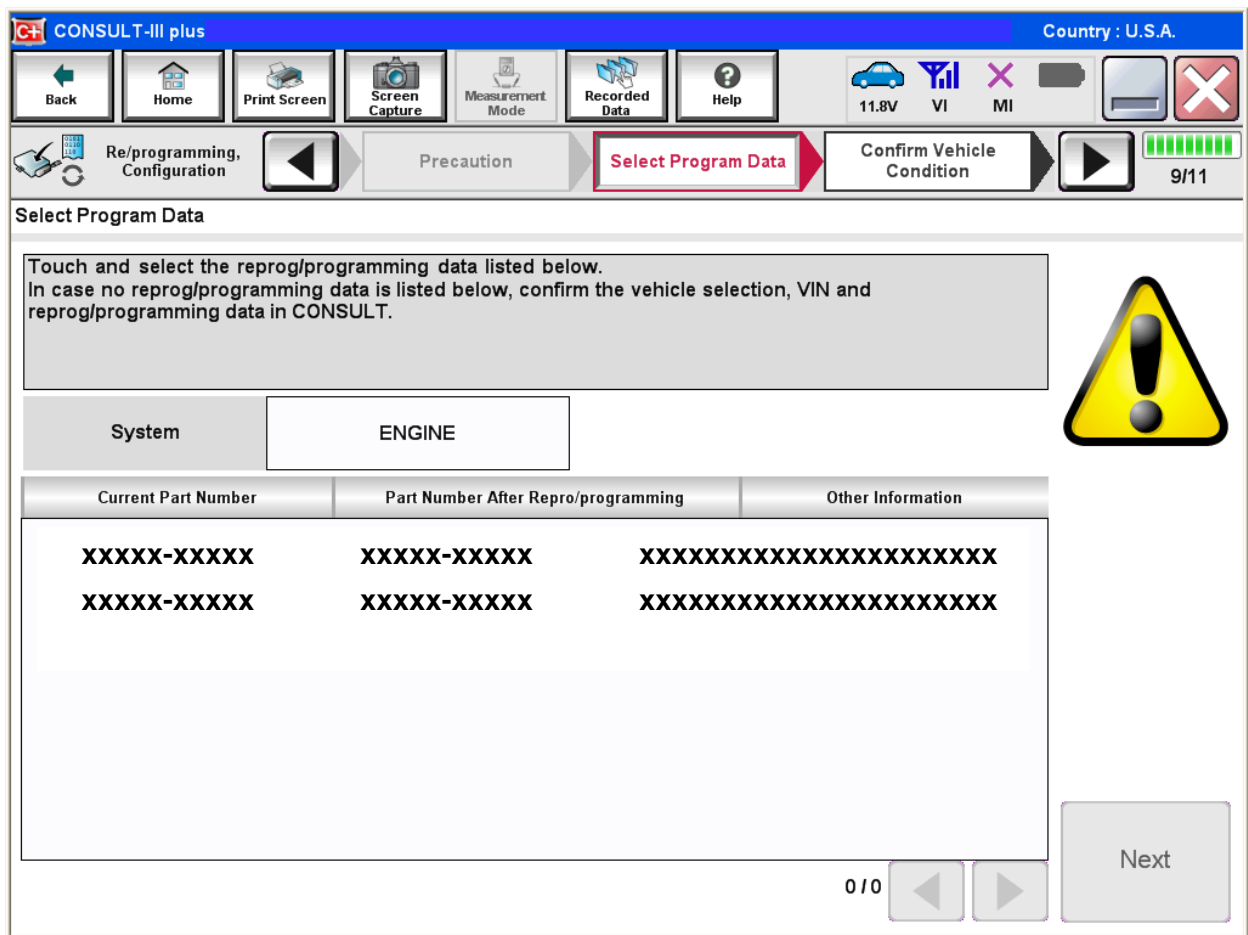
- In some cases, more than one new P/N for reprogramming is available.
  - In this case, the screen in Figure 3 displays.
  - Select and use the reprogramming option that **does not** have the message “Caution! Use ONLY with NTBXX-XXX”.
- If you get this screen and it is blank (no reprogramming listed), it means there is no reprogramming available for this vehicle. Close C-III plus and refer back to ASIST for further diagnosis.
