NISSAN BULLETIN

ECM Reprogram Dealer Service Action

Reference: PC479
Date: August 16, 2016

Frontier (D40) ECM OBD Software Update

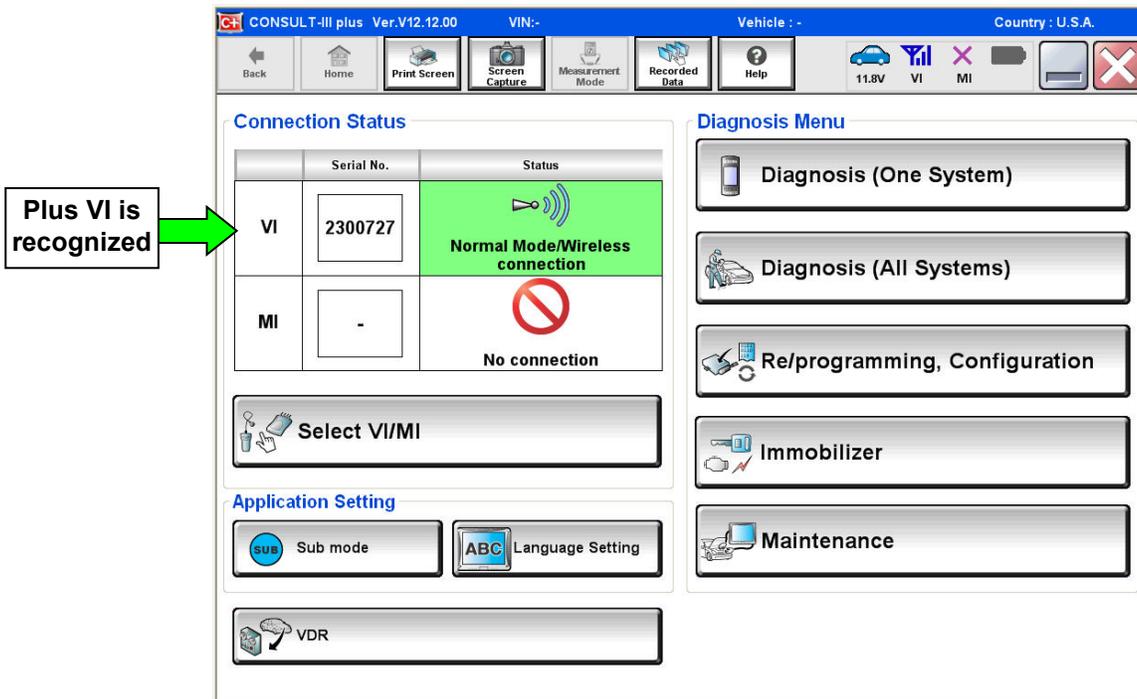
Figure 1

9. Wait for the plus VI to be recognized / connected.

- Serial number will display when the plus VI is recognized / connected.

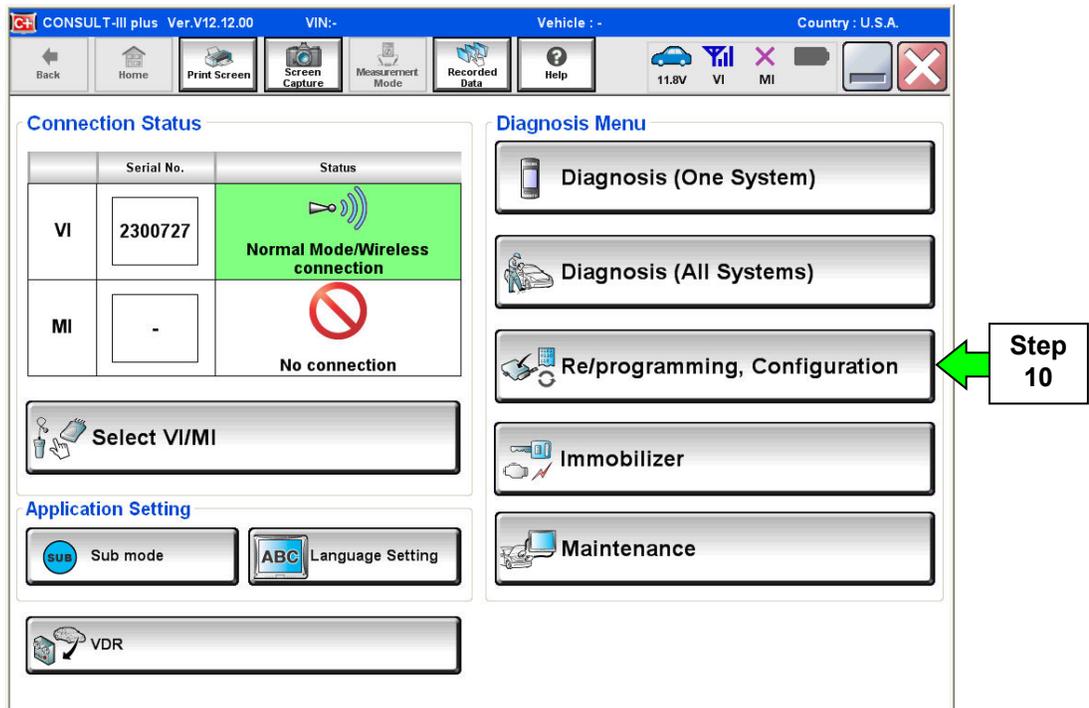
Figure 2

10. Select **Re/programming, Configuration**.

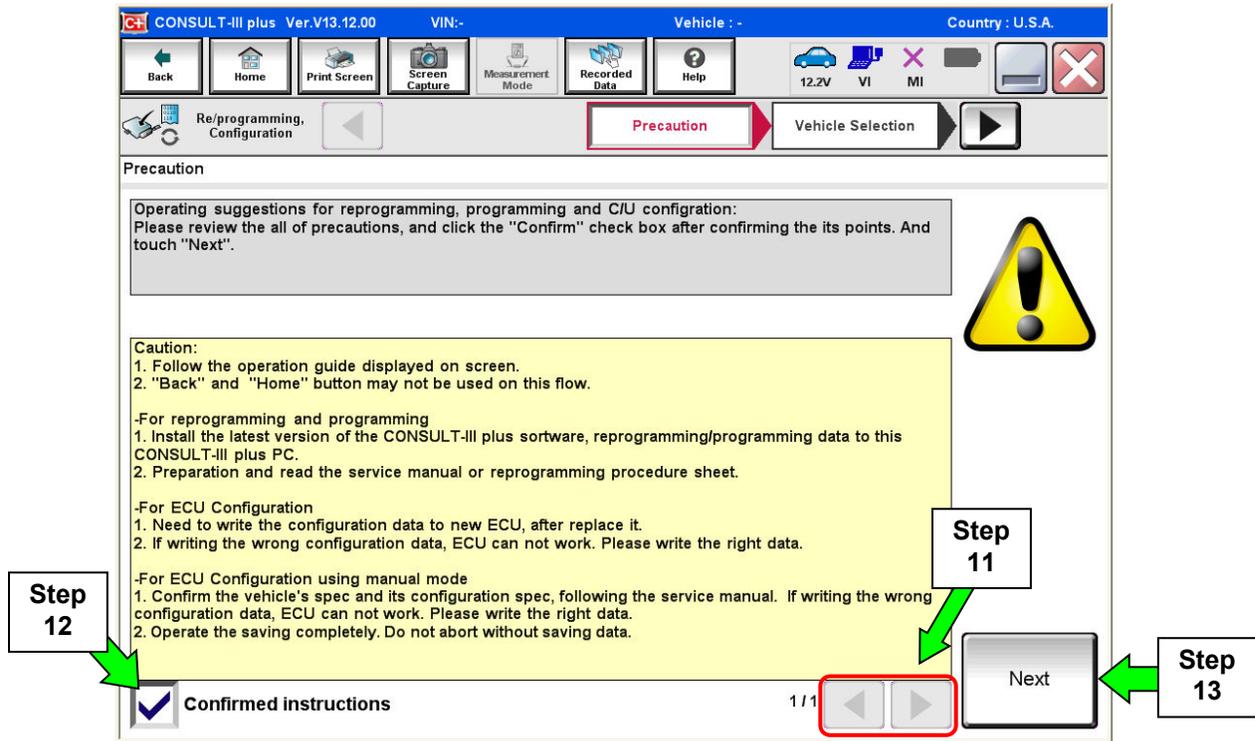
Figure 3

11. Use arrows (if needed) to view and read all precautions.
12. Check the box confirming the precautions have been read.
13. Select **Next**.

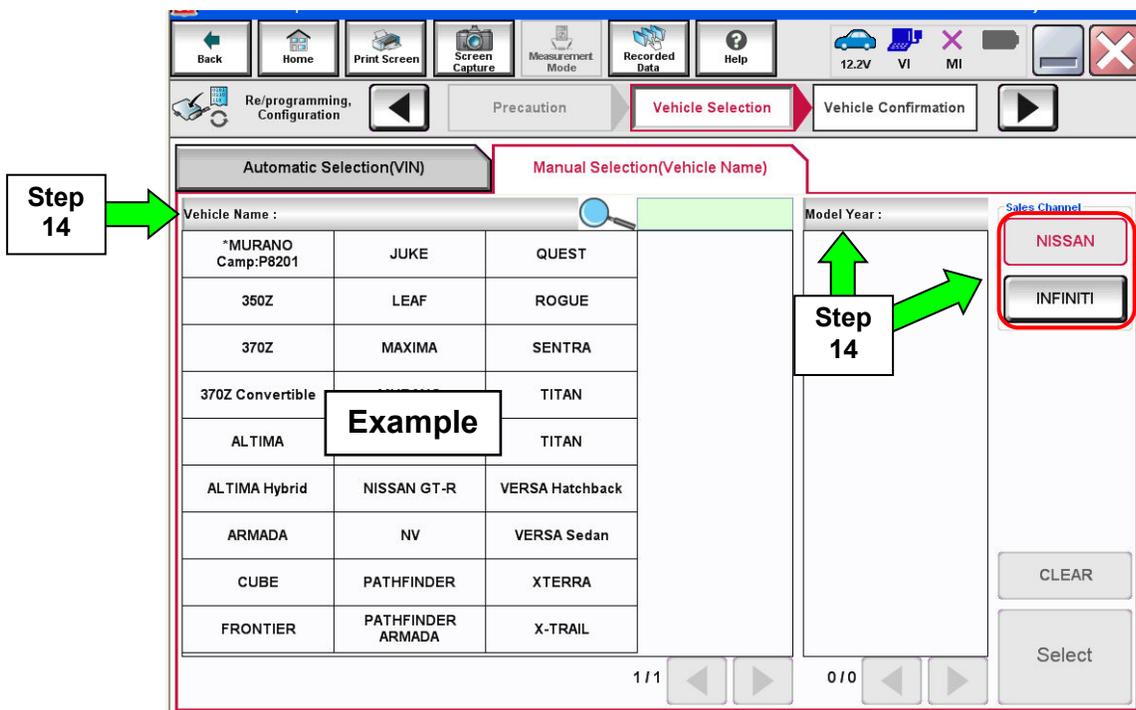
14. Select **Nissan, Vehicle Name**, and then the correct **Model Year**.

- If the screen in Figure 4 does not display, skip to step 15.

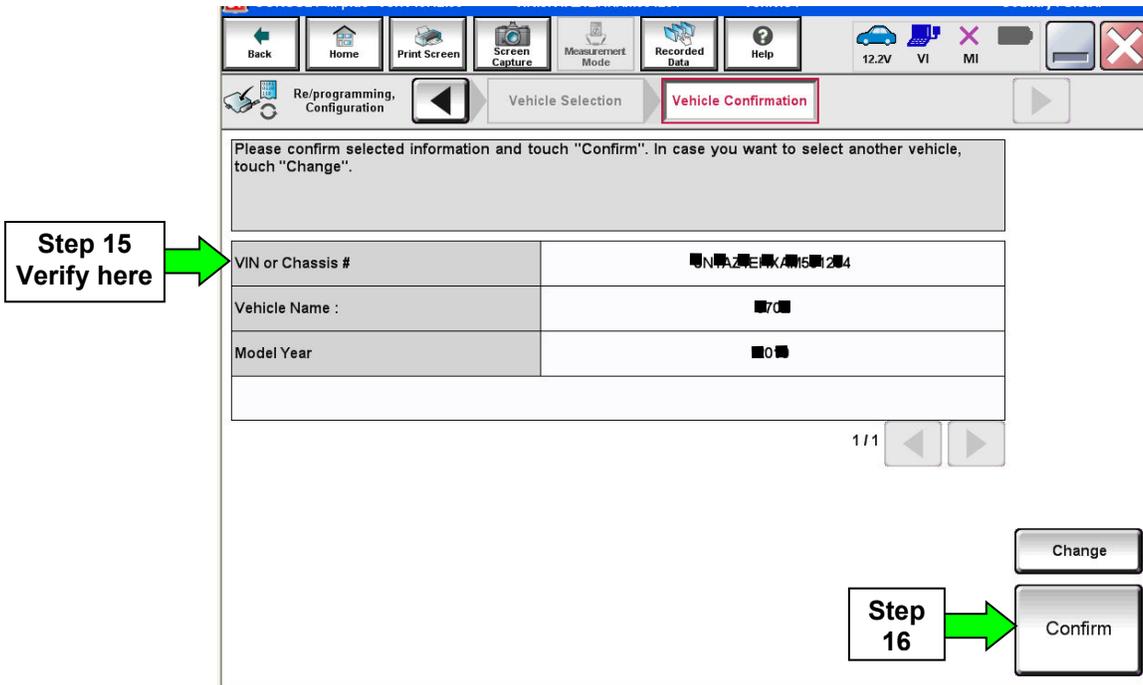
Figure 5

15. Make sure **VIN or Chassis #** matches the vehicle's VIN.

16. If the correct VIN is displayed, select **Confirm**.

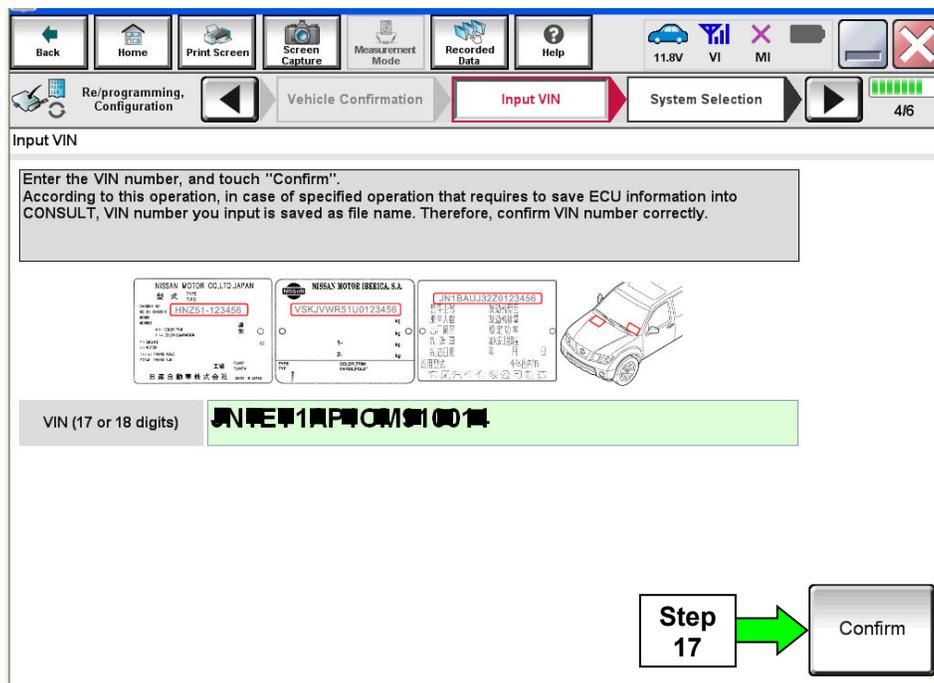
Figure 6

17. Select **Confirm**.

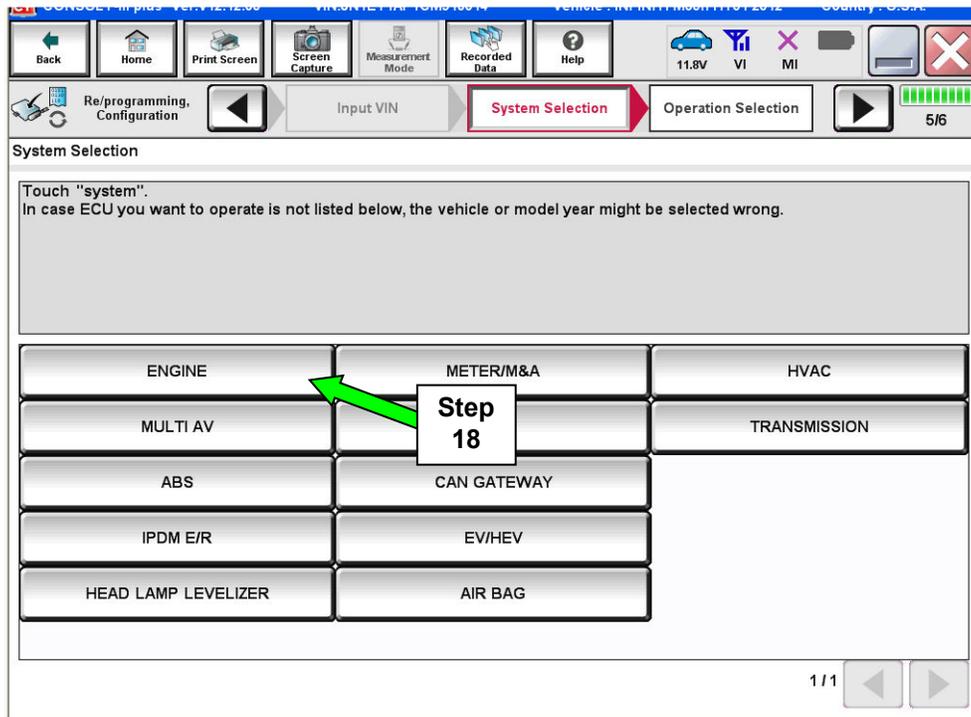
Figure 7

18. Select ENGINE.

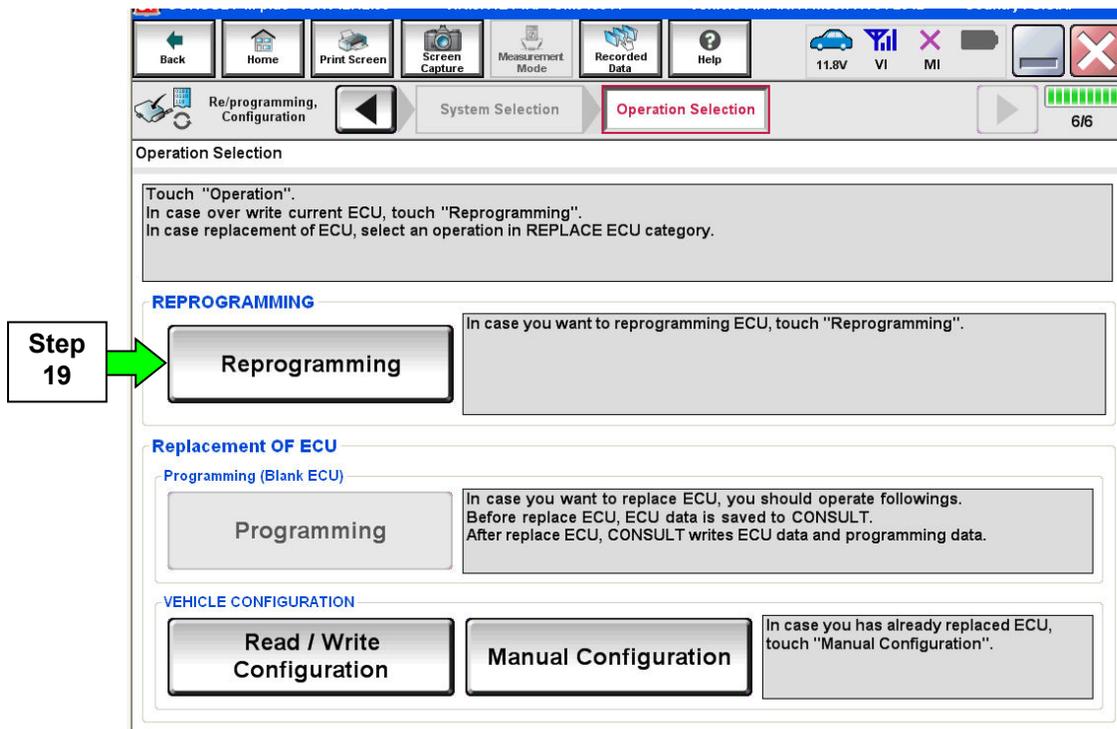
Figure 8

19. Select Reprogramming.

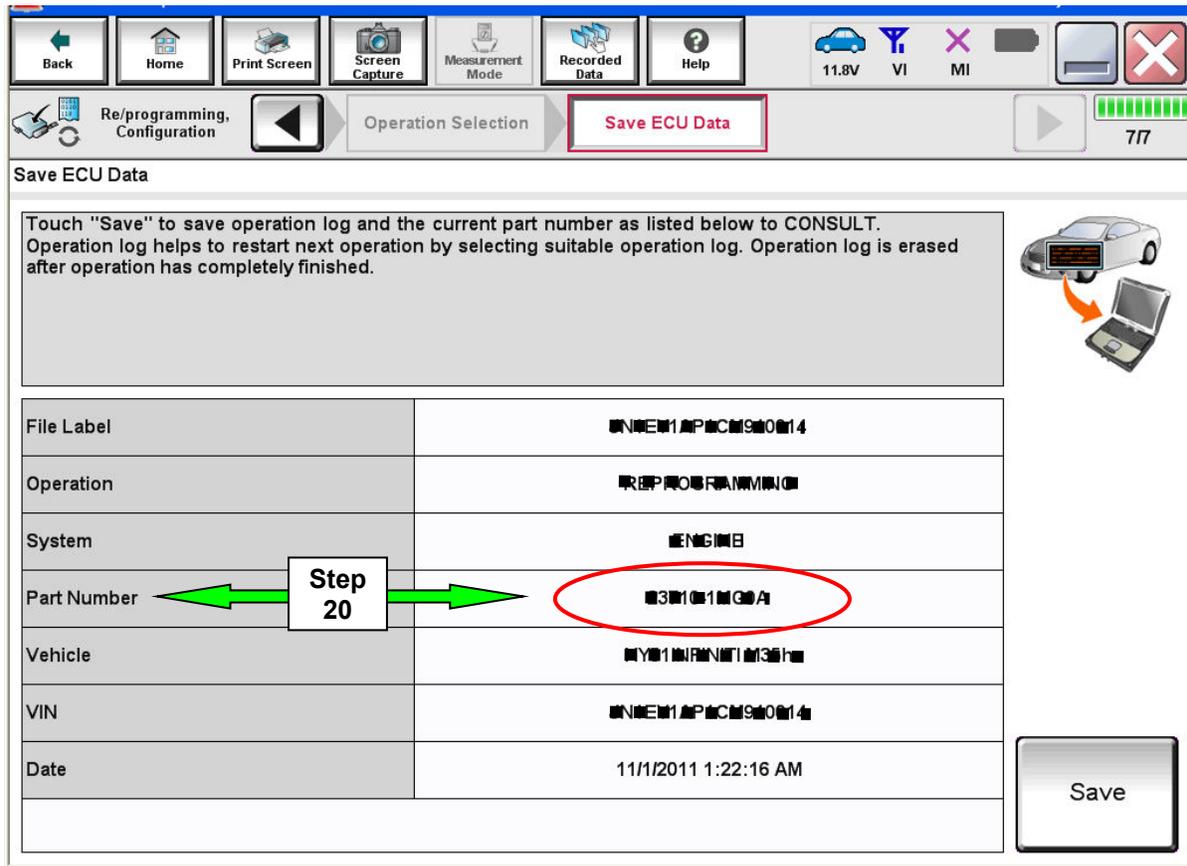
Figure 9

20. Find the ECM **Part Number** (see Figure 9) and write it on the repair order.

NOTE: This is the current Part Number (P/N).

B. Compare the P/N you wrote down to the numbers in the **Current ECM Part Number** column in **Table A** below.

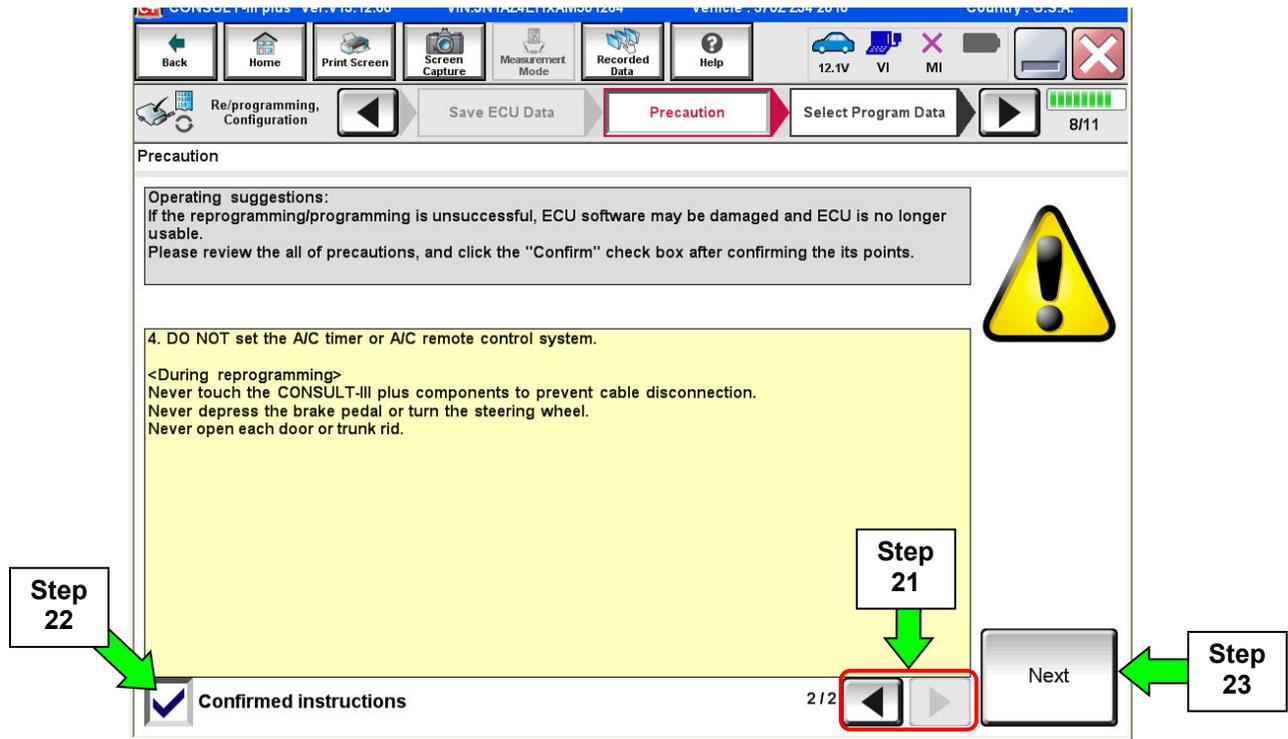
Figure 10

21. Use arrows (if needed) to view and read all precautions.
22. Check the box confirming the precautions have been read.
23. Select **Next**.

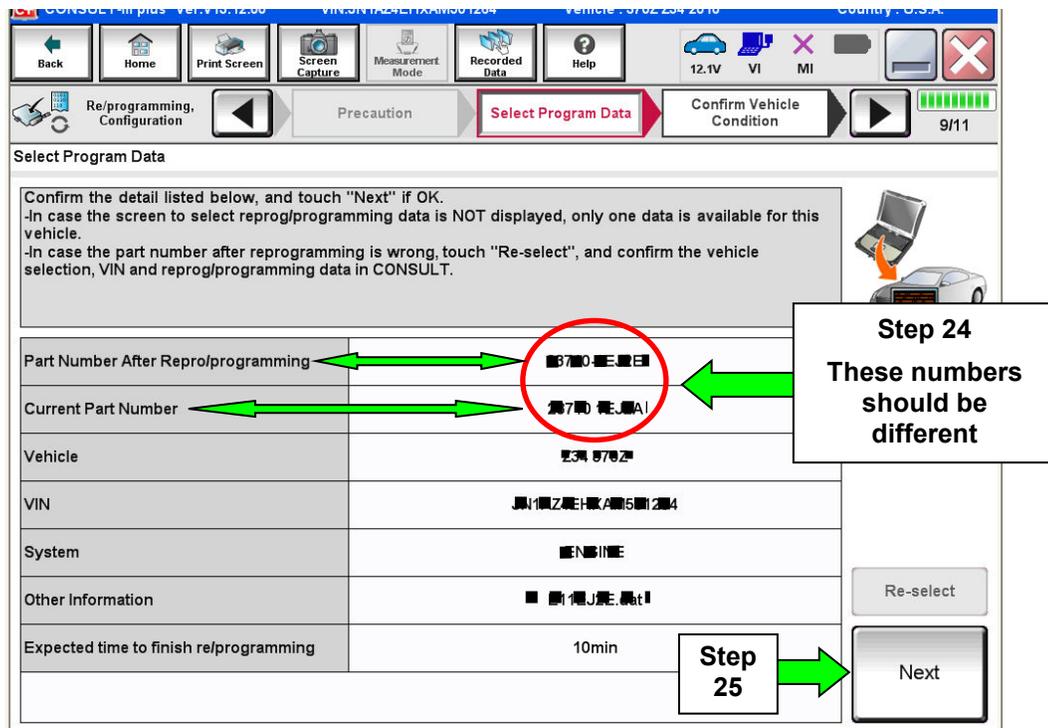
Figure 11

24. Read the **Current Part Number** and **Part Number After Reprogramming**. They should be different.
25. Select **Next**.

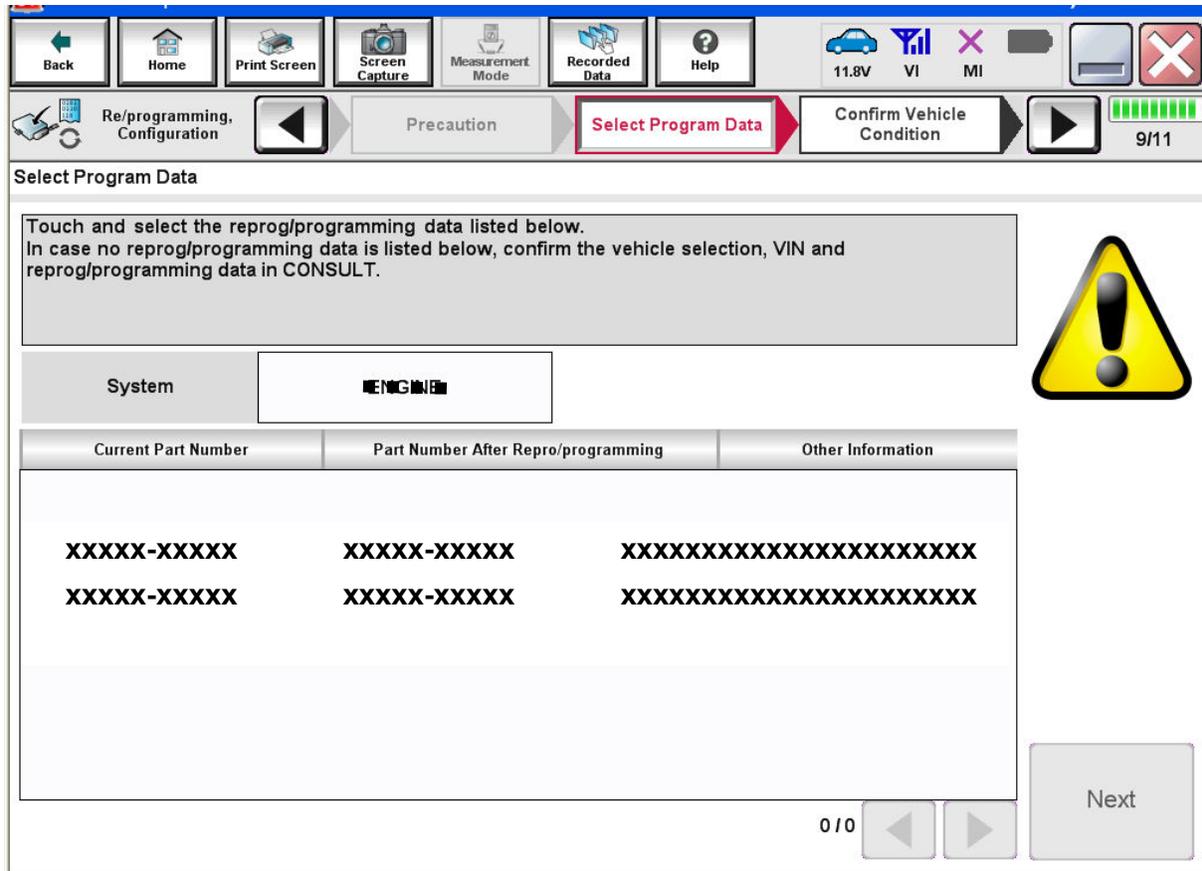
Figure 12

- If you get this screen and it is blank (no reprogramming listed), it means there is no matching ECM reprogramming available for this vehicle. If there is not a match, refer to the Claims Information and submit a claim using OP-CODE PC4791 (ECM Reprogram Not Needed).

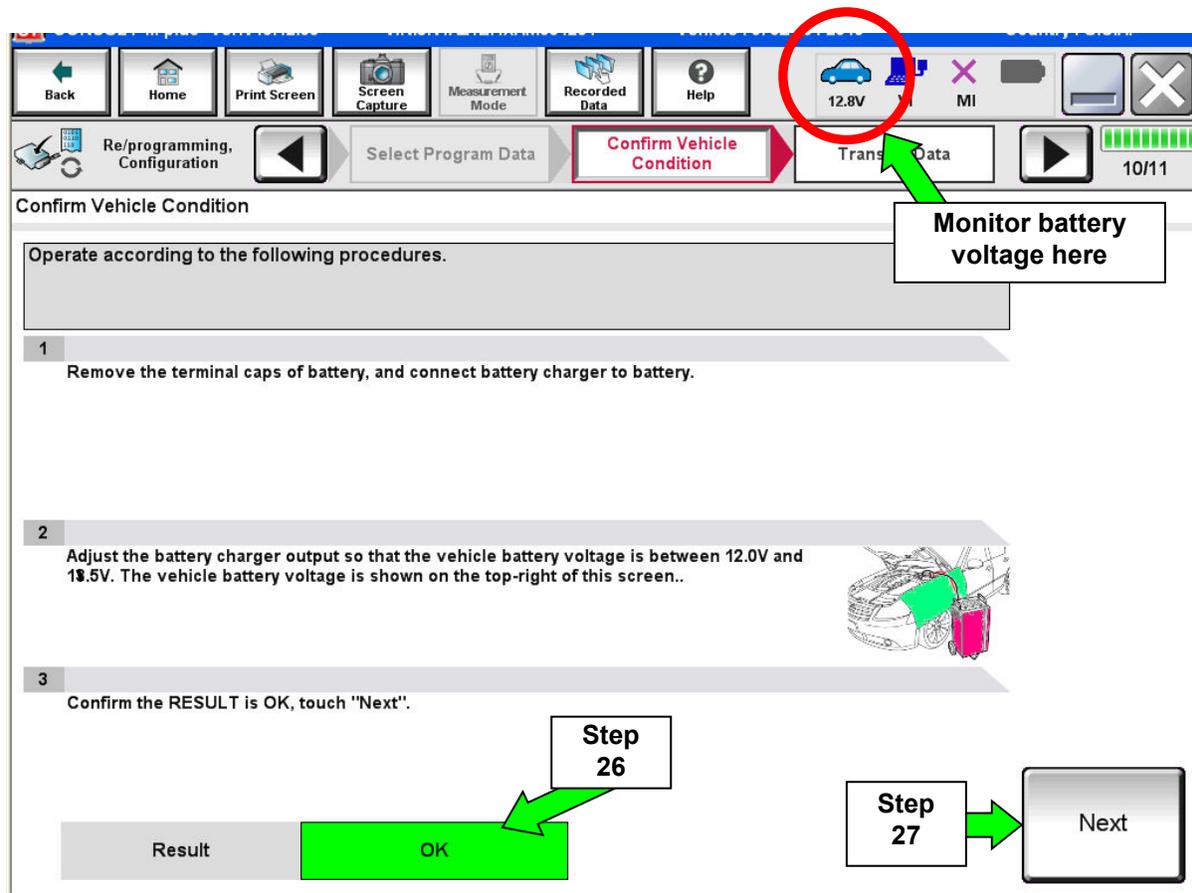
Figure 13

26. Make sure **OK** is highlighted **green** (battery voltage must be between **12.0 and 15.5 Volts**).

27. Select **Next**.

IMPORTANT: Battery voltage must stay between **12.0 and 15.5 Volts** during reprogramming or ECM reprogramming may be interrupted and ECM may be damaged.

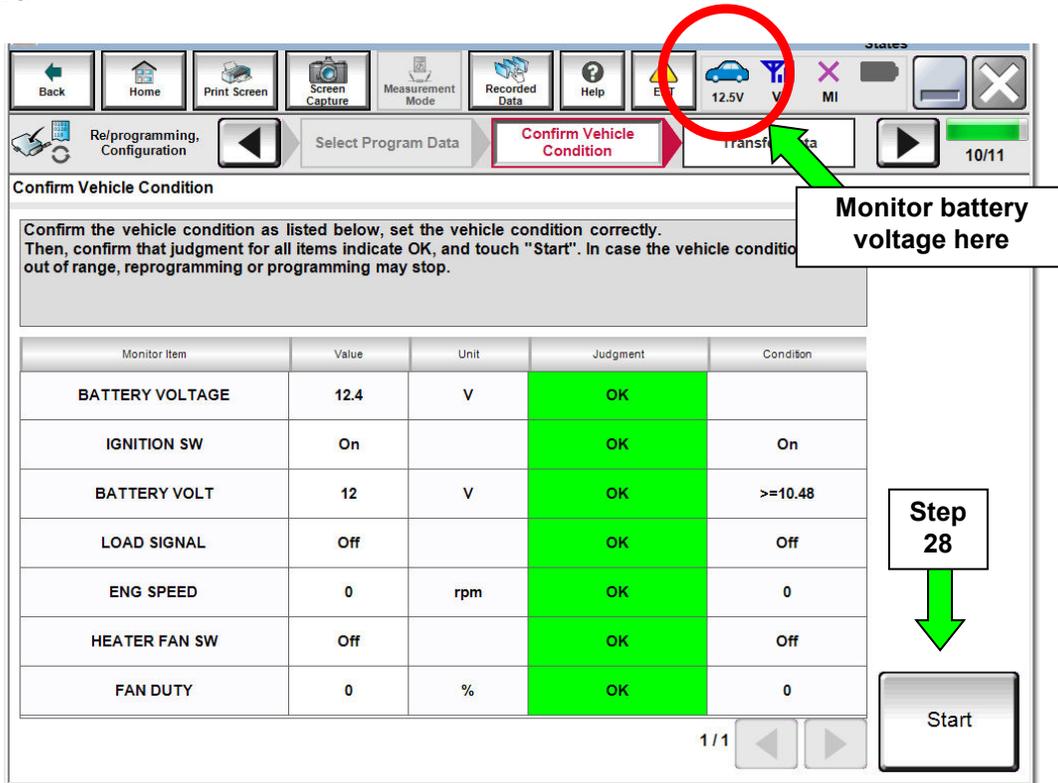
Figure 14

NOTE: In the next step, the reprogramming process will begin when **Start** is selected.

28. Select **Start**.

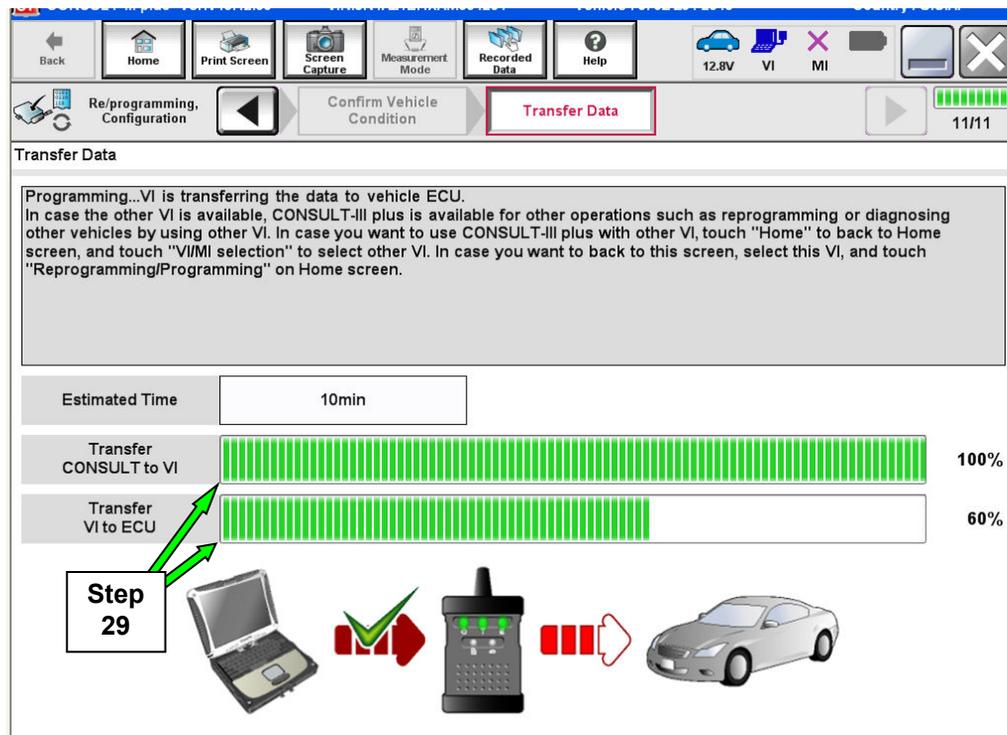
Figure 15

29. Wait for both progress bars to complete.

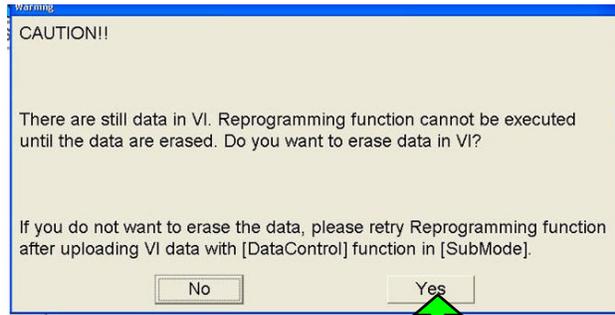
NOTE: If the message shown in Figure 16 appears, there is data stored in the plus VI. Select **“Yes”** to proceed with reprogramming.

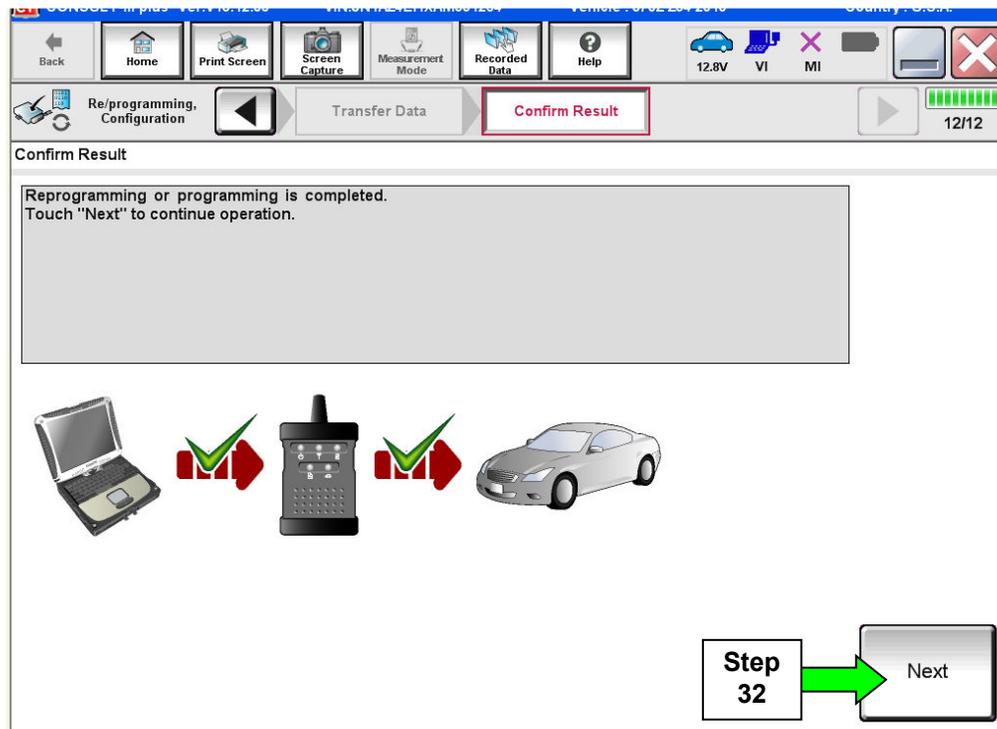
30. When the screen in Figure 17 displays, the reprogramming is complete.

NOTE: If the screen in Figure 17 does not display (reprogramming does not complete), refer to the information on the next page.

31. Disconnect the battery charger from the vehicle.

32. Select **Next**.

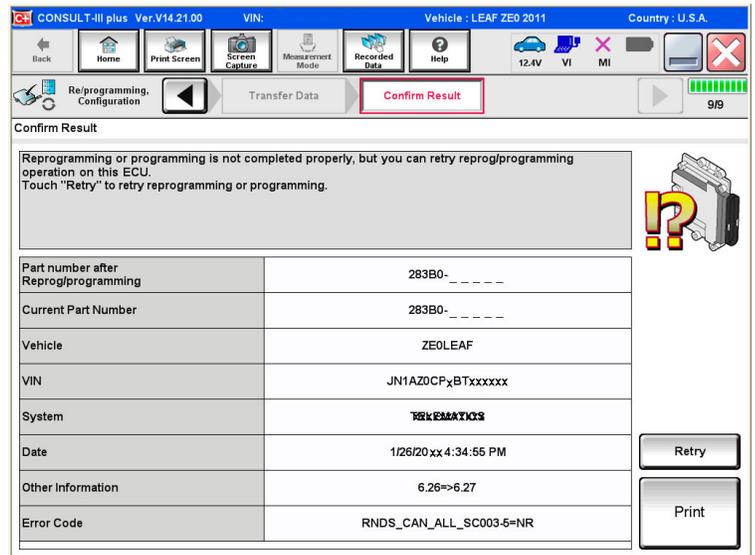
Figure 18

If reprogramming does not complete and the “!?” symbol displays as shown in Figure 18:

- Check battery voltage (12.0 – 15.5V).
- Ignition is ON, Ready Mode is OFF.
- External Bluetooth® devices are OFF.
- All electrical loads are OFF.
- **Select Retry and follow the on screen instructions.**

NOTE: Retry may not go through on first attempt and can be selected more than once.

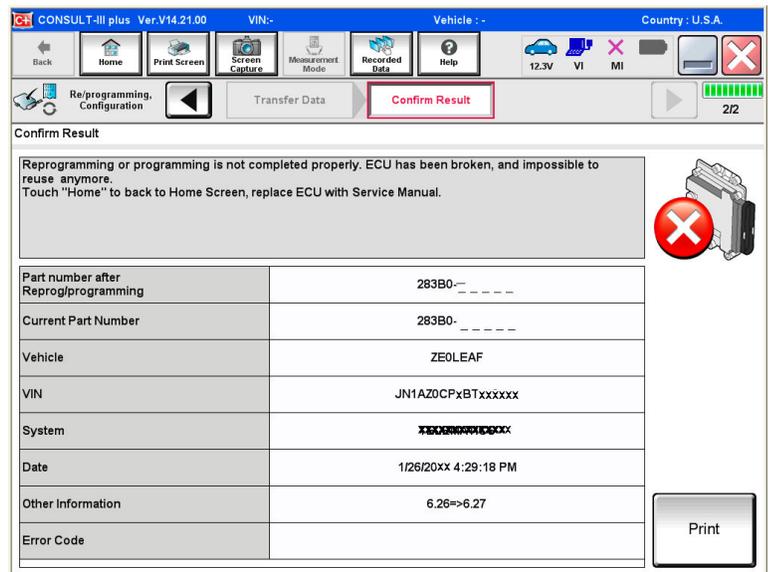
Figure 19

If reprogramming does not complete and the “X” symbol displays as shown in Figure 19:

- **Do not disconnect the plus VI or shut down C-III plus if reprogramming does not complete.**
- Check battery voltage (12.0 – 15.5V).
- CONSULT A/C adapter is plugged in.
- Ignition is ON, Ready Mode is OFF.
- Transmission in Park.
- All C-III plus / plus VI cables are securely connected.
- All C-III plus updates are installed.
- **Select Home, and then restart the reprogram procedure from the beginning.**

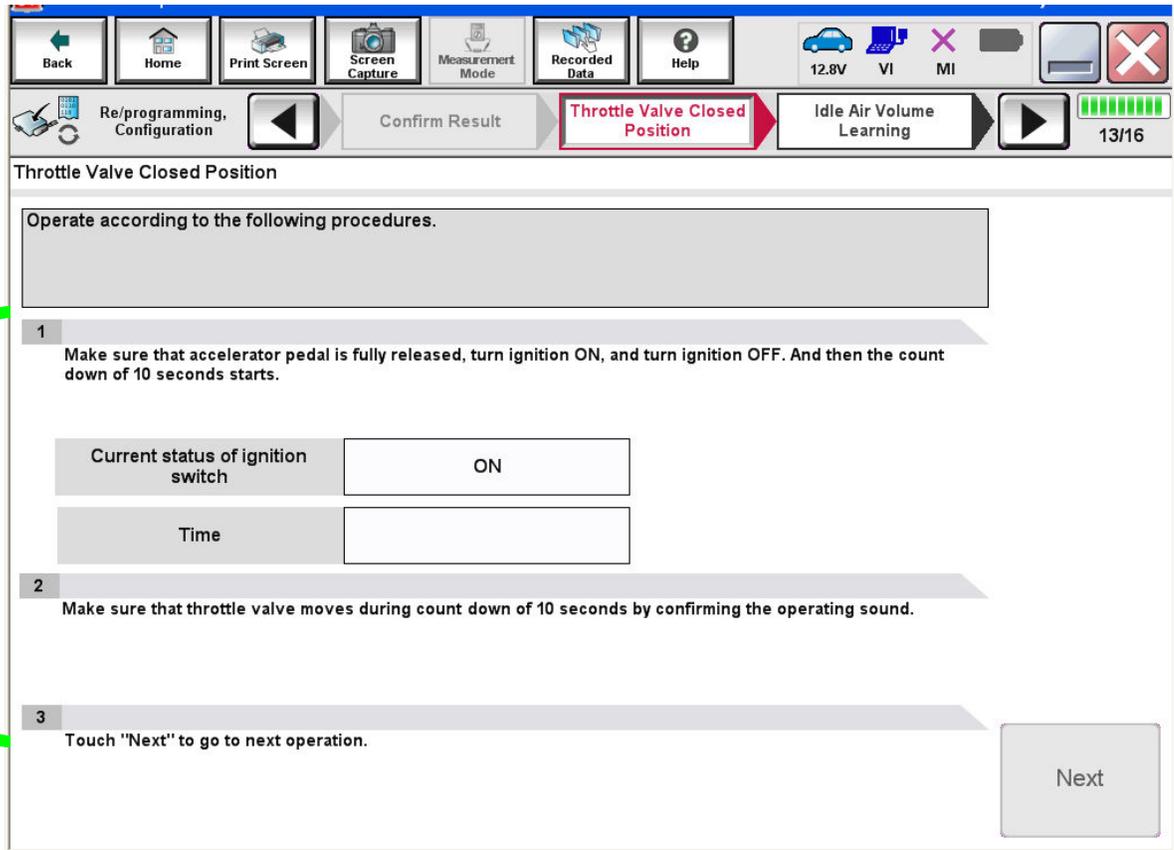
Figure 20

33. Perform **Throttle Valve Closed Position** procedure.

- Follow the on-screen instructions (**1, 2, and 3**) to complete the procedure.

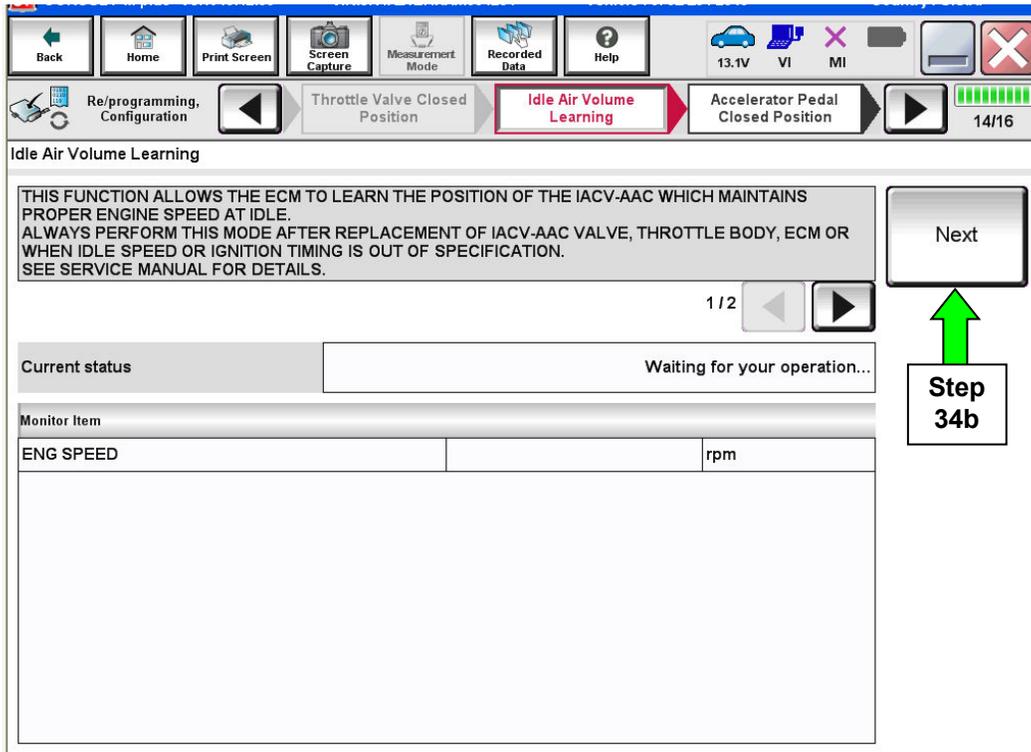
Figure 21

34. For **ECM** reprogramming: Perform **Idle Air Volume Learn (IAVL)**.

- a. Start the engine and let it idle.
- b. Select **Next**.

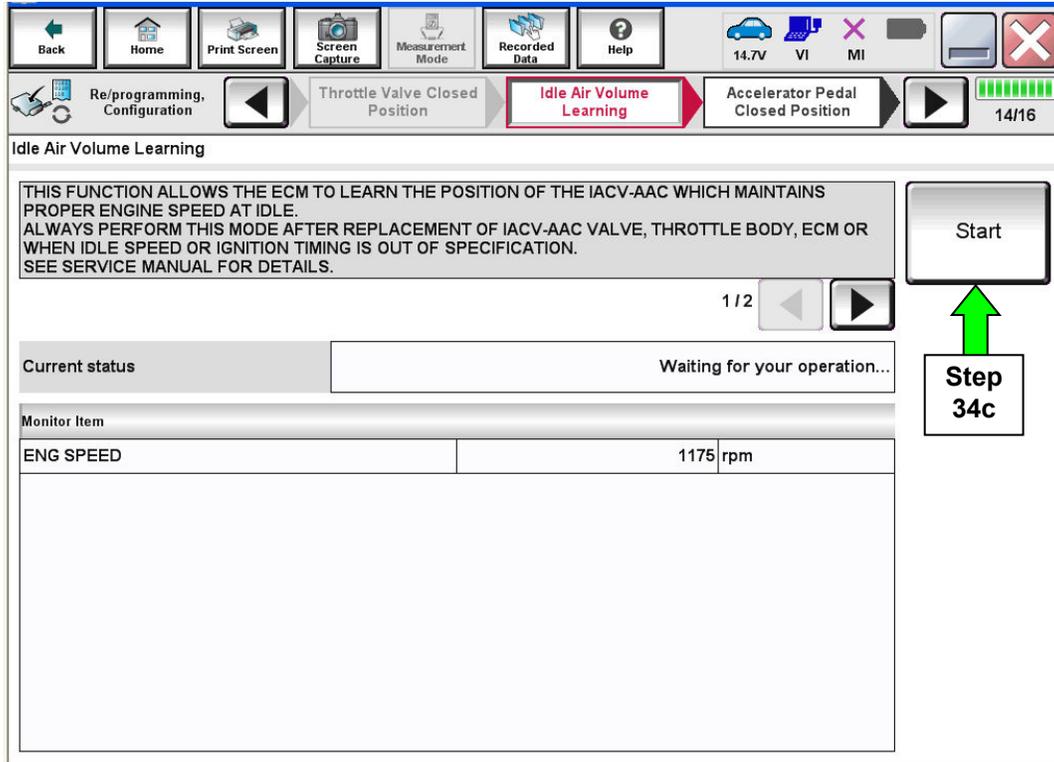
Figure 22

c. Select **Start**.

d. Wait for IAVL to complete.

- Listed below are common required conditions for IAVL to complete.
- If IAVL does not complete within a few minutes, a condition may be out of range.
- Refer to the appropriate Electronic Service Manual (ESM) for specific conditions required for the vehicle you are working on.
 - Engine coolant temperature: 70 – 100° C (158 – 212°F)
 - Battery voltage: More than 12.9V (At idle)
 - Selector lever: P or N
 - Electric load switch: OFF (Air conditioner, headlamp, rear window defogger)
 - Steering wheel: Neutral (Straight-ahead position)
 - Vehicle speed: Stopped
 - Transmission: Warmed up

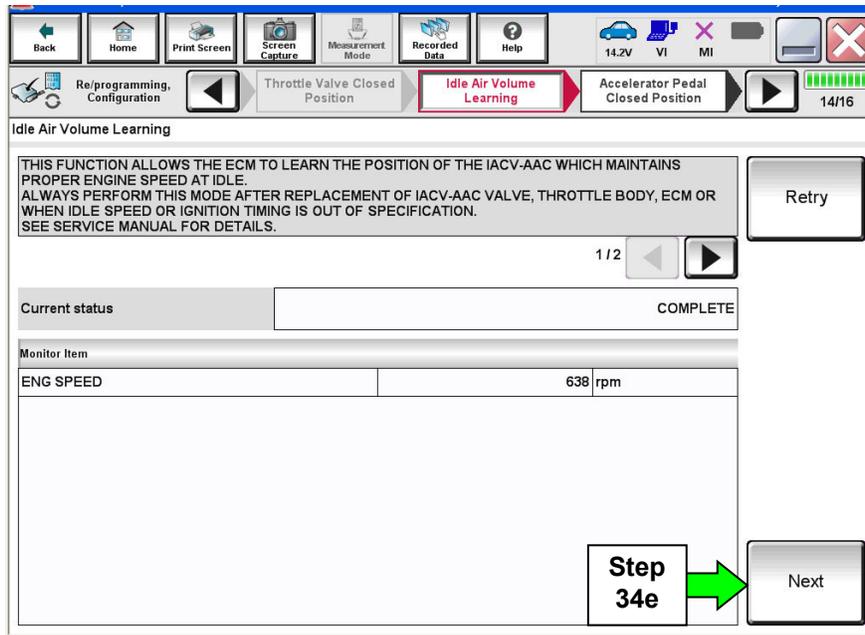
Figure 23

e. Select **Next**.

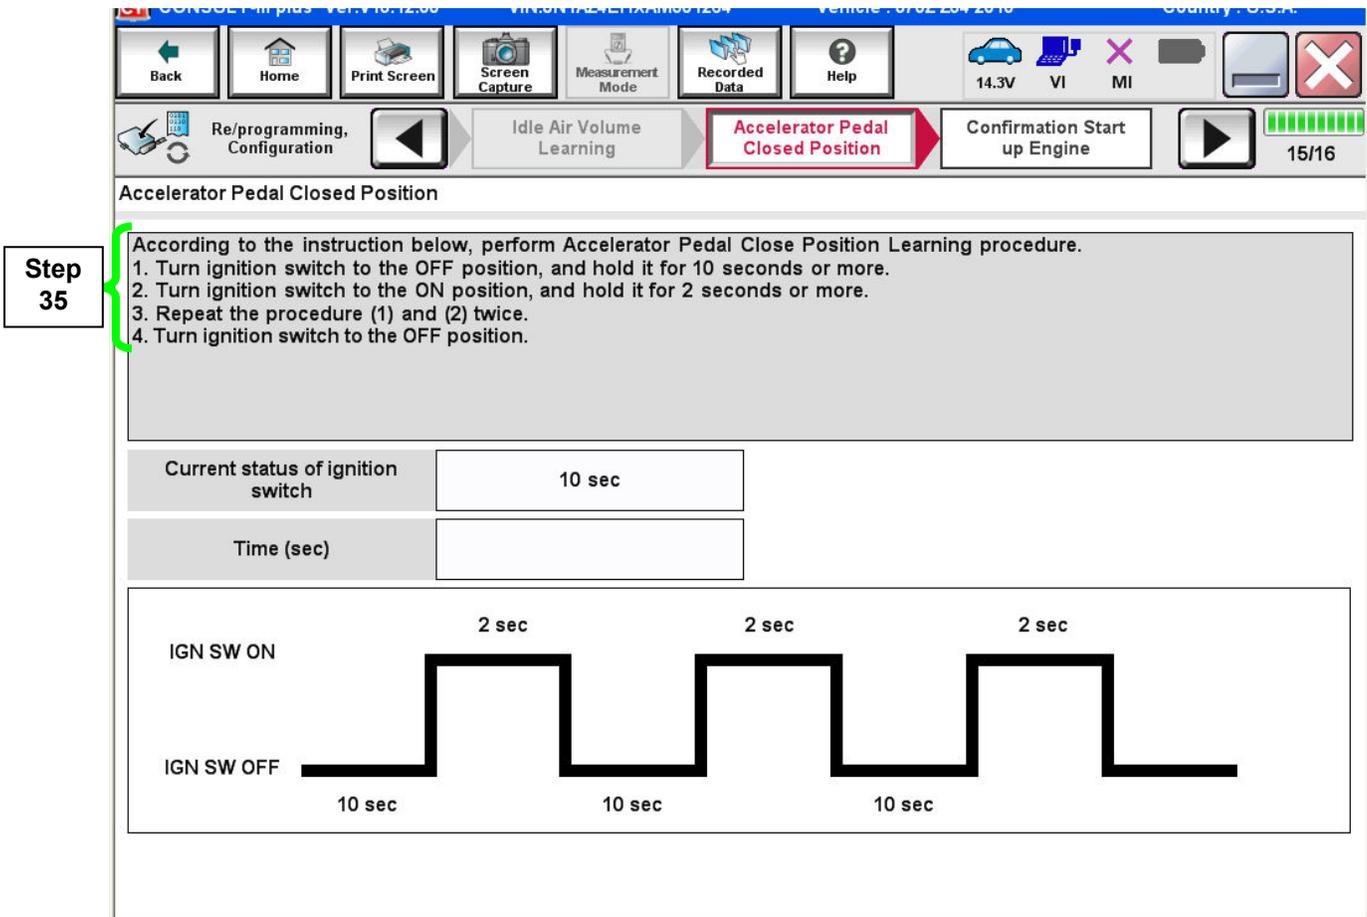
Figure 24

35. For **ECM** reprogramming: Follow the on screen instructions to complete **Accelerator Pedal Close Position Learning**.

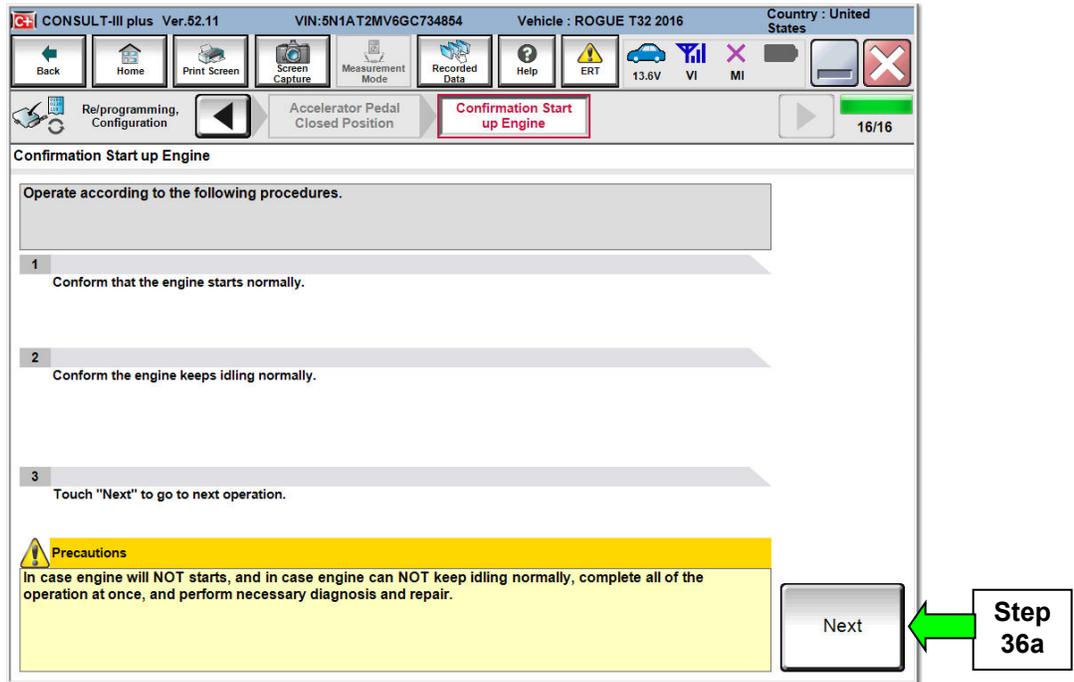
Figure 25

36. Confirm engine start-up.

- a. Select **Next**.

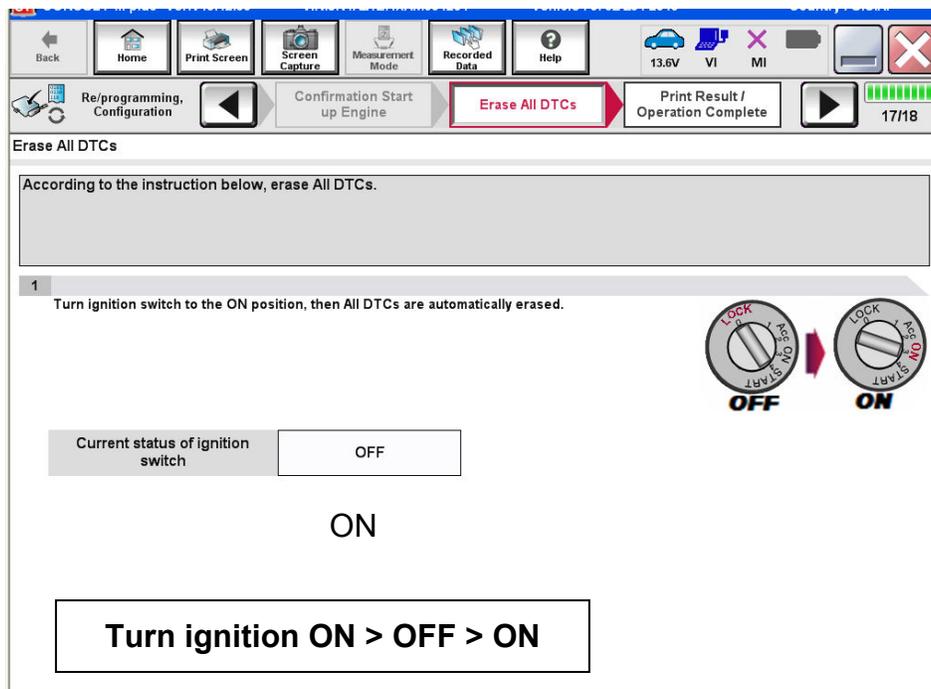
Figure 26

37. Erase all DTCs as follows:

- a. Turn the ignition OFF
- b. Turn the Ignition ON.
- c. Wait for DTC erase to complete.

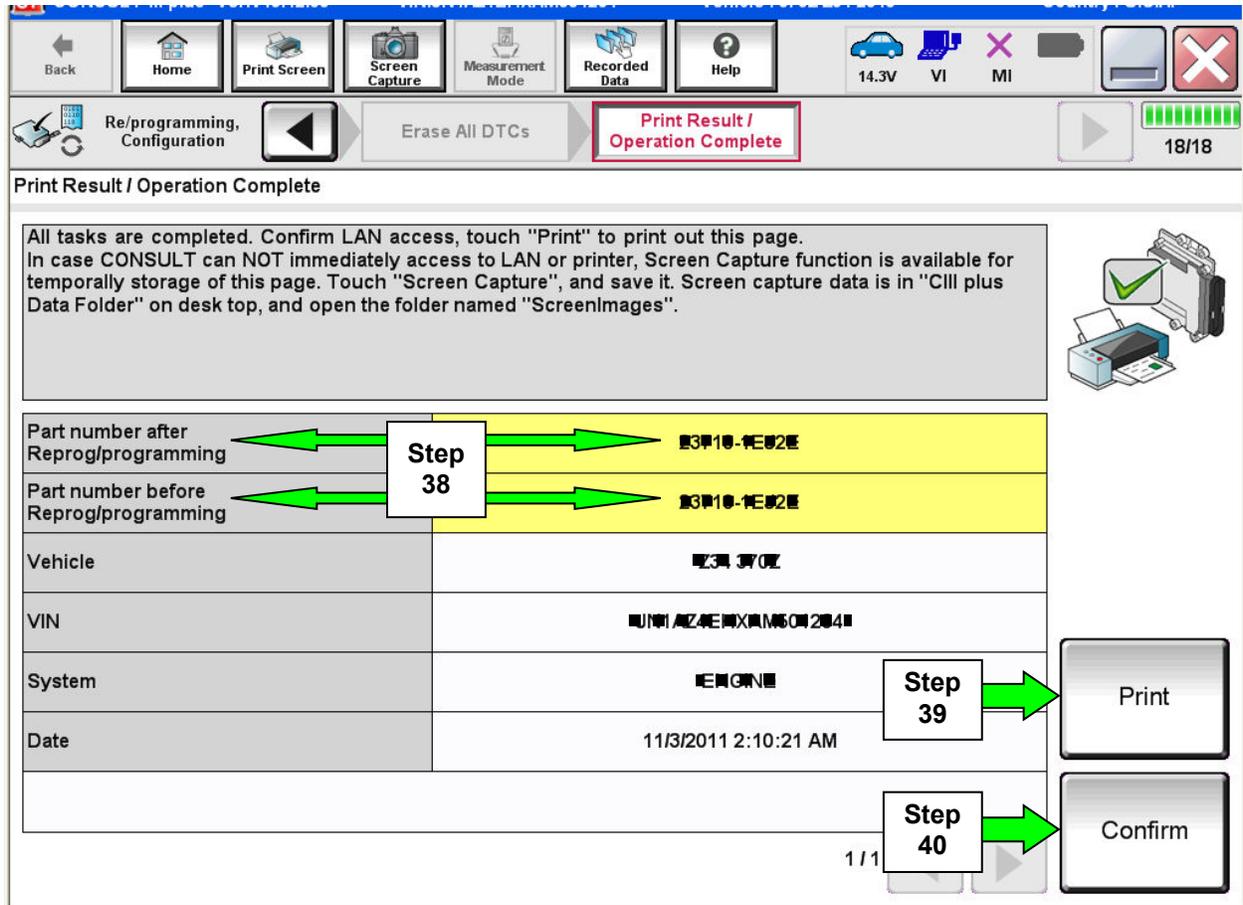
Figure 27

38. Verify the before and after part numbers are different.

39. Print a copy of this screen (Figure 27) and attach it to the repair order.

40. Select **Confirm**.
