Subject Instrument Cluster Software Upgrade

Instrument cluster software upgrade.

Aventador LP700 MY 2012 From VIN CLA00091 to VIN CLA000557

As a continuous product monitoring, Automobili Lamborghini Spa has found that sporadically on some vehicles the coolant level warning light might not promptly activate.

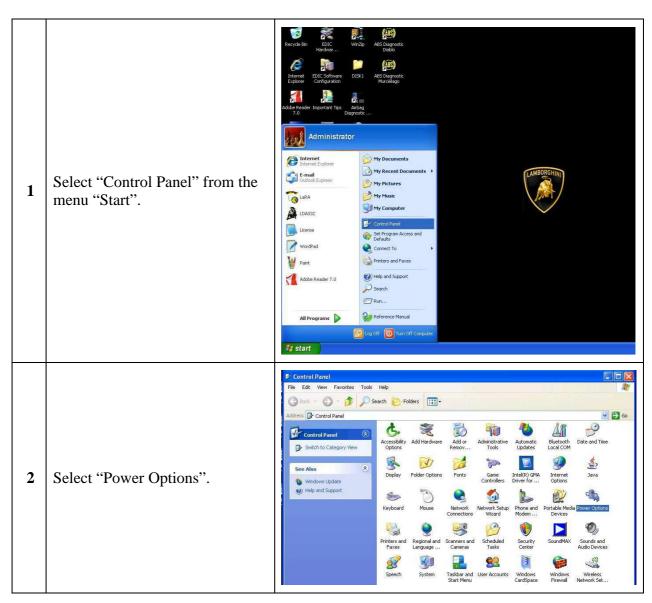
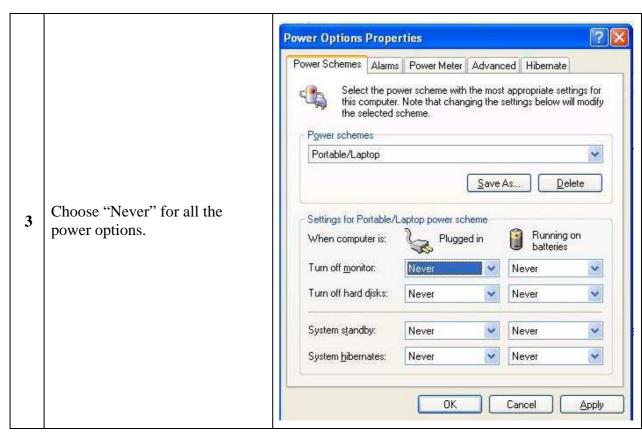
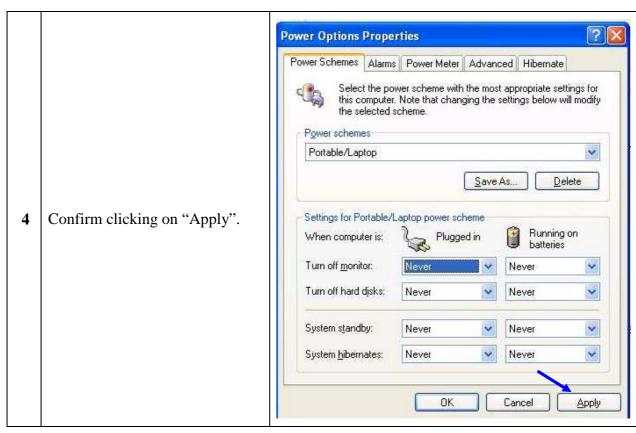
# Deactivation of energy saving options

The Instrument cluster update lasts more than 30 minutes, hence it is necessary to plug the diagnostic laptop into an electrical socket and to deactivate screen savers and all the energy saving options in order to avoid any interruption of the procedure.

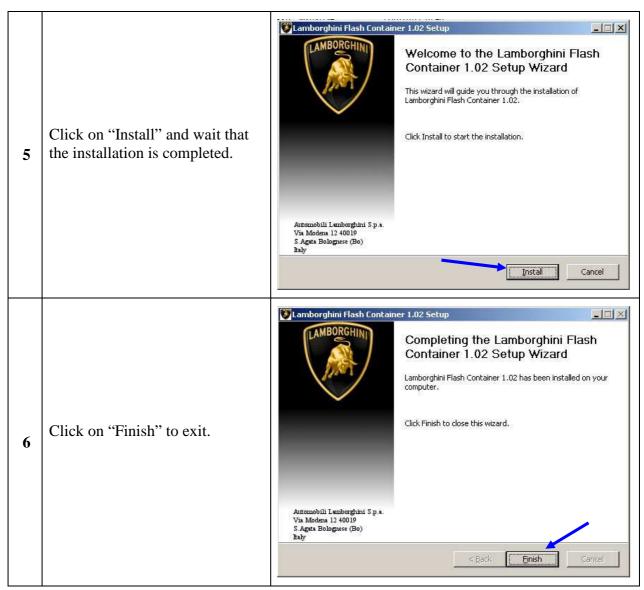
## Lamborghini Flash Container version 1.02 download and installation procedure

**NOTE**: the installation of the flash container is necessary to perform the instrument cluster ECU software update.

This software only extracts the flash files in the right folder (C:\SIDIS\home\datflash)

1	Connect your Lamborghini Diagnosis Tester to internet and log on the Lamborghini web portal.									
2	Open the section Customer Service/Downloads/Diagnosis SW 2012									
3	Download the file "Lamborghini_flash_container_v1_02.zip"									
4	Double click on the just downloaded zip file and then open the file Lamborghini_Flash_Container_v1_02.ex e, as shown in the picture beside.	WinZip (Evaluation Version) - Lamborghini_Flash_Container_v1_02.zip   Elle Actions Options Help   New Open Favorites Add Extract View CheckOut Wizard   Name

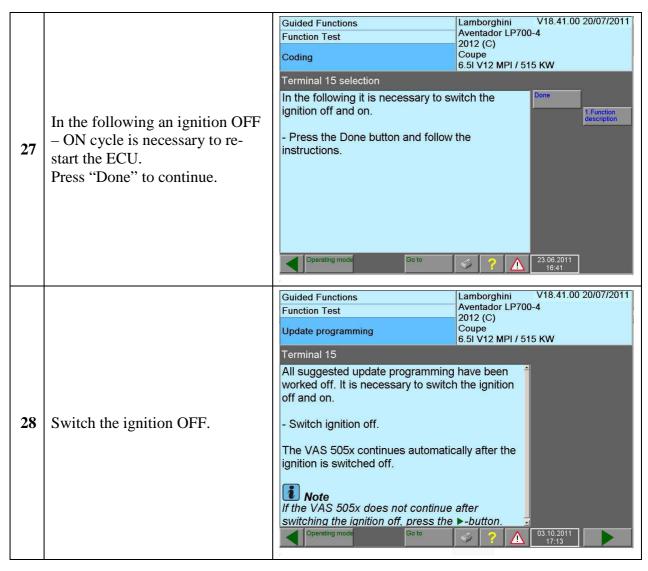
V18.41.00 20/07/2011 **Guided Functions** Lamborghini Aventador LP700-4 Function Test 2012 (C) Coupe 6.5I V12 MPI / 515 KW Update programming Job will be performed... Wait until the update programming of the instrument cluster ECU is completed (estimated time: 35 minutes). 100 % Lamborghini V18.41.00 20/07/2011 **Guided Functions** Once the update programming Aventador LP700-4 **Function Test** 2012 (C) has been completed successfully Coupe 6.5I V12 MPI / 515 KW Update programming a feedback as in the picture beside is displayed. 1 - Update programming - 17 The update programming on control module 17 Press "Done" to continue. Instrument cluster was successful. If the update programming has - Press < Done > to continue the program. not been completed or has been unsuccessful: turn the ignition OFF 26 wait 1 minute before turning the ignition ON again if offered by the program: select "Repeat" to retry the update programming, otherwise repeat the procedure from step 12

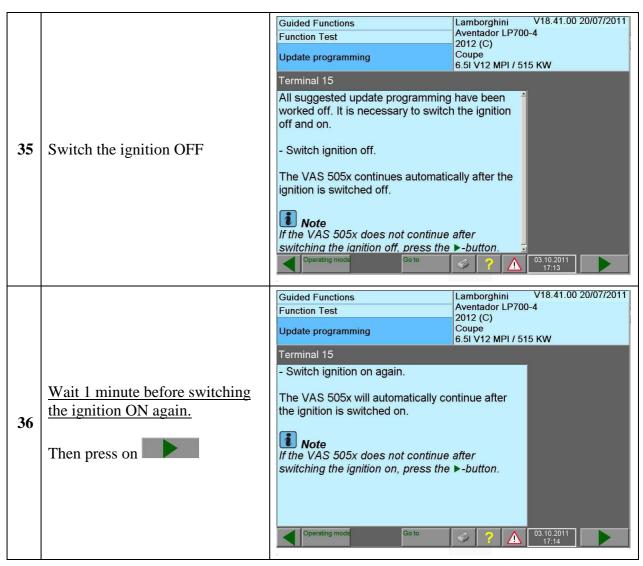
V19.63.00 16/01/2012 Lamborghini Guided Functions Once the parameter setting has Aventador LP700-4 **Function Test** been completed successfully a 2012 (C) Coupe 6.5I V12 MPI / 515 KW Parameter setting feedback as in the picture beside Parameter setting is displayed. The parameter setting on the control module 09 -Press "Done" to continue. Electronic central electric was successful. If the parameter setting has not - Press < Done > to continue the program. been completed or has been unsuccessful: 33 turn the ignition OFF wait 1 minute before turning the ignition ON again if offered by the program: select "Repeat" to retry the parameter setting, otherwise repeat the procedure from step 12 V18.41.00 20/07/2011 Lamborghini **Guided Functions** Aventador LP700-4 **Function Test** 2012 (C) Coupe 6.5I V12 MPI / 515 KW Codina Terminal 15 selection In the following it is necessary to switch the ignition off and on. In the following an ignition OFF - Press the Done button and follow the - ON cycle is necessary to re-**34** instructions start the ECU. Press "Done" to continue.
