Applies To: **2013 Accord** – Check the iN VIN status for eligibility
2013 Crosstour – Check the iN VIN status for eligibility

Product Update: Audio and Audio-Navigation Unit Software Update (Supersedes 13-001, dated March 2, 2013, to revise the information marked by the black bars)

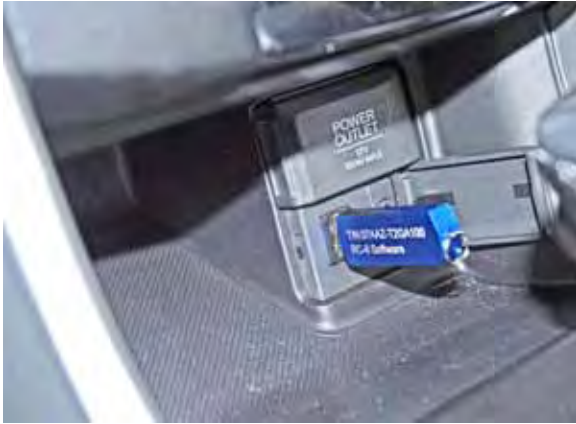
Accord

NOTE: The ignition must remain ON during the entire update procedure. If the ignition is turned OFF, the engine is started, or the USB update device is removed at any time *during* the update process, the audio-navigation unit will be locked up and you will need to use the RECOVERY PROCESS.

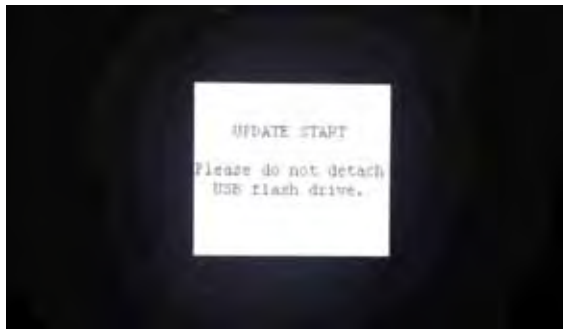
- Both screens will shut off for about 10 seconds and reboot with the notification below flashing on the navigation screen.

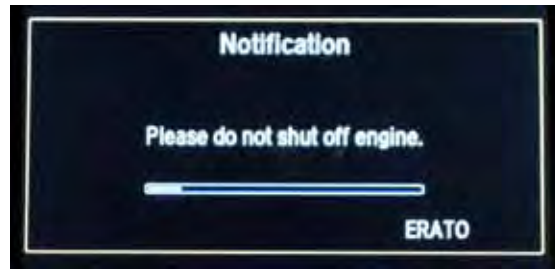
Navigation screen

- The software update will begin. A Notification screen loading bar will display on both screens. **NOTE: The engine does not need to be running to do this update.**

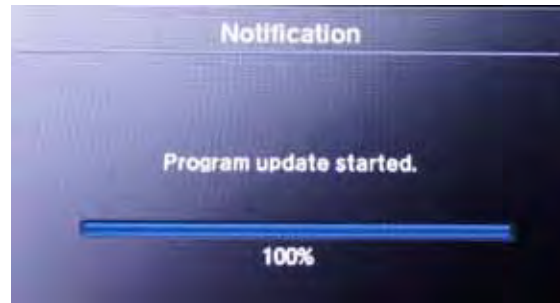
Touch screen

On the touch screen, the progress bar will stop at 100% after ERATO is updated and remain at 100% throughout all SH and Utility updates. The progress bar will go back to 0% and resume when the BUuCOM update starts.

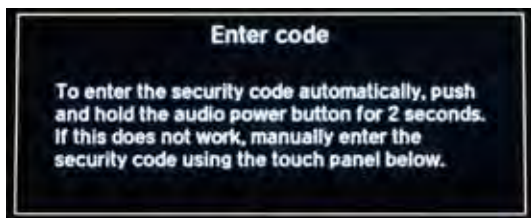
Navigation screen

- When the update is complete, the system will reboot to the HondaLink screen, the Enter code message and keypad screens will appear, although they may not appear at the same time. **Wait for both screens to appear**, then press the engine start/stop button to select the vehicle OFF mode.

- You must wait for both screens to appear before selecting the vehicle OFF mode, or you will lock up the unit**
- Do not remove the USB update device until you turn the vehicle off because the audio-navigation unit will lock up. If it locks up, go to RECOVERY PROCEDURE.
- If the battery power was interrupted during the update because the battery died, the vehicle was started or turned to the OFF mode during the update, or the software update failed, the audio-navigation unit may be locked. Go to RECOVERY PROCEDURE.

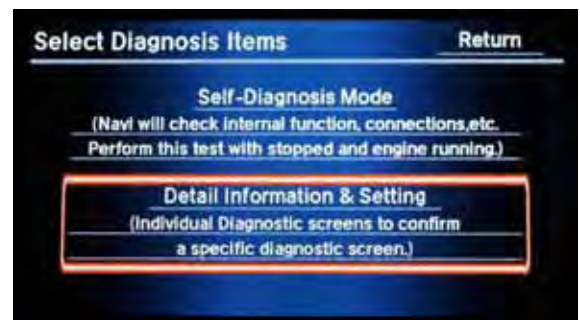
- Press and hold the NAVI, BACK, and MENU buttons until the Select Diagnosis Items screen appears.

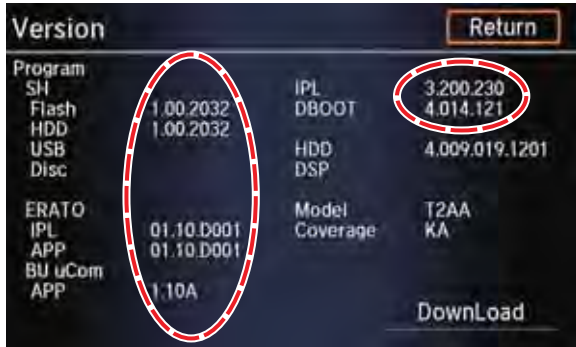
Accord

- Verify that the software was updated to the new version as shown below. If the software is not updated, turn the vehicle to the OFF mode, and go back to step 2 and repeat the update procedure.

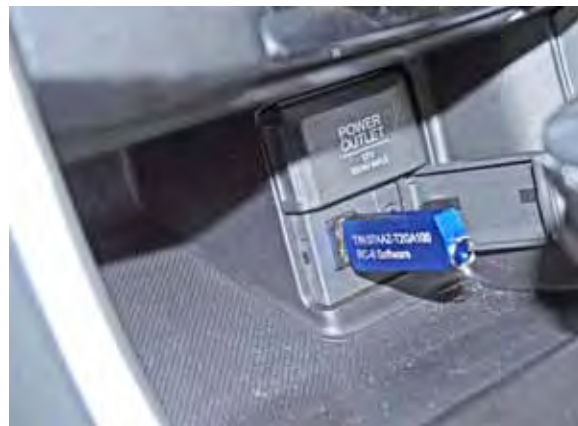
Accord

- Connect a battery charger, or a fully charged jumper battery to the vehicle and leave it connected during the entire update procedure to maintain a steady voltage.
- Press the engine start/stop button to select the vehicle ON mode.
- Wait for the audio system to boot up, then insert the USB update device into the USB port in the center console. See TOOL INFORMATION.

NOTE: The ignition must remain ON during the entire update procedure. If the ignition is turned OFF, the engine is started, or the USB update device is removed at any time *during* the update process, the audio unit will be locked up and you will need to use the RECOVERY PROCESS.

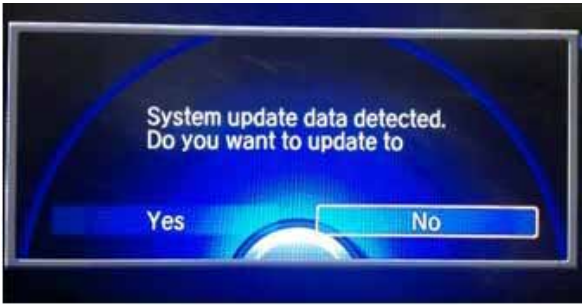
4. When the System update data detected screen appears, select **Yes**.

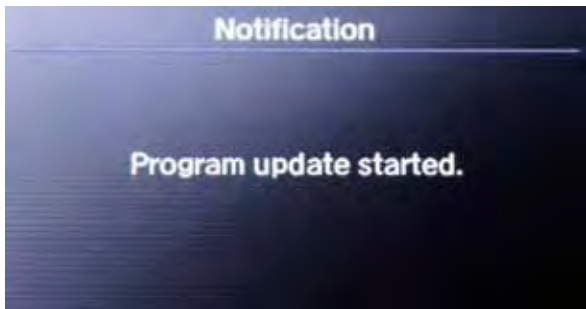
5. Both screens will shut off for about 10 seconds and reboot with the notification shown below on both screens.

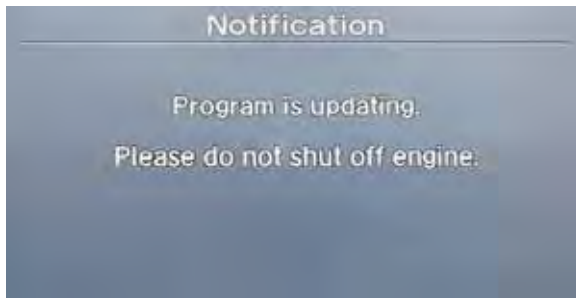
6. The notification below will appear on the upper display screen for the duration of the update process.

- The engine does not need to be running to do this update.
- You do not have to oversee the update during this time as no action is needed until the update is loaded.

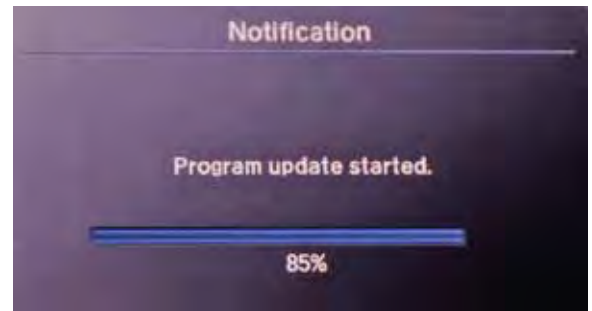
7. The software update will begin. A Notification screen loading bar will display on the touch screen.

NOTE: After the loading bar reaches 100%, it will go back to 0% for the second part of the update.

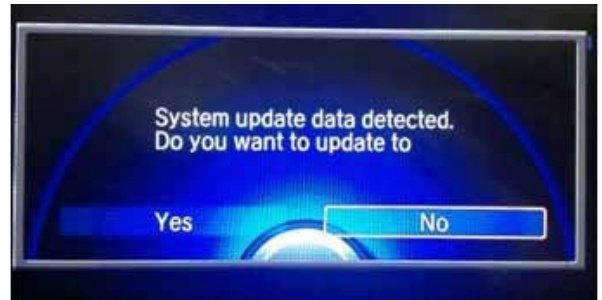
8. When the update is complete, the system will reboot to the H screen, and the System update data detected screen will reappear.

- Do not remove the USB until you turn the vehicle off because the audio unit will lock up. If it locks up, go to RECOVERY PROCEDURE.
- If the battery power was interrupted during the update because the battery died, the vehicle was started or turned to the OFF mode, or the update failed, the audio unit may be locked. Go to RECOVERY PROCEDURE.

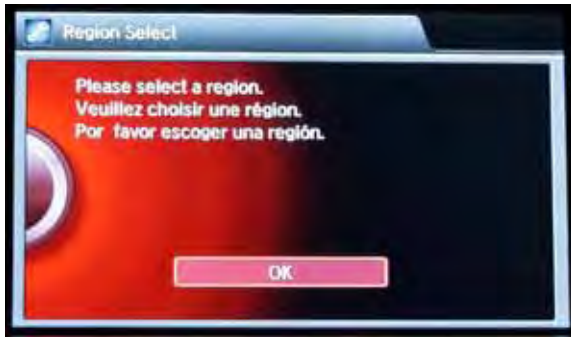
12. When the Region Select screen appears, select **OK**.

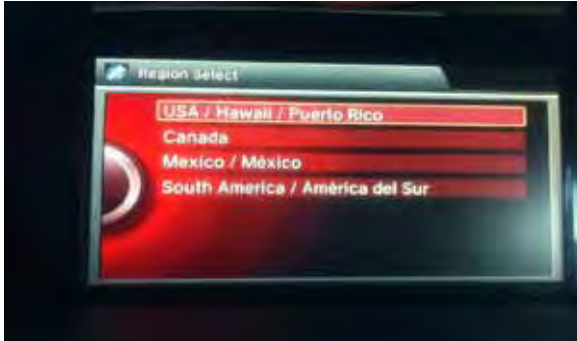
13. Select **USA/Hawaii/Puerto Rico**.

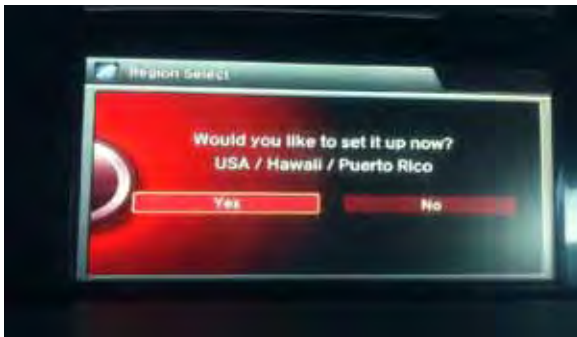
14. Select **Yes**.

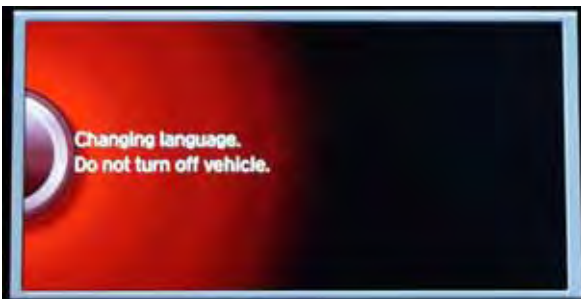
The screen below appears momentarily, then the system reboots to the Enter code screen.

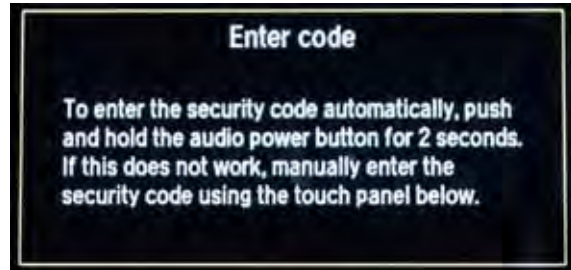
Upper display

15. The Enter code message and keypad screens will appear, although they may not appear at the same time. **Wait for both screens to appear.** Then, press and hold the power button for 2 seconds until you hear the beep.

NOTE: You must wait for both screens to appear before pressing the power button, or you will lock up the unit. If you lock up the unit, go to RECOVERY PROCEDURE.

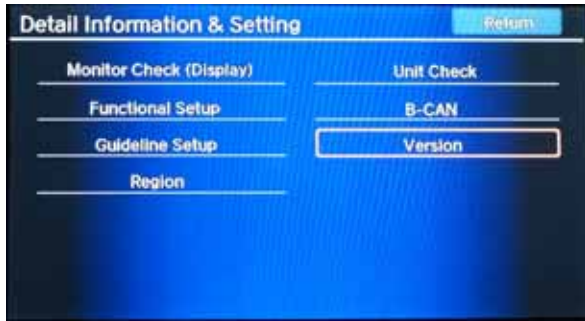
17. Select **Detail Information & Setting**.

18. Select **Version**.

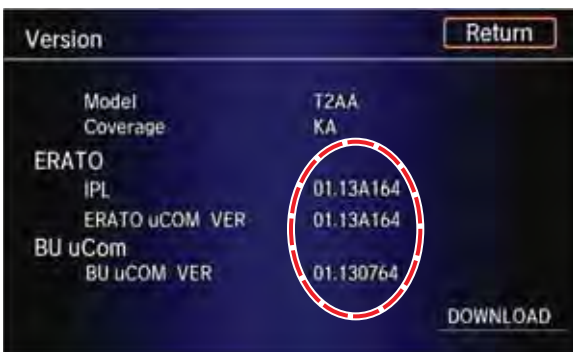
Accord

19. Verify that the software was updated to the new version as shown below. If the software is not updated, turn the vehicle to the OFF mode, and go back to step 2 and repeat the update procedure.
