**WE37 - Updating Software for Various Control Equipment and Devices (Workshop Campaign)**

Model Year: **2015**

Vehicle Type: **918 Spyder**

Concerns: **Software update of the following control equipment and devices:**

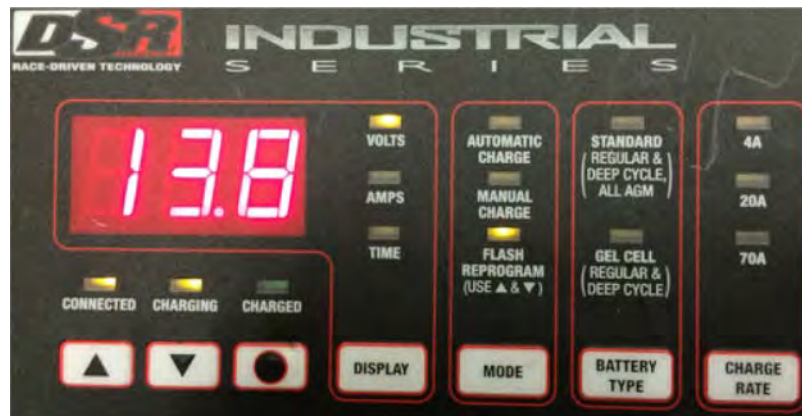
Work Procedure: 1 Connect the Shumacher INC-700A to the jump-start terminals in the luggage compartment, set the charger to "Flash Reprogram" and adjust the charging voltage to 13.8 V.

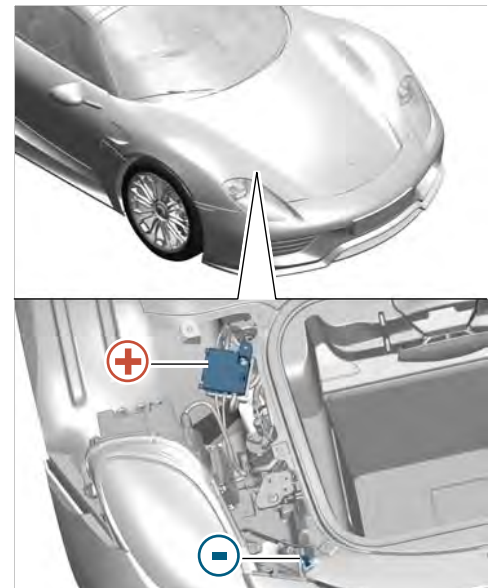
*Installation position of external power connection*

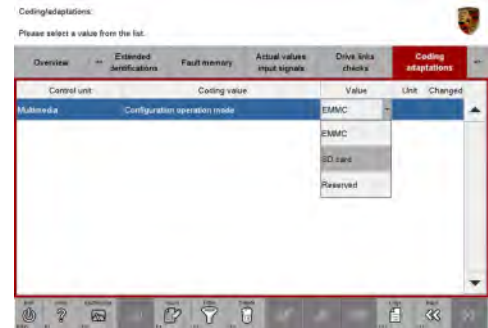
4.6 Change the operating mode in the ⇒ **'Value'** column from **'EMMC'** to **'SD card'** (⇒ *Changing operating mode to SD card*) and press **•F8** ("Write") to save the change. The message "Coding has been written successfully" then appears in the upper status line.

*Changing operating mode to SD card*

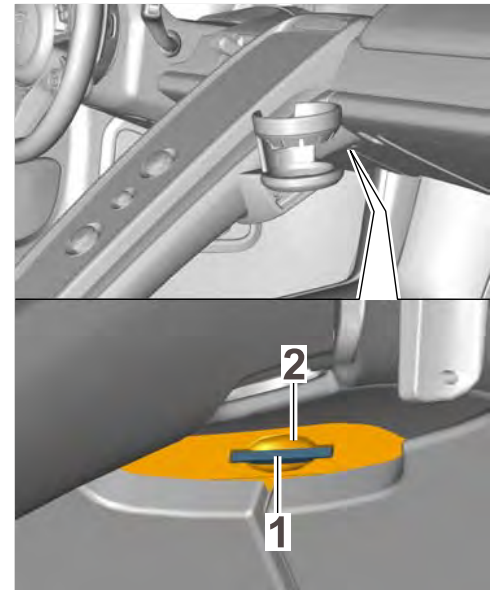
4.9 Remove SD card ⇒ *Removing SD card-1-* containing the navigation map data from the card slot in the PCM system ⇒ *Removing SD card-2-*.

The card slot in the PCM system is in the cut-out below the centre console ⇒ *Removing SD card* at the same height as the button for opening the glove box.

To remove the SD card from the card slot, press the SD card in first with your finger and then let it go so that the SD card is released. Then pull the SD card out of the card slot. Keep the SD card in a safe place.

*Removing SD card*

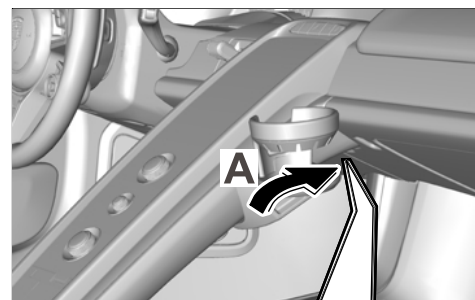
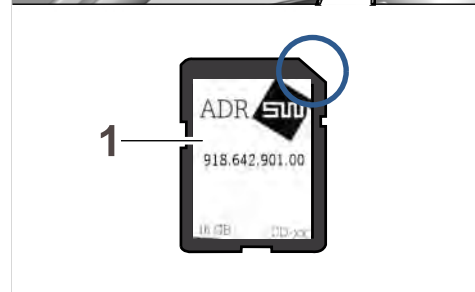
4.10 Insert SD card for the software update, Part No. 918.642.901.00 ⇒ *Inserting SD card -1-*, into the card slot in the PCM system.

Make sure that the bevelled edge of the SD card is at the front right ⇒ *Inserting SD card -circle-*.

*Inserting SD card*

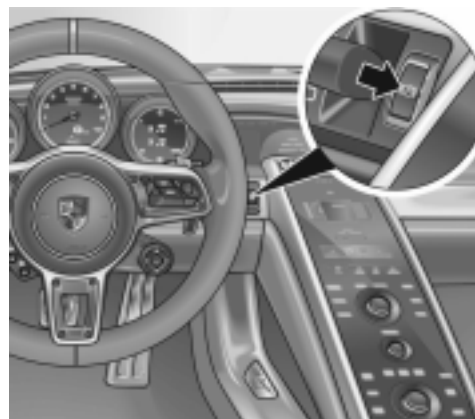
- 4.11 Switch off ignition, remove ignition key and lock the vehicle.  
Leave the vehicle locked until the red light on the button for the electric parking brake ⇒ *Button for electric parking brake -arrow-* goes out.
- 4.12 Unlock the vehicle, insert ignition key into the ignition lock and switch on ignition.

*Button for electric parking brake*

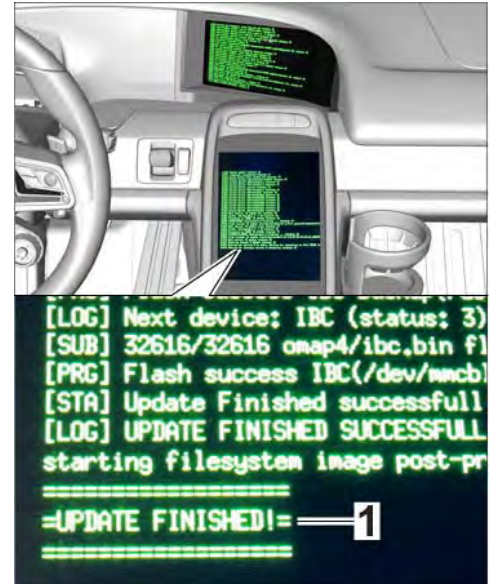
The PCM update starts automatically after a short time. The update status is displayed as a progress report in green lettering on the PCM operator control unit display in the center console as well as in the display unit (central display) on the dashboard and is updated continuously ⇒ *PCM update*.

When the PCM update is complete, the message "=Update finished!=" ⇒ *PCM update -1-* appears on the PCM operator control unit display in the center console.

*PCM update*

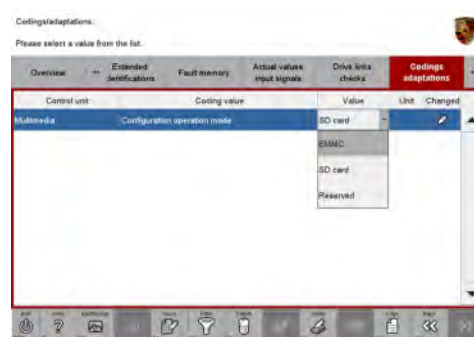
2.5 Change the operating mode in the ⇒ **'Value'** column from **'SD card'** to **'EMMC'** (⇒ *Changing operating mode*) and press **•F8"** ("Write") to save the change. The message "Coding has been written successfully" then appears in the upper status line.

*Changing operating mode*

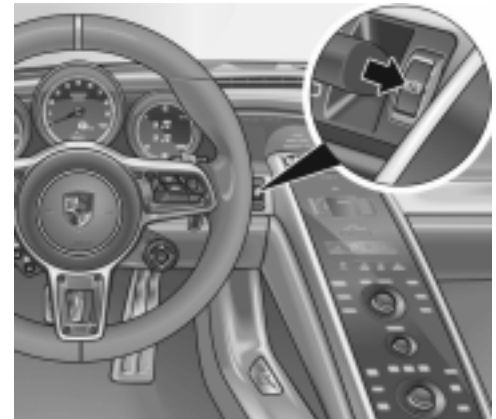
Leave the vehicle locked until the red light on the button for the electric parking brake ⇒ *Button for electric parking brake -arrow-* goes out.

*Button for electric parking brake*

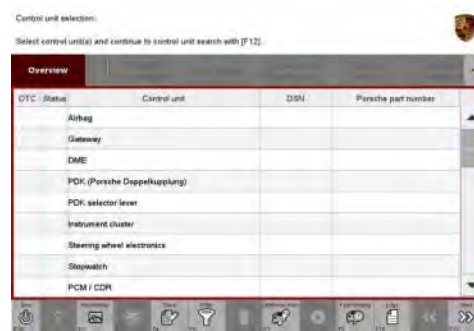
- 6 Once you have erased the fault memories, select the ⇒ **'Overview'** menu to return to the control unit selection screen ⇒ *Control unit selection*.

*Control unit selection*

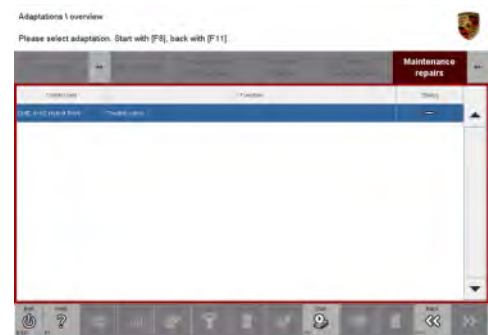
- 5 Select the ⇒ **'Throttle valve'** function so that the corresponding text line turns blue and press •F8“ to start throttle valve adaptation.

- 7 Press •F8“ ("Stop") to end throttle valve adaptation.
- 8 Press •<<“ to return to the start page of the ⇒ **'Maintenance/repairs'** menu.

*Throttle valve adaptation*

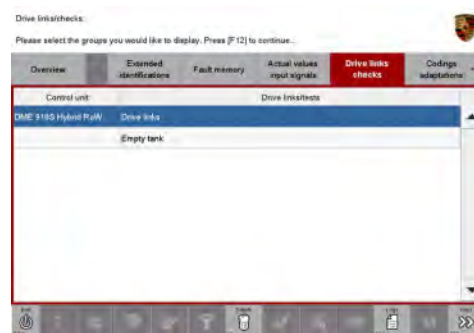
- 2 Select the ⇒ **'Drive links'** sub-menu and press •>>" to confirm ⇒ *DME drive links*.

*DME drive links*

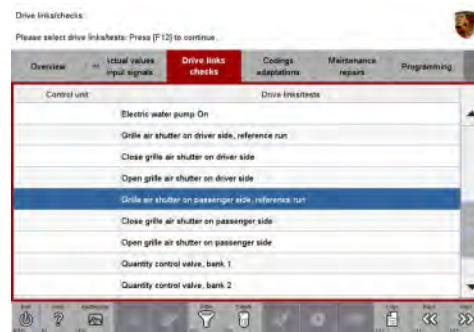
- 4 Adapt cooling-air flaps on the **passenger's side**.
  - 4.1 Select **'Radiator shutter on passenger's side, reference run'** and press •>>" to confirm ⇒ *Radiator shutter on passenger's side, reference run*.
  - 4.2 Carry out the reference run in the same way as described in **Step 3.2** .

*Radiator shutter on passenger's side, reference run*

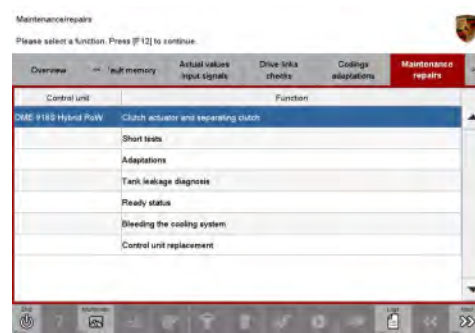
- 3 Once the DME control unit has been found and is displayed in the overview, select the ⇒ **'Maintenance/repairs'** menu.
- 4 Select the menu item ⇒ **'Clutch actuator and separating clutch'** and press **•>>"** to confirm your selection ⇒ *Clutch actuator and separating clutch*.
- 5 Read and comply with the preconditions for the state of charge of the high-voltage battery and confirm by pressing **•>>"** .

*Clutch actuator and separating clutch*

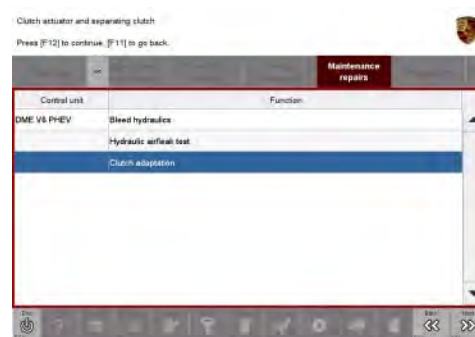
- 6 Select the ⇒ **'Clutch adaptation'** function and press **•>>"** to confirm your selection ⇒ *Decoupler adaptation*.
- 7 Confirm the query as to whether the electric machines are already calibrated by pressing **•F12"** ("Yes").

*Decoupler adaptation*

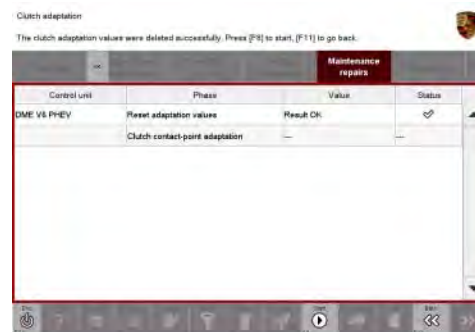
- 10 During adaptation, the adaptation values will first be deleted ⇒ *Resetting adaptation values*. The clutch contact point and the clutch characteristic will then be adapted ⇒ *Adapting contact point* and ⇒ *Adapting characteristic*. Start each step by pressing **•F8"** and follow the instructions on the PIWIS Tester.

*Resetting adaptation values*

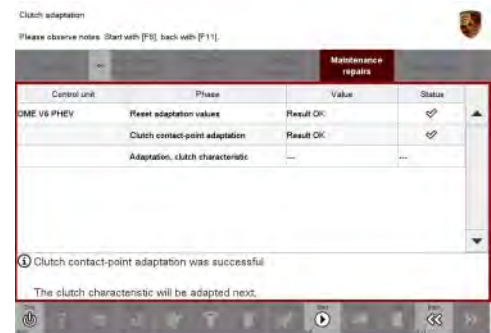
*Adapting characteristic*
