Subject: MAZDA CONNECT FUNCTIONALITY CONCERNS	Bulletin No: 09-022/15
	Last Issued: 08/10/2015

MAZDA CONNECT Software Version Verification Procedure

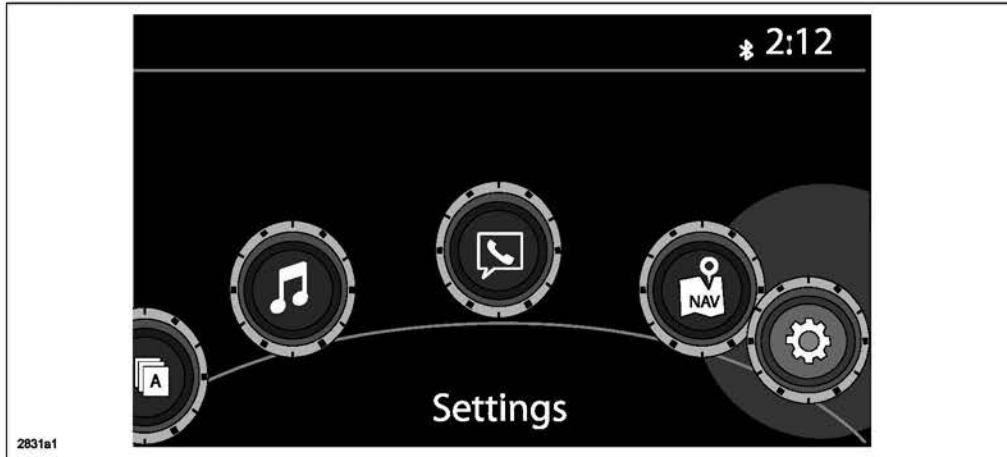
1. Select "Settings" from the Home screen to check the software version.

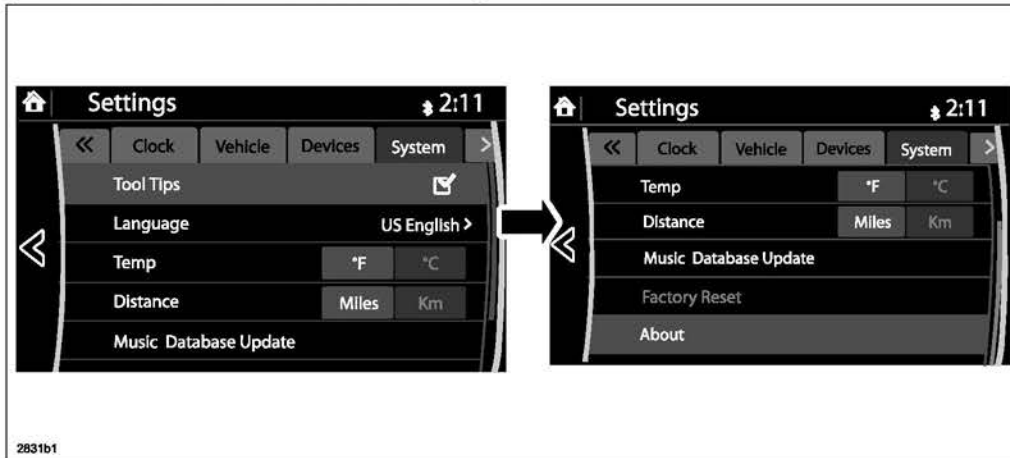
2. Select "System" and scroll down to the "About" option.

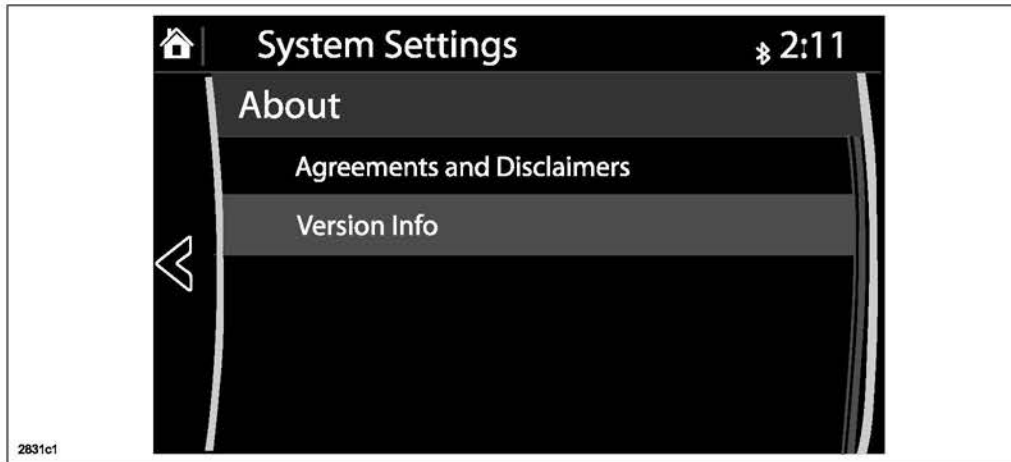
3. Select "Version Info" from the "About" screen.

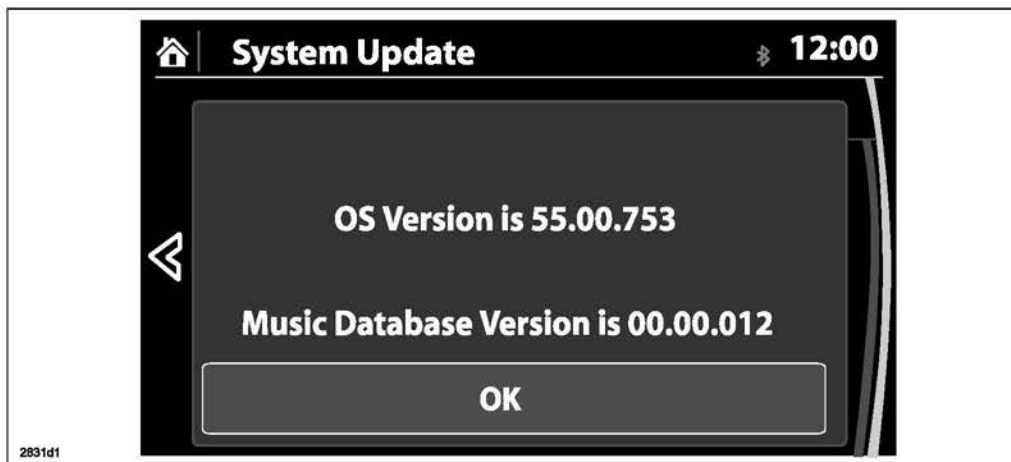
4. Make sure the software version is **55.00.753** or later, then select OK. If it is not **55.00.753** or later, update the system using a USB memory stick with the latest software according to the "Reflash Procedure." If needed, refer to "Downloading Update Software to a USB Memory Stick (for additional USB memory sticks)" below.

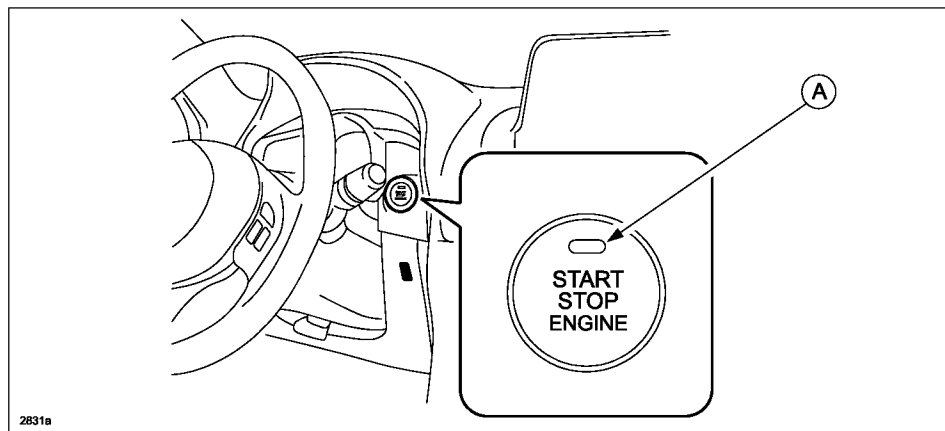
4. Install the ROOM FUSE and AUDIO FUSE to the fuse block in the engine compartment (if not installed).
5. Connect battery charger (charge current maintained about 7A) to the vehicle to stabilize voltage fluctuation.
6. Press the START/STOP ENGINE push button 1 time without depressing the clutch pedal (manual transaxle) or the brake pedal (automatic transaxle), to switch the ignition position to ACC. Confirm that the push button start indicator light (A) is illuminated (amber) and the display in the instrument cluster is OFF (ignition position is in ACC).

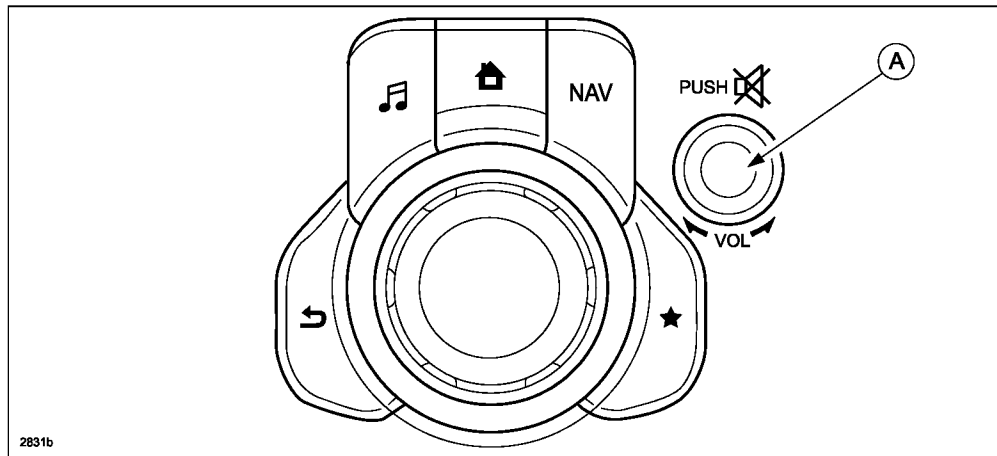
7. Verify that there is a sound coming from the speakers. If sound cannot be heard, turn the volume dial (A) to turn the volume up, or make sure that MUTE is not on.

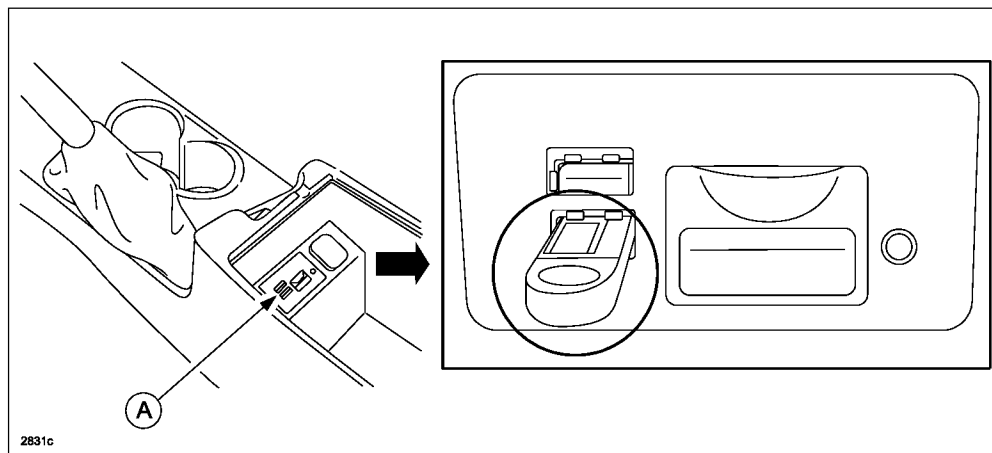
8. Connect the prepared USB memory stick to the either one of the two USB port (A).

NOTE: There should only be the prepared USB memory stick inserted in one of the USB ports. Nothing should be inserted in the other USB port during the re-flashing process.

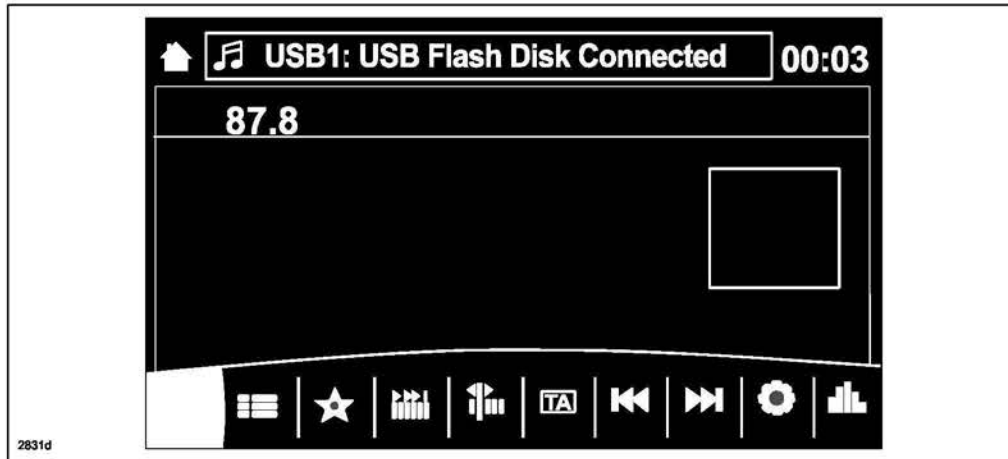
9. When the USB memory stick is recognized, the following message will appear briefly on the screen.

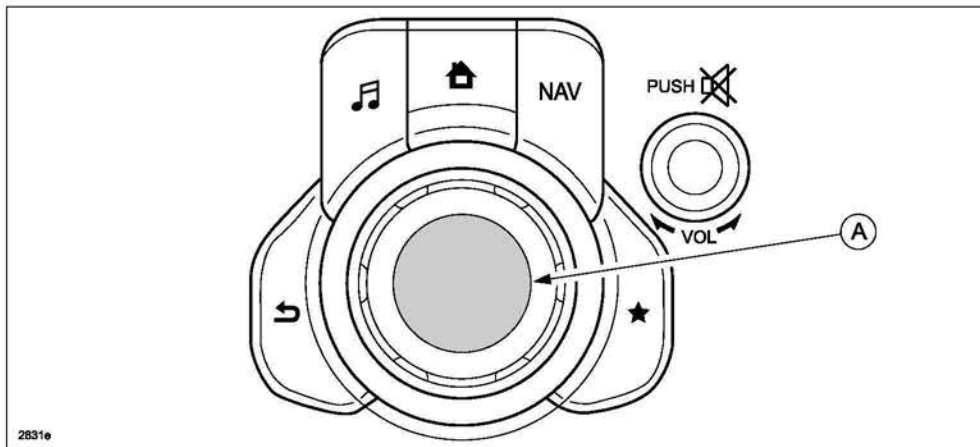
- It takes approx. 5 seconds before the USB memory stick is recognized.
- If the USB memory stick is not recognized, perform the following:
 - (1) Select "Setting".
 - (2) Select "System".
 - (3) Select "Factory Reset".
 - (4) Push the commander switch knob (A) to "Enter".

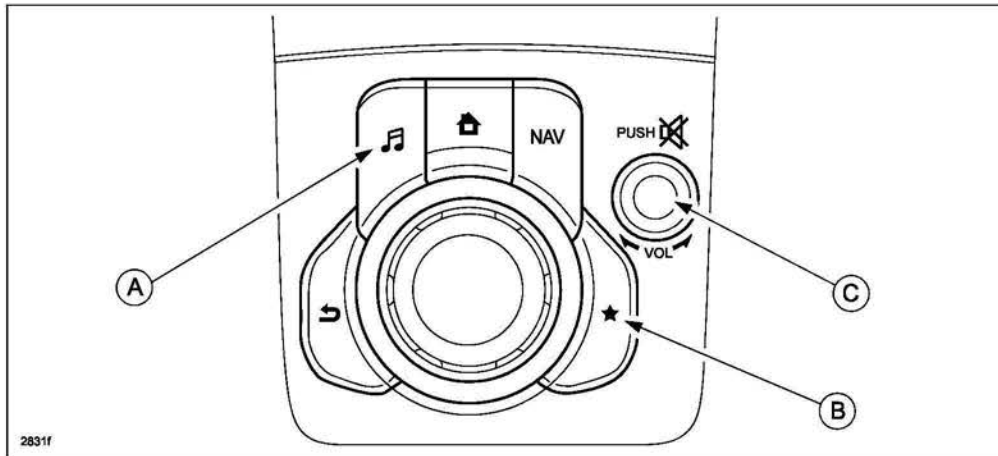
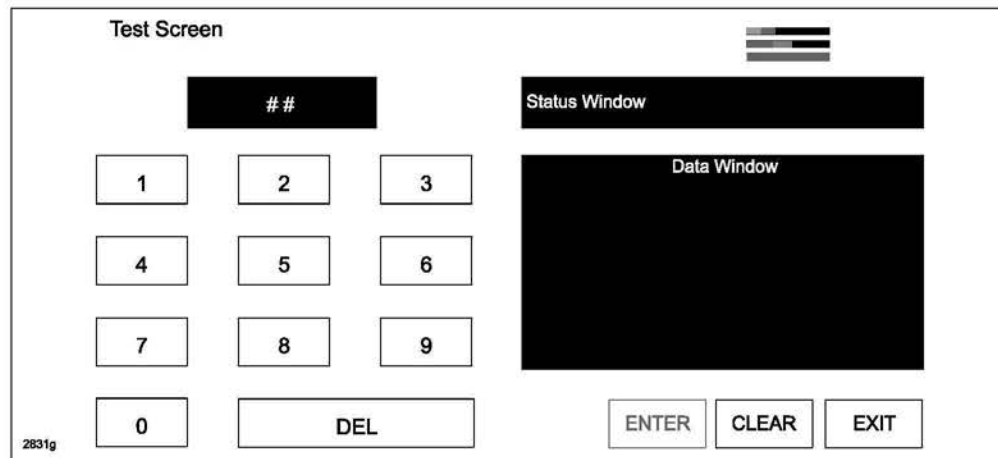
10. Press the three buttons (Music (A) + Favorites (B) + Volume Mute(C)) on the commander switch at the same time for 2-5 seconds and the Diagnostic Test Screen will appear.

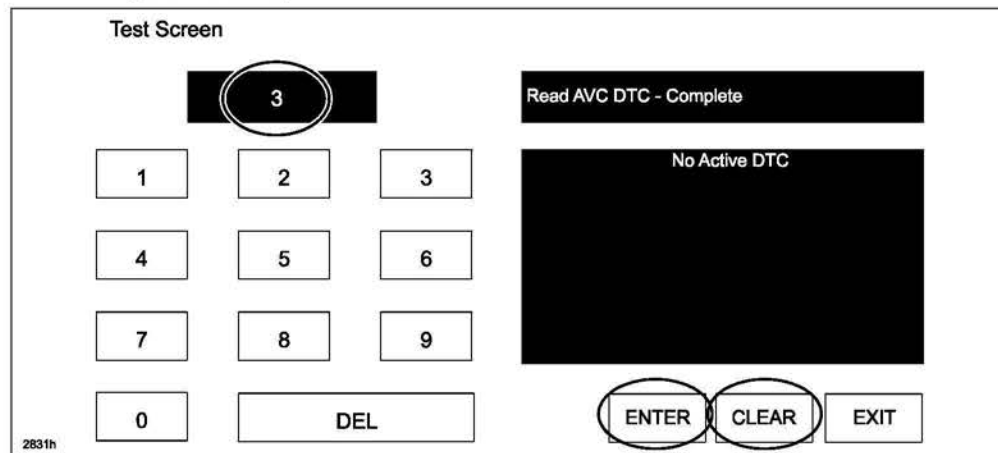
11. On the test screen, input '3' and then select "ENTER" to verify whether any DTCs (in the CMU) are active. Select "CLEAR" to go next step.

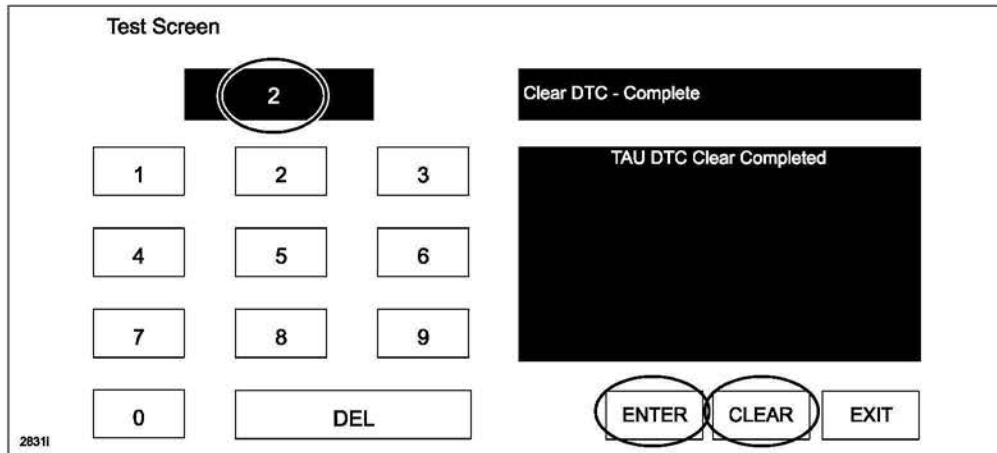
12. If any DTCs are present, input '2' on the test screen and then select "ENTER". This will internally clear all the earlier set DTCs (in the CMU). Select "CLEAR" to go to next step.

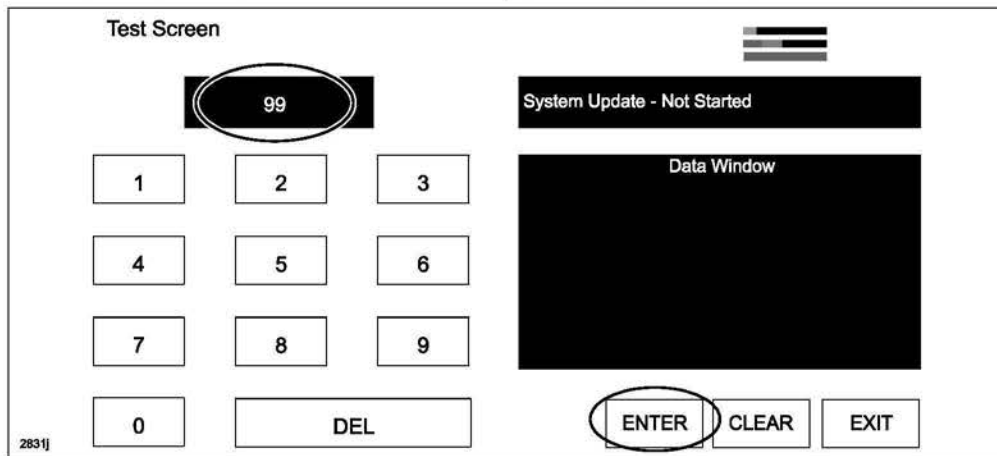
13. Use the touchscreen or the commander switch to input '99' and then select "ENTER" on the Test screen.

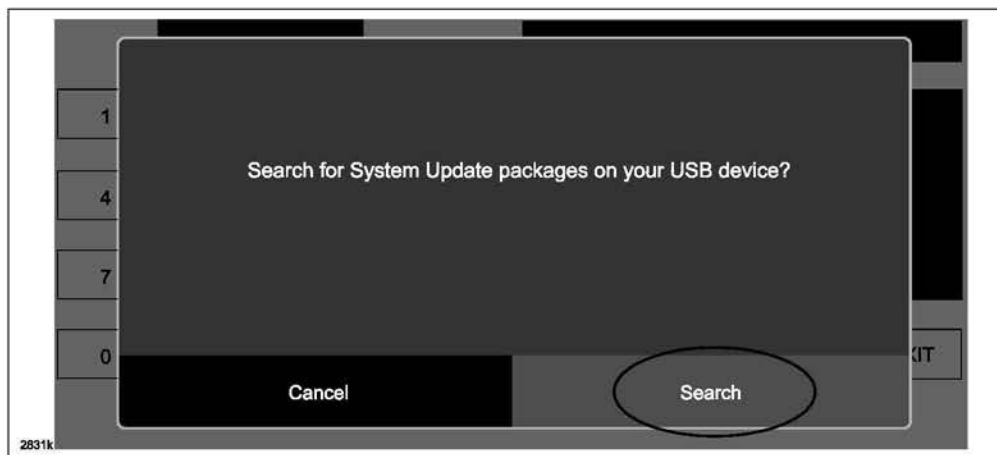
14. Select "Search" on the screen below.

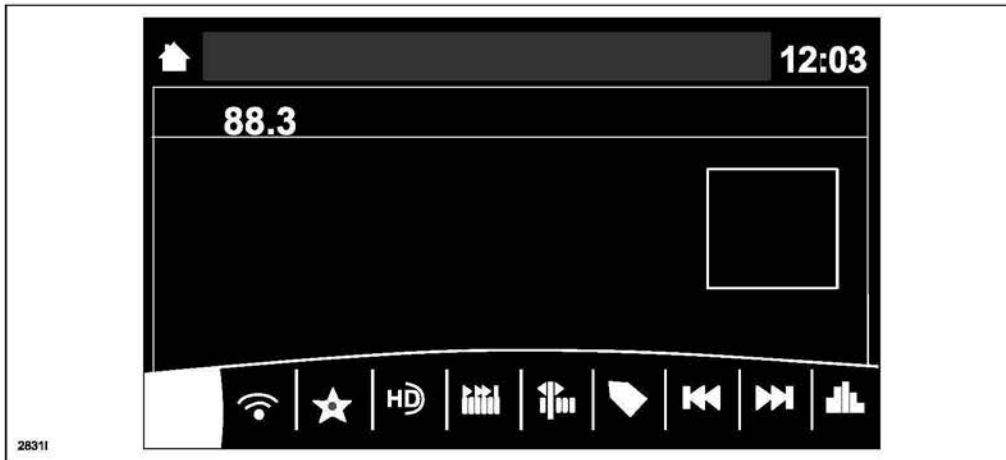
NOTE: If the following screen is displayed, perform the following.

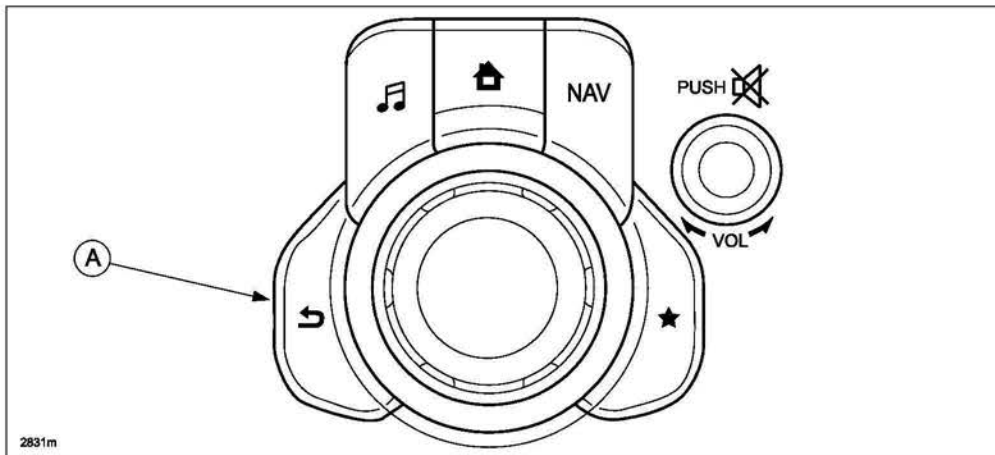
(1) Press the "Return" button (A) on the commander switch.

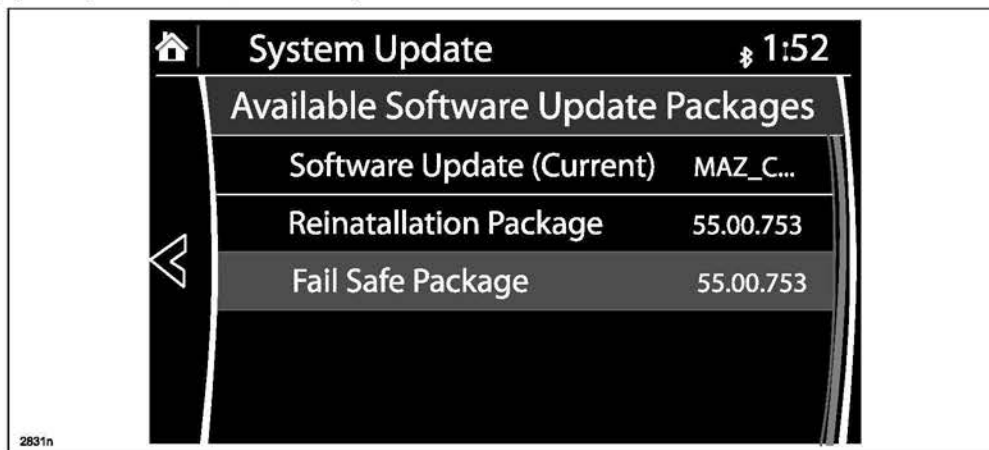
(2) Verify that the screen changes back to the screen below.

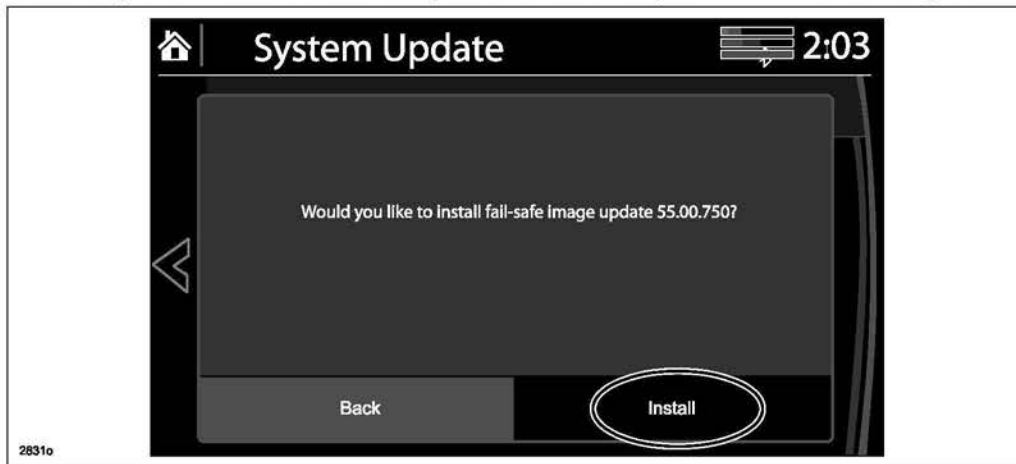
15. Select "Fail Safe Package" first using the touch screen.

CAUTION: Always do the "Fail Safe Package" first, followed by "Reinstallation Package".

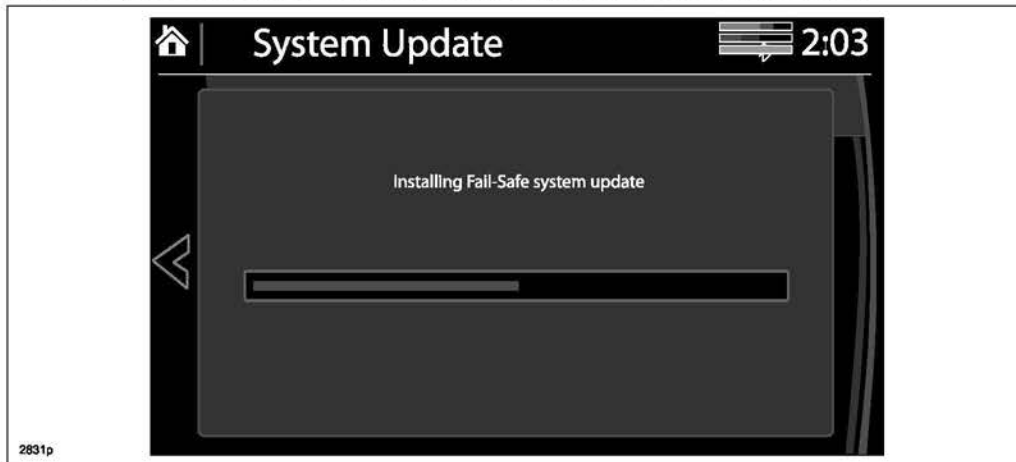
16. Select "Install" on the screen below and the Failsafe installation process will start.

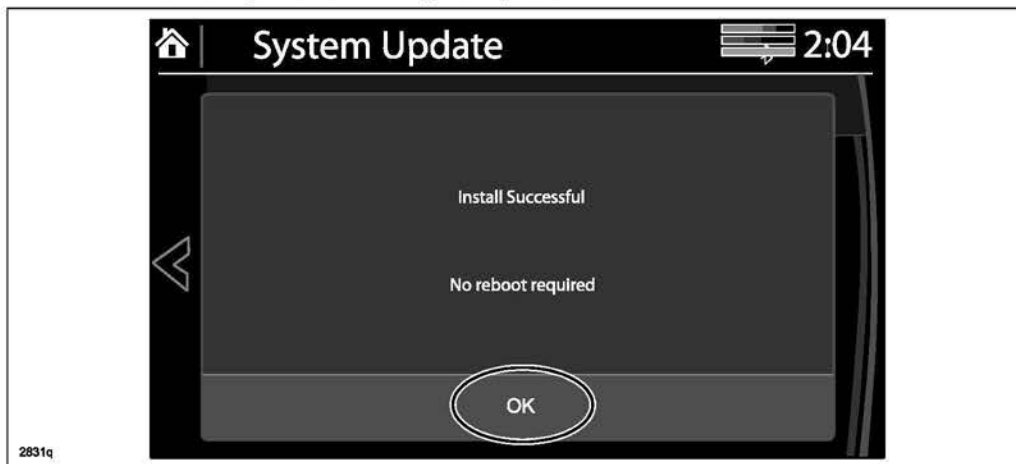
17. After the Failsafe installation process is completed, select "OK".

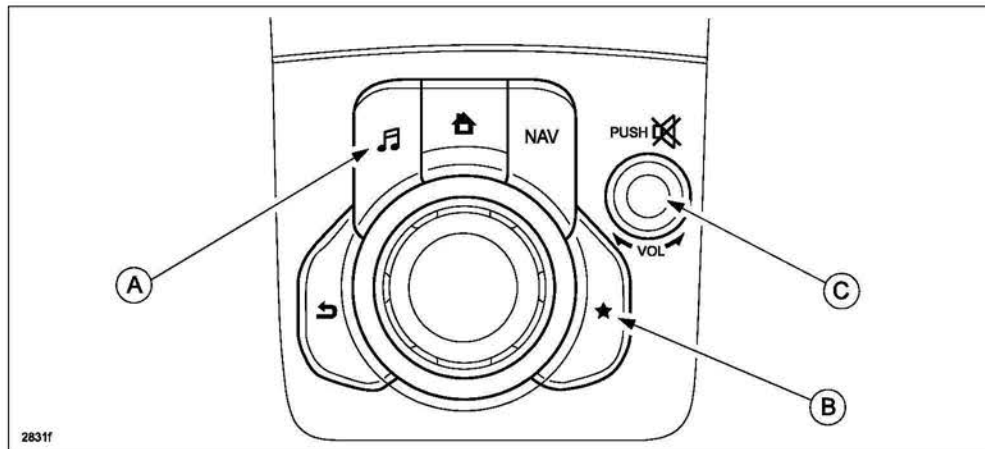
19. Press the three buttons (Music (A) + Favorites (B) + Volume Mute(C)) on the commander switch at the same time for 2-5 seconds to open the Diagnostics Test screen again.

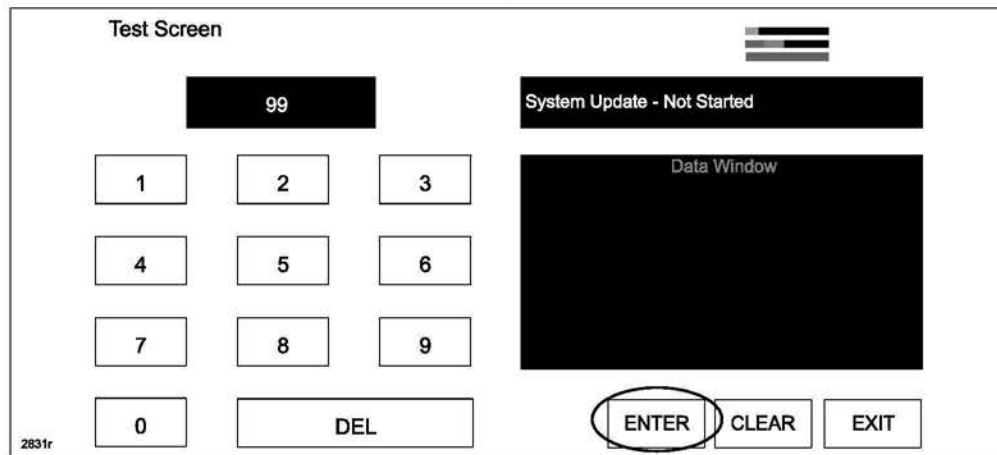
20. Use the touchscreen or the commander switch to input '99' and then select "ENTER" on the Test screen.

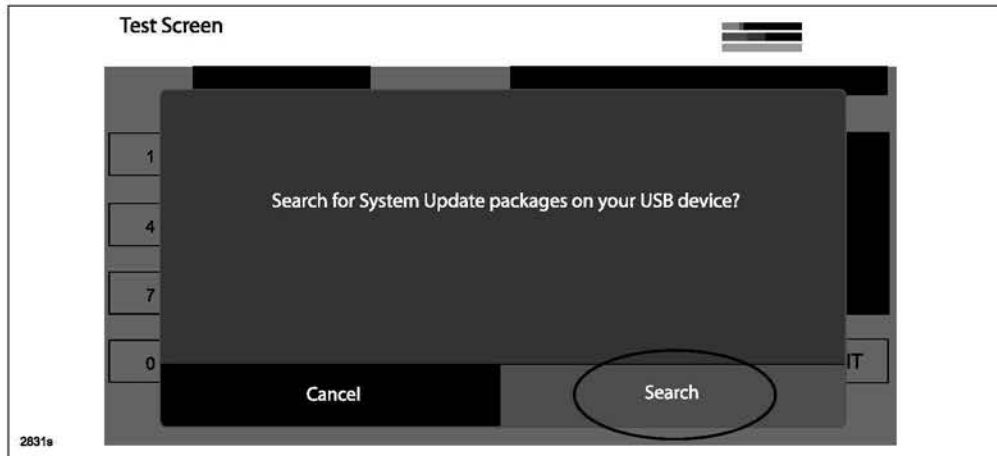
21. Select "Search" on the screen below.

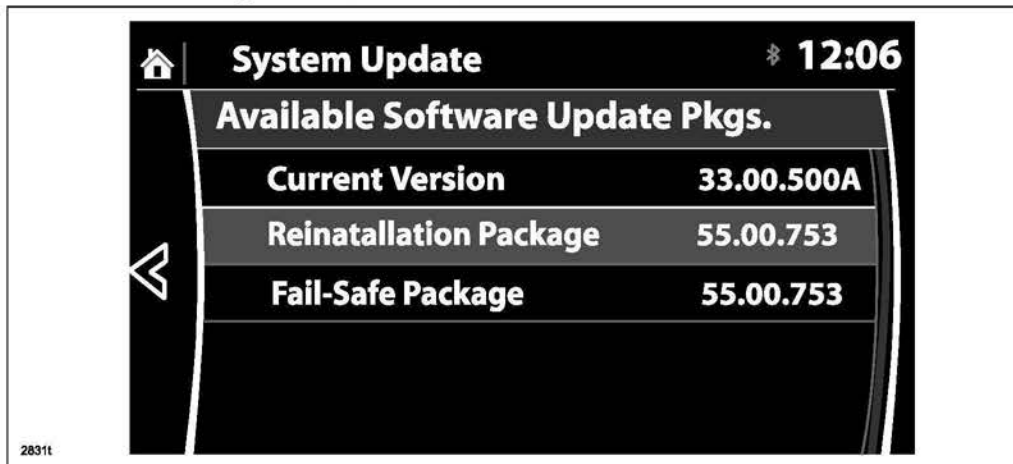
22. Select "Reinstallation Package" on the screen below.

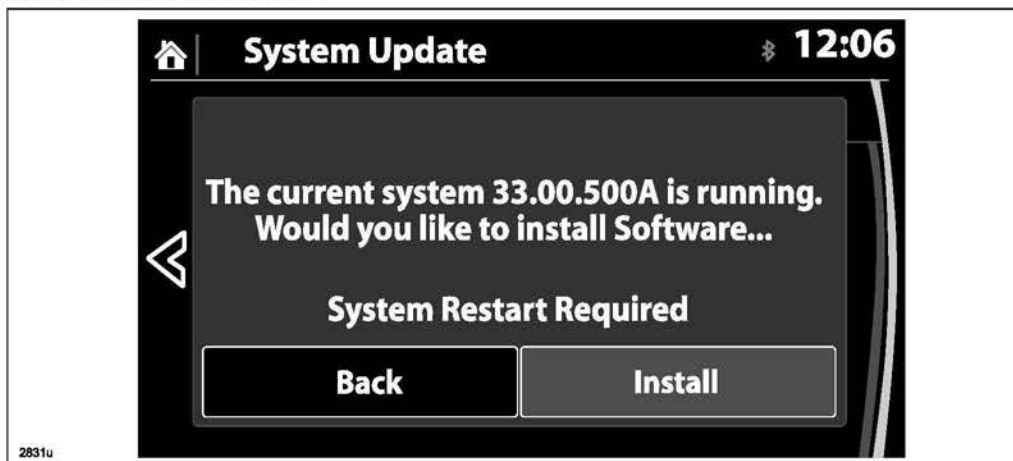
23. Select "Install" on the screen below.

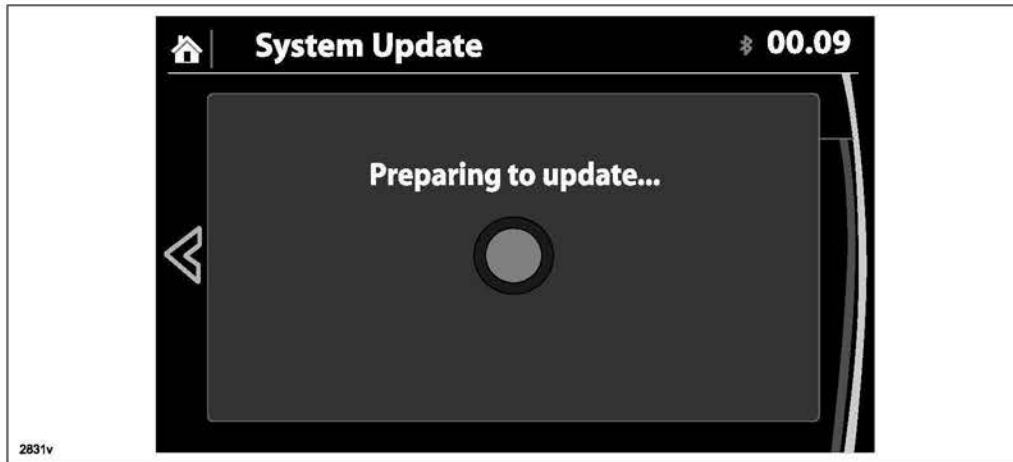
24. The screen below will be displayed.

NOTE: A blank screen is displayed momentarily. It will take approx. 2 minutes before the reflashing process moves to the next screen.

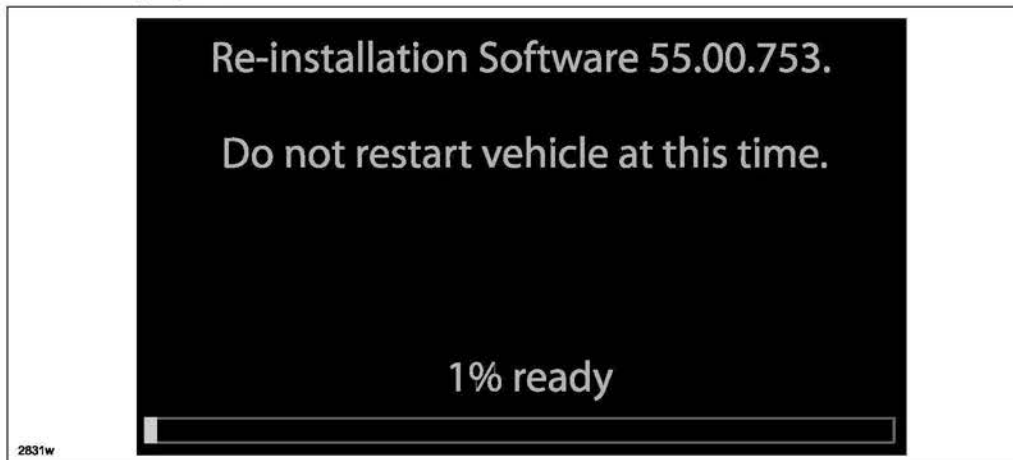
25. Reinstallation will start from 0% and as the reflashing process takes place, the progress bar will gradually increase to 100%.

NOTE: It may be difficult to read the display at times as it becomes dark, but "Do not restart vehicle at this time" is displayed.

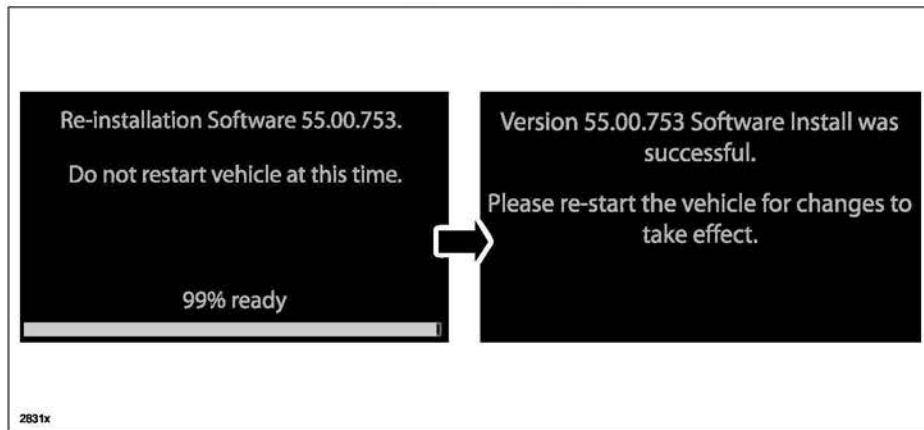
NOTE: It will take some time for the reflashing process to get from 98 % to “100%.”

26. After the update is completed with the above right screen, confirm that the push button start indicator light is illuminated (amber) and the display in the instrument cluster is OFF (ignition is in “ACC”). If the ignition is “OFF” and the push button start indicator light is not illuminated (amber), turn the ignition to “ACC” and one of the following two screens will be displayed.

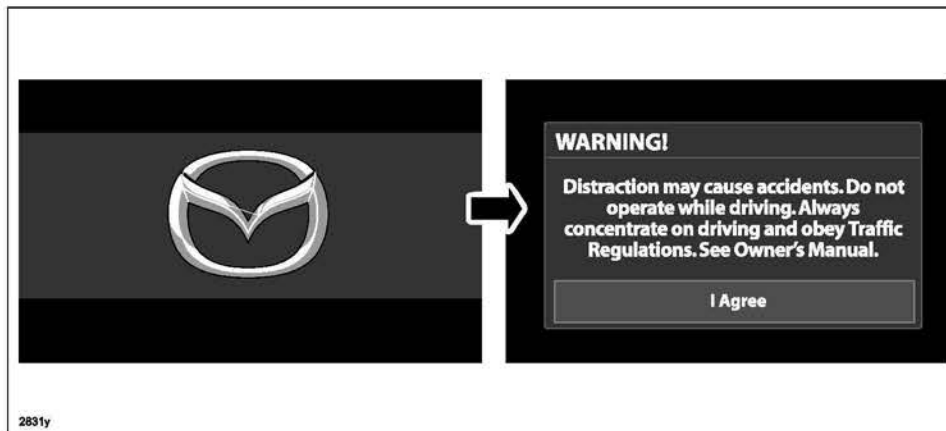
Type A: Reprogramming has already been completed. Go to next step.

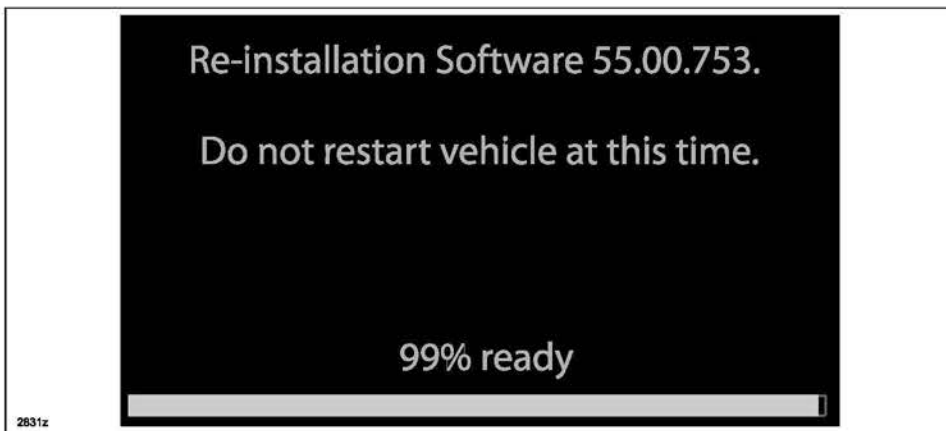
Type B: The ignition was turned “OFF” during the reflashing process. This screen will continue to be displayed until reflashing is completed. After the reflashing is completed, go to next step.
