GROUP  
Service Campaign

MODEL  
2015 MY  
Sedona (YP)  
(EX, SX & SXL)

NUMBER  
SC109 (REV 1, 12/19/2014)

SUBJECT: SEDONA (YP) – BCM LOGIC REPROGRAMMING (SC109)

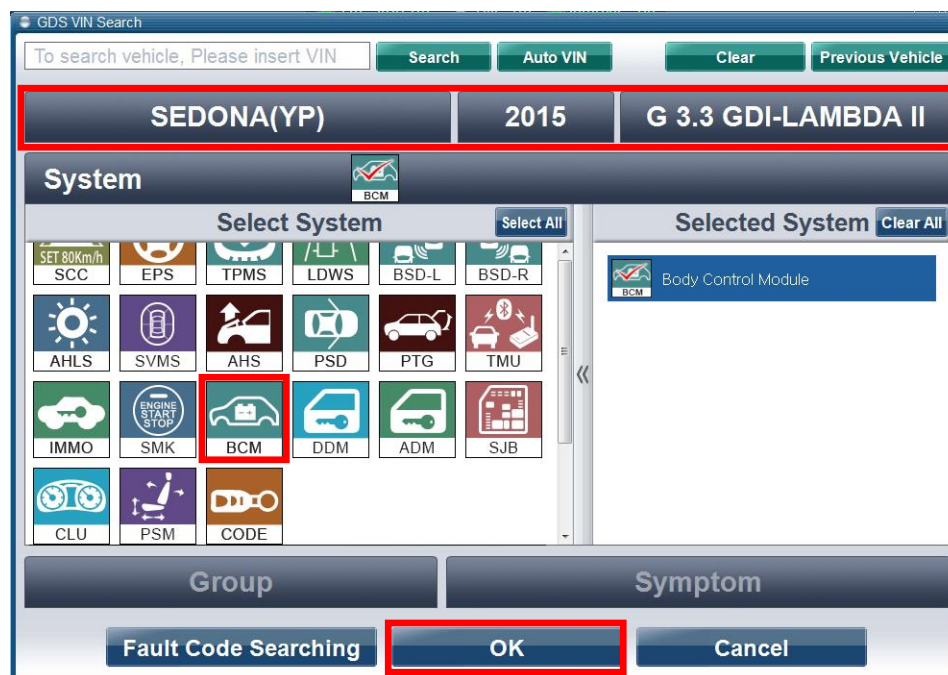
- With the ignition key ON, turn ON the VCI and GDS. Access the GDS vehicle identification number (VIN) screen and configure the vehicle using the **VIN AUTO DETECT** Function.
- Select **BCM** system and click **OK**.

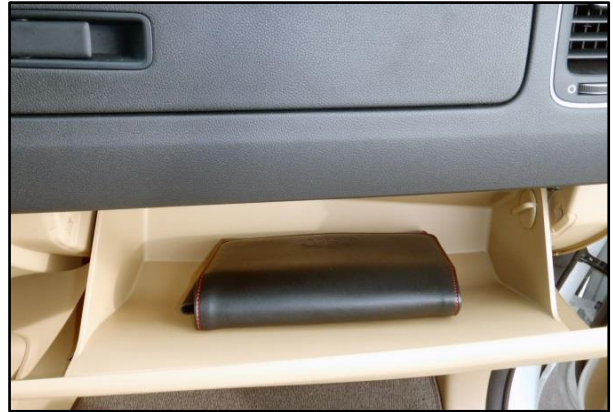
1. Open the glove box and locate the Owner’s Manual and the Features and Functions Guide (FFG).

**Discard the original FFG and replace it with a new one (See “Required Parts” table on Page 7).**
