Technical Bulletin

Section Title: Engine
 TSB No. TS 12 12177R

SUBJECT: P0133 (FRONT OXYGEN SENSOR SLOW RESPONSE)
MODEL(S): FORENZA, FORENZA WAGON, RENO (RQ420)
YEAR: 2006~2007
REVISION: O2 SENSOR INSPECTION AND REPLACEMENT IS ELIMINATED FROM PROCEDURE. NEW SOFTWARE TO ADDRESS CONCERN IS AVAILABLE

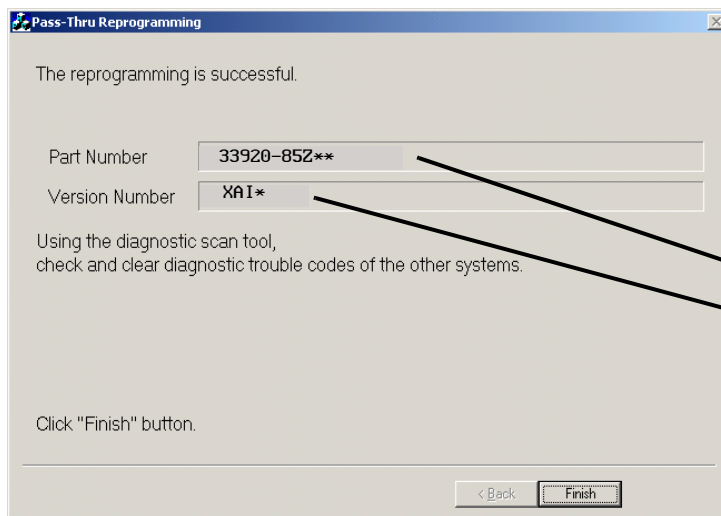
6. Fill out the Reprogram Label P/N 99963-01501-224 (the part number and version will be displayed at the "The reprogramming is successful" screen). Then affix the label to the back of the glove box door as pictured below.
7. Perform the idle relearn after reprogramming as follows.
 - a. Turn the ignition ON.
 - b. Turn the ignition OFF for 15 seconds.

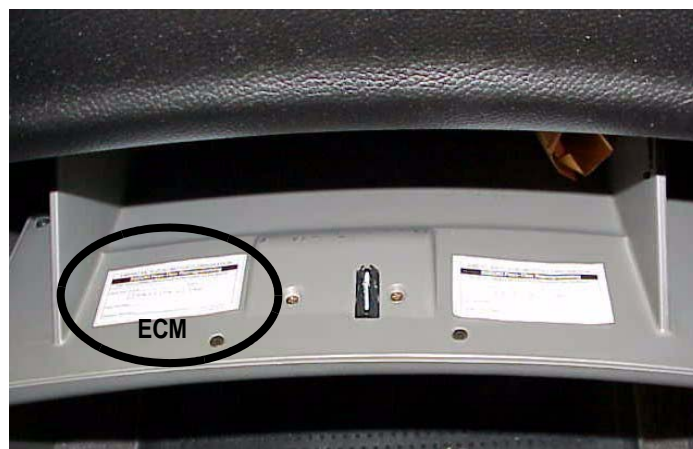
Example:

AMERICAN SUZUKI MOTOR CORPORATION	
SUZUKI Pass-Thru Reprogramming	
THE FOLLOWING MODIFICATIONS HAVE BEEN MADE:	
DEALER CODE: _____	DATE: _____
<input checked="" type="checkbox"/> ECM or <input type="checkbox"/> TCM or <input type="checkbox"/> other	
Part Number: 33920-85Z**	
Version Number: XAI*

PN 99963-01501-224
