Ford Motor Company

DPS6 Transmission and Dual Clutch Service

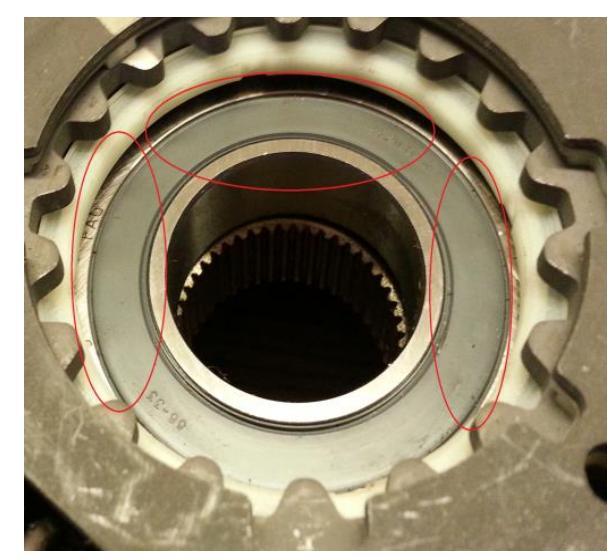
Ex: Bearing seal damage from improper snap ring removal

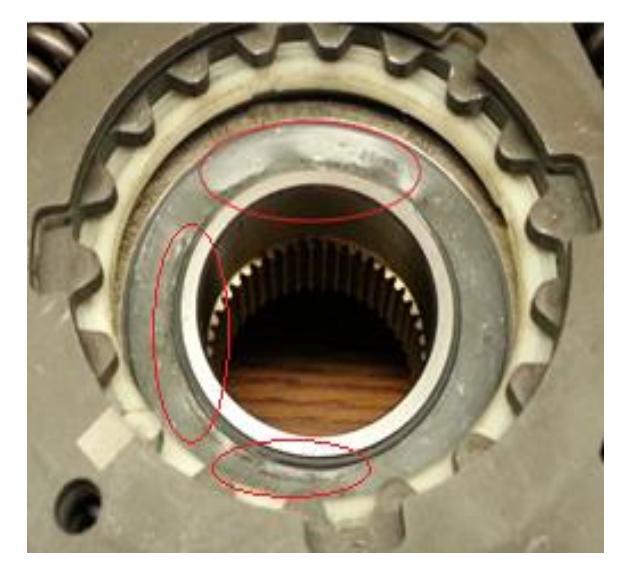
Topic: Clutch Lifting Legs

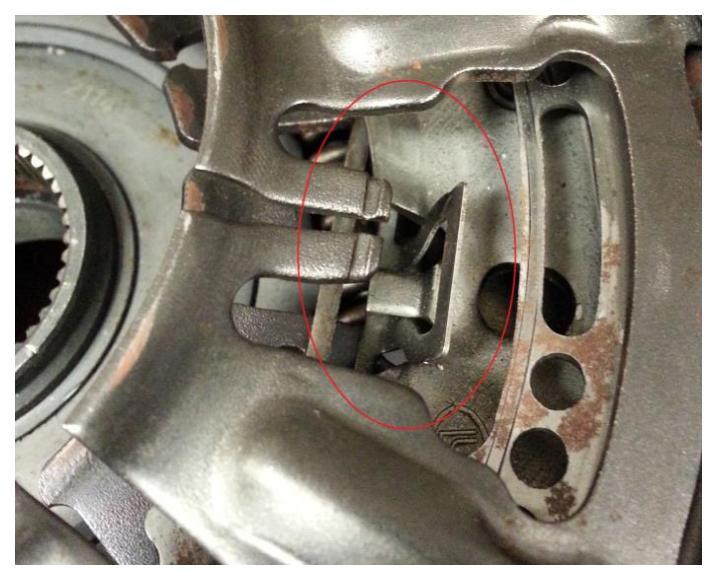
Topic: Clutch 1 Reset (Part 2)

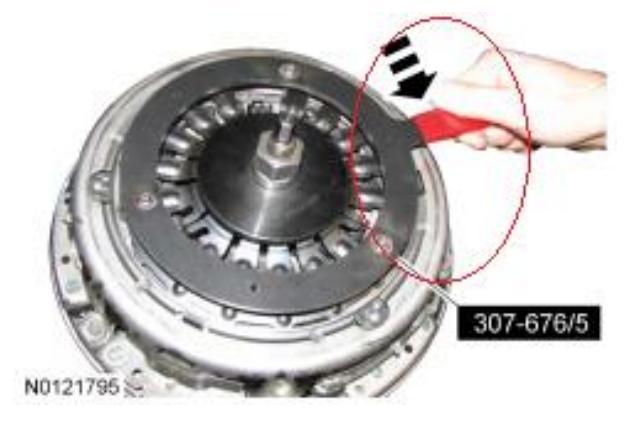
Ex: Clutch 1 locks free from damage

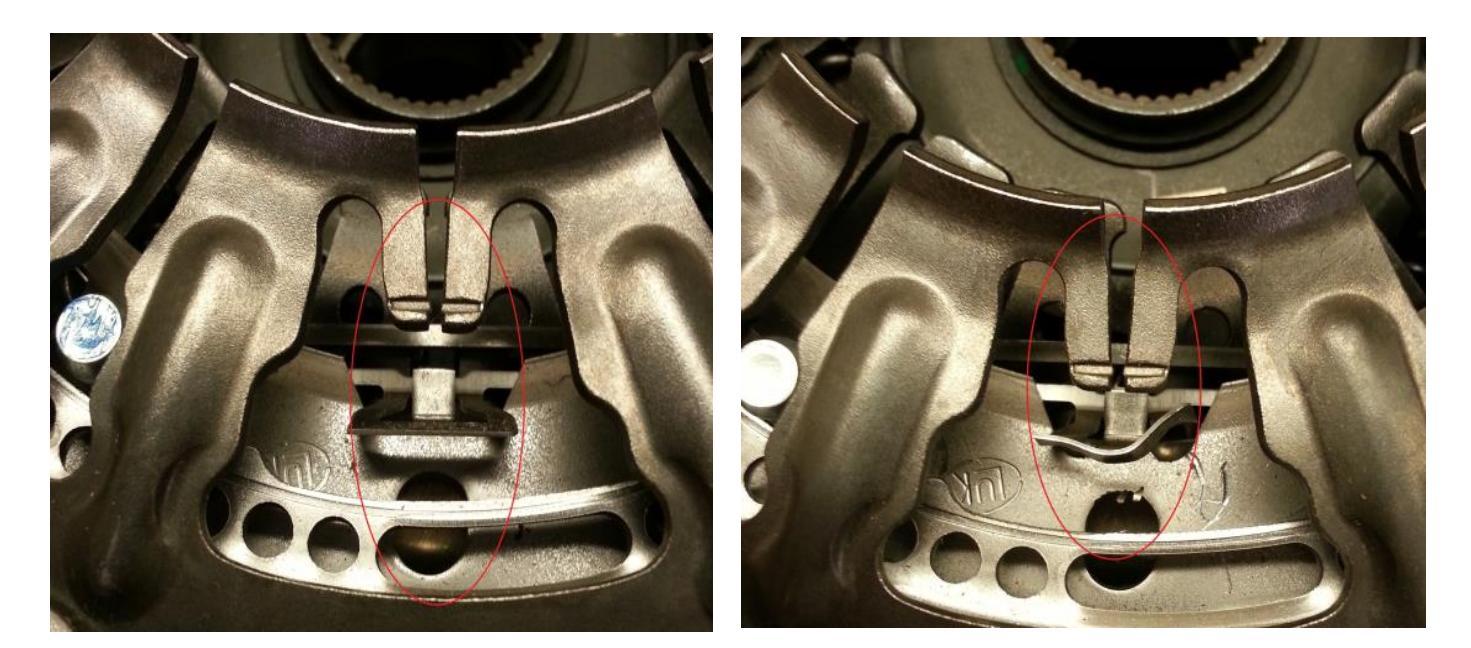
Topic: Clutch 2 Reset (Part 1)

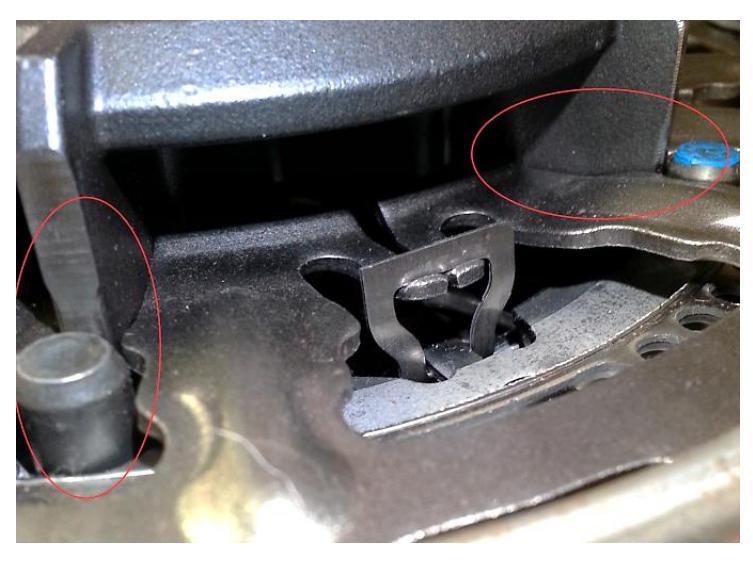
Ex: Improper alignment of tool 307-676/2 (tool rests on clutch 1 spring fingers)

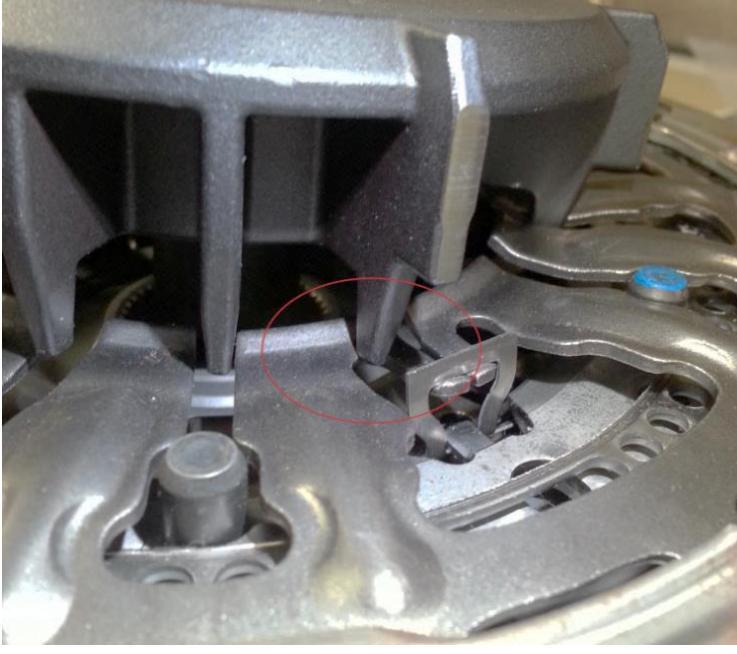
Topic: Clutch 2 Reset (Part 2)

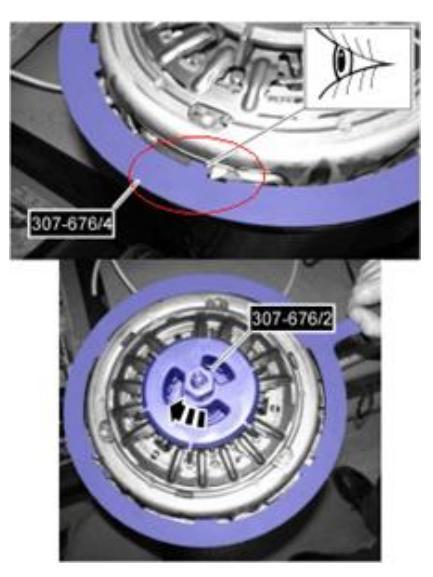
Ex: Proper resetting of clutch 2

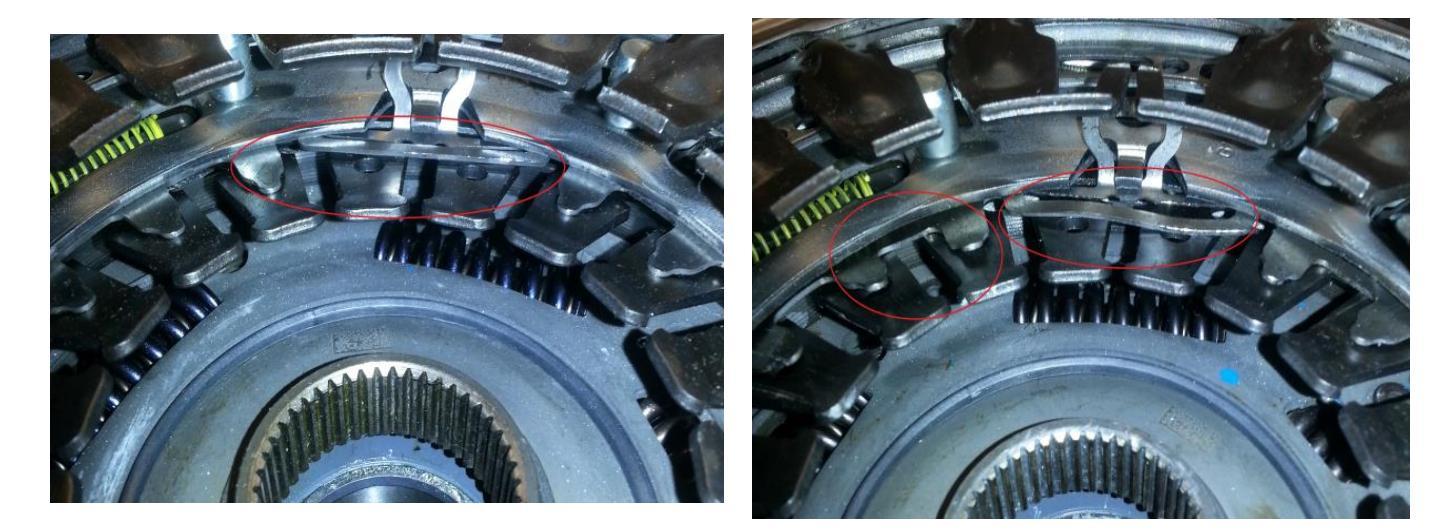
Topic: Clutch 2 Locks

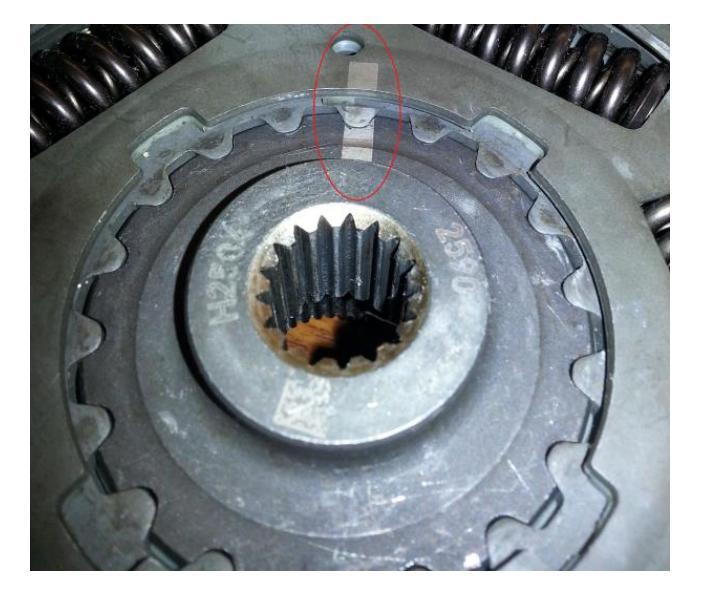
Ex: Improperly aligned clutch 1 hub

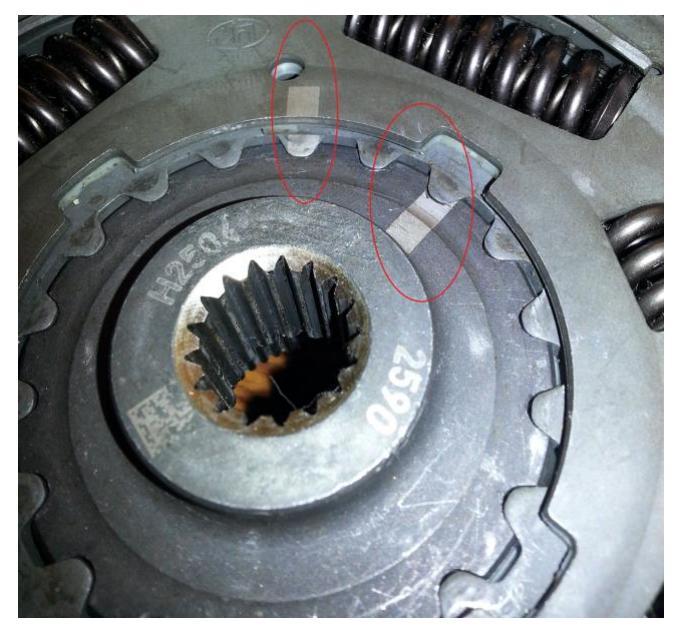
Topic: Clutch Lock Release

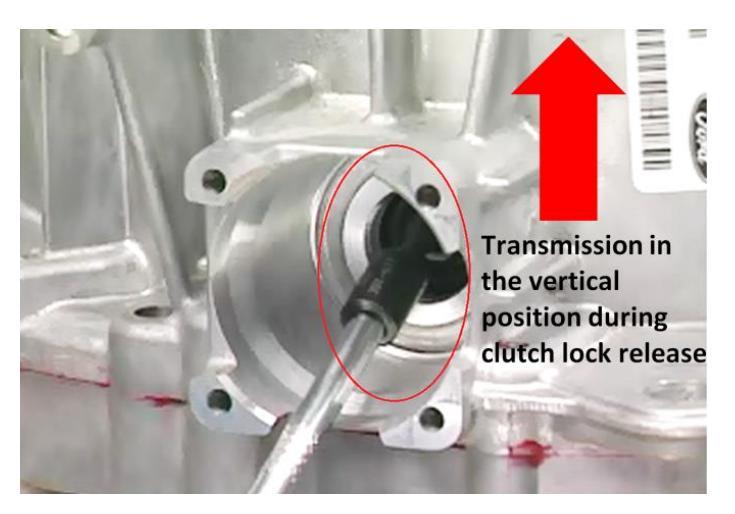
Ex: Improper release of clutch locks

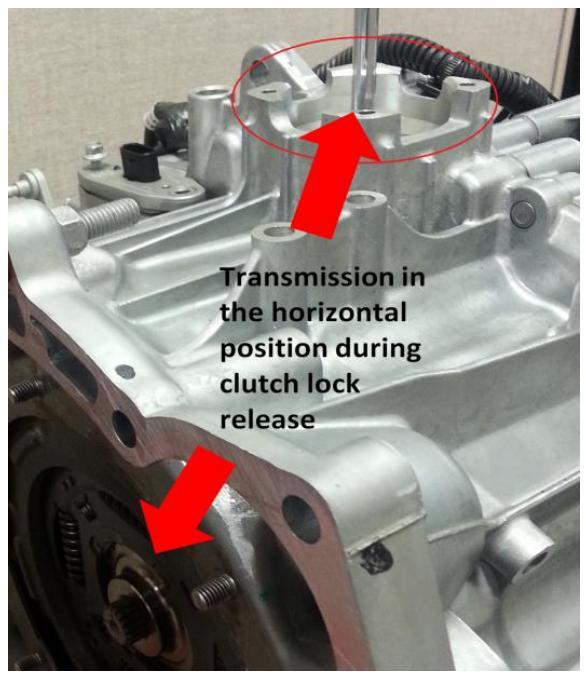
Transmission Installation

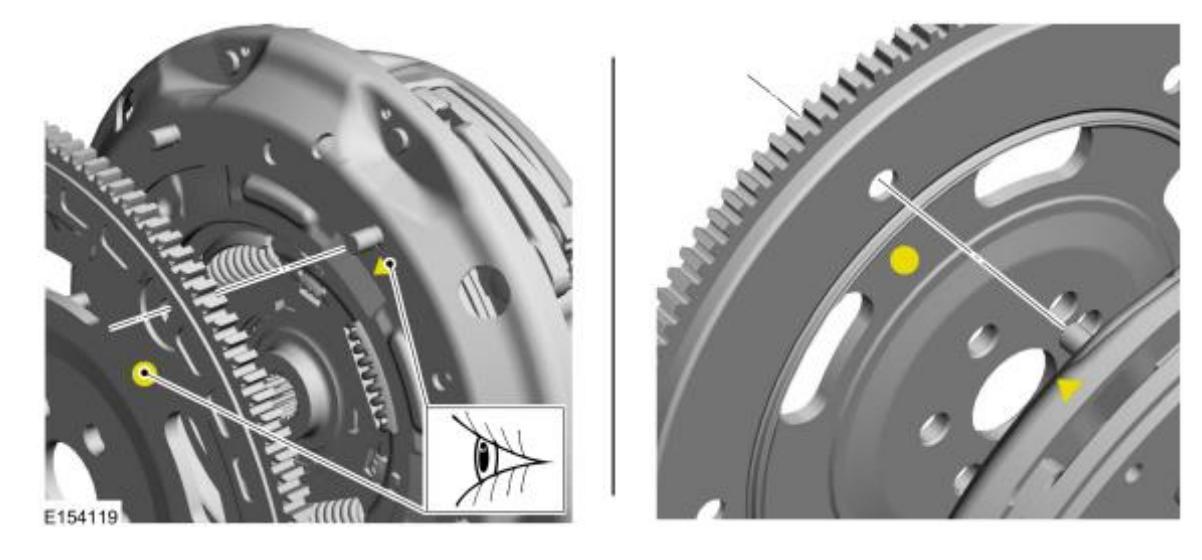
Ex: Properly indexed flexplate and clutch

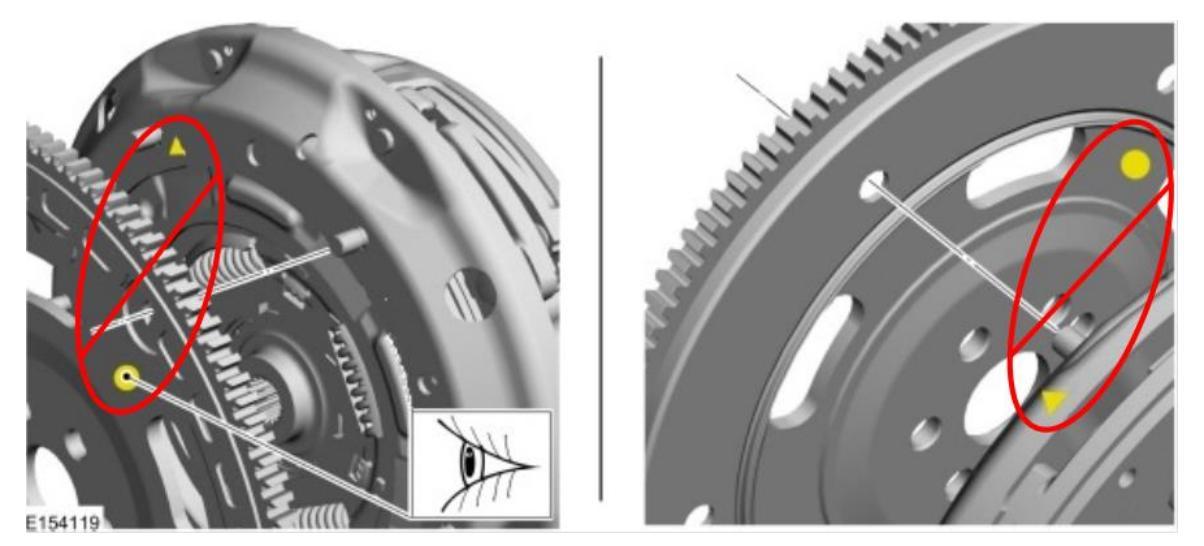
Topic: Flexplate-to-Clutch Seating (Part 1)

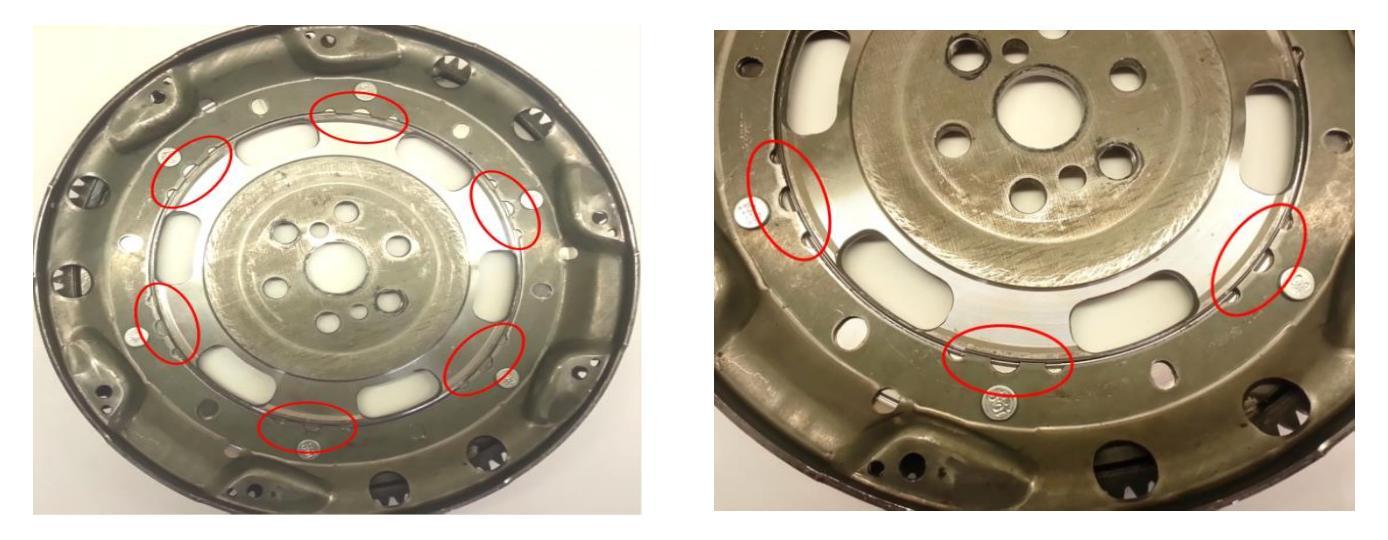
*Clutch has been disassembled to educate Job Aid users about the root cause of post-repair vibrations. During transmission installation, this area of the clutch will not be visible. Pictures used in the examples were taken from the perspective of the clutch facing the engine.

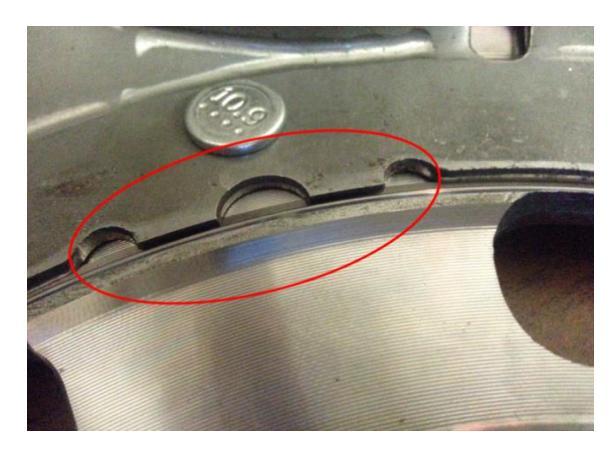
Ex: Properly seated clutch*- Clutch alignment tabs flush on flexplate

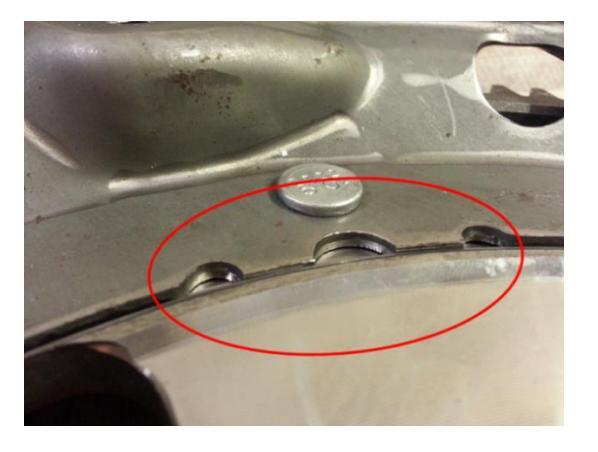
Ex: Improperly seated clutch*- Interference of alignment tabs

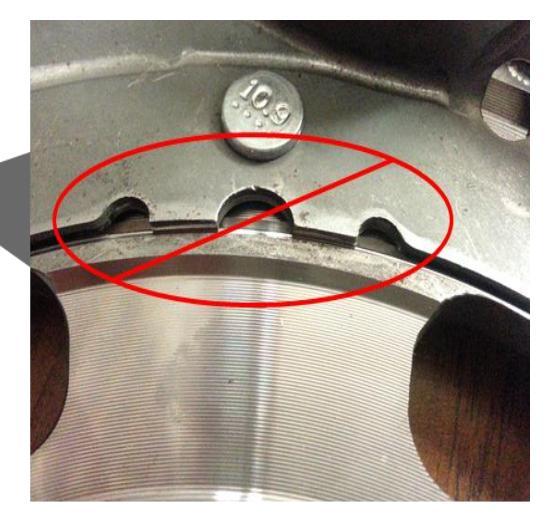
Clutch and flexplate not fully seated

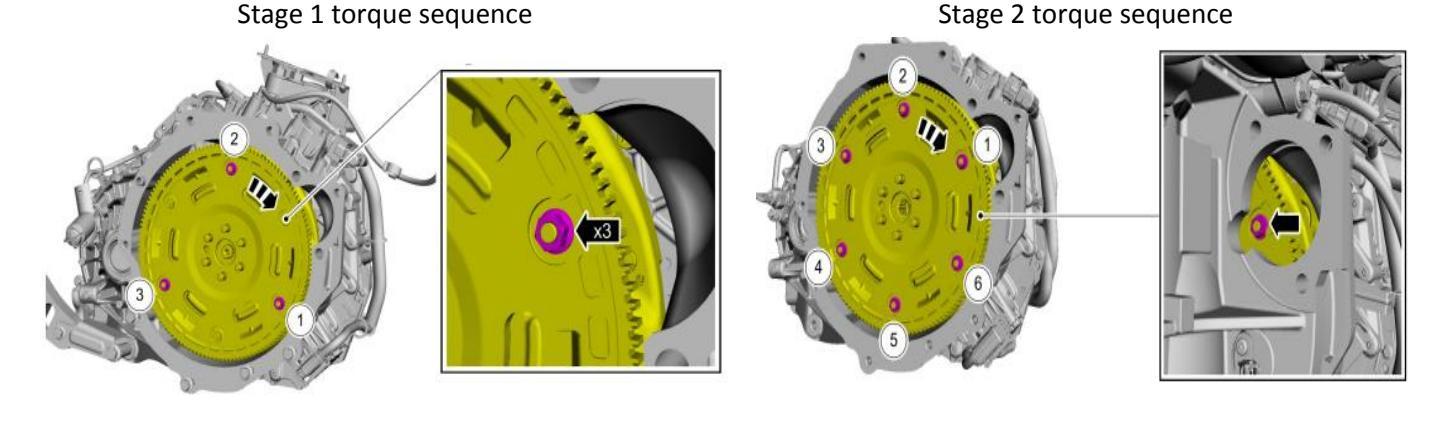
Ex: Proper tightening sequence

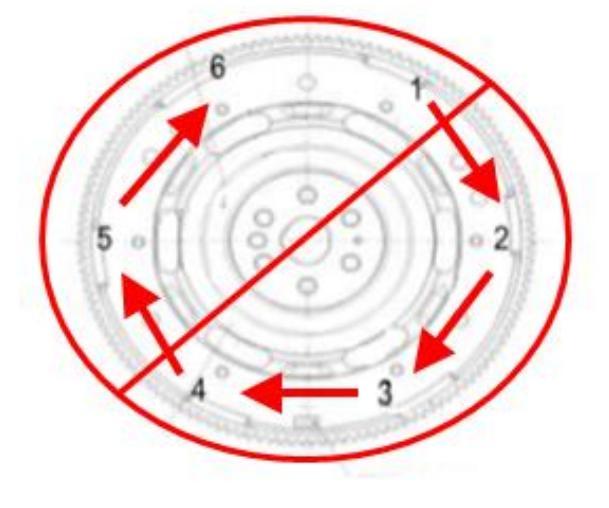
Ex: Improper tightening sequence

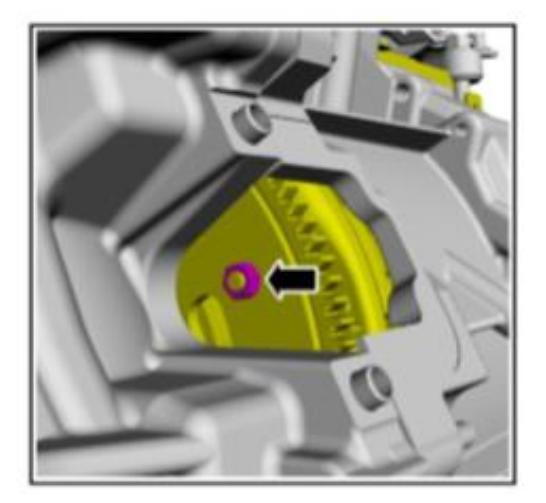
Topic: Roll Restrictor Bolt Installation (Focus Only)
