General Service Bulletin (GSB):	Gasoline Engine oil and coolant leaks at the turbocharger
GSB Overview:	This bulletin provides information on diagnosing gasoline engine oil and coolant leaks at the turbocharger
NOTE: This information is not intended to replace or supersede any warranty, parts and service policy. Work Shop Manual (WSM) procedures or technical

$\mbox{GSB}-\mbox{Gas}$ Engine Oil or Coolant Leak at the Turbocharger V 1.0

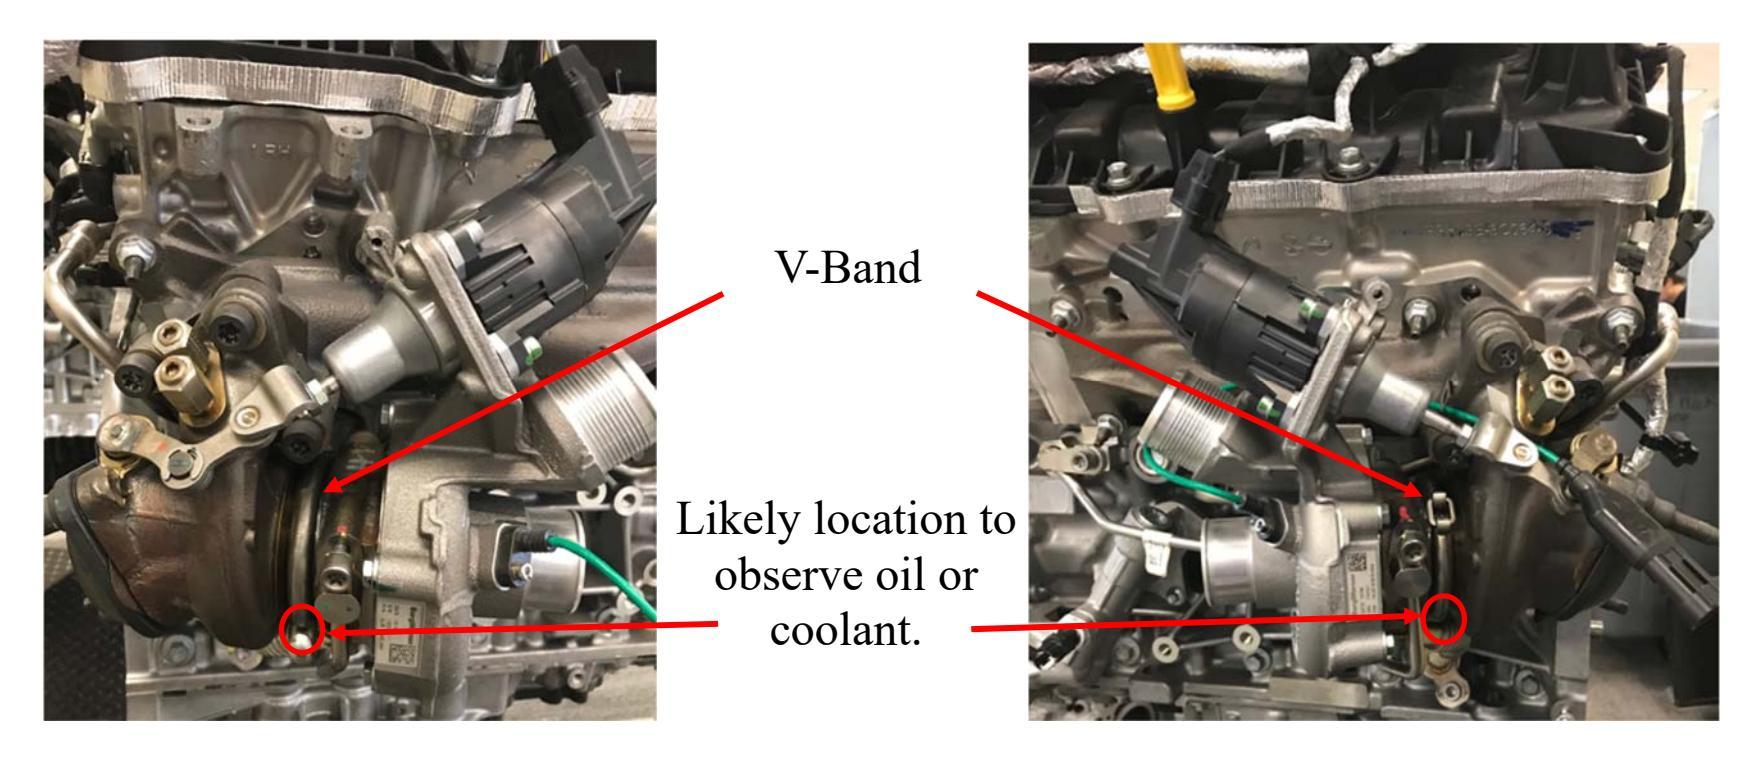
- Oil and coolant may be observed on the external surfaces of turbochargers. This is <u>NOT</u> an indication of a faulty turbocharger.
- Staining or wet oil / coolant dripping may be present on the lower point of the turbocharger v-band.

- Oil and coolant on the external surfaces of the turbocharger may come from several sources
 - o Turbo oil feed/drain line joints
 - o Turbo coolant drain/feed line joints
 - Engine oil fill port drips
 - o Other engine sealing leaks above the turbocharger

• Do <u>NOT</u> replace gasoline engine turbochargers for oil or coolant leaks without first following the appropriate diagnostic procedures within the Workshop Manual.

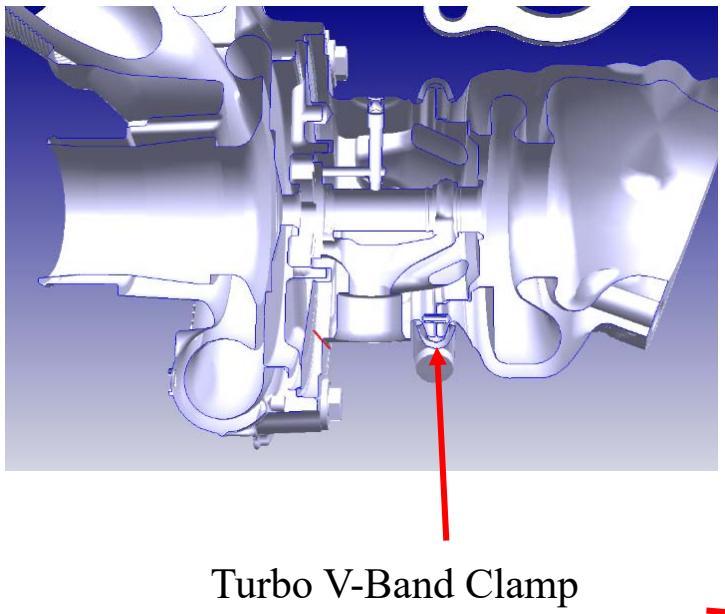
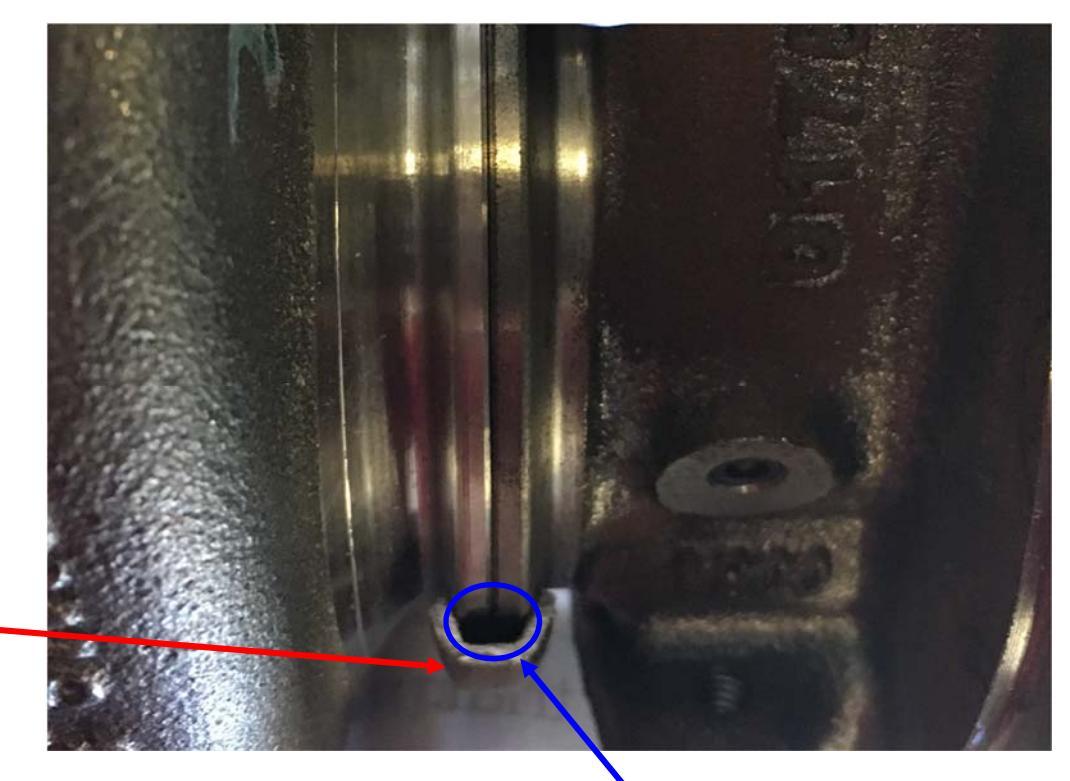
(Oil/Coolant Catch Basin)

• Any oil / coolant leaks from turbo connections / areas higher on the engine can be funneled through the vband making it look like the turbo itself is leaking. This is <u>NOT</u> an indication of a faulty turbocharger.

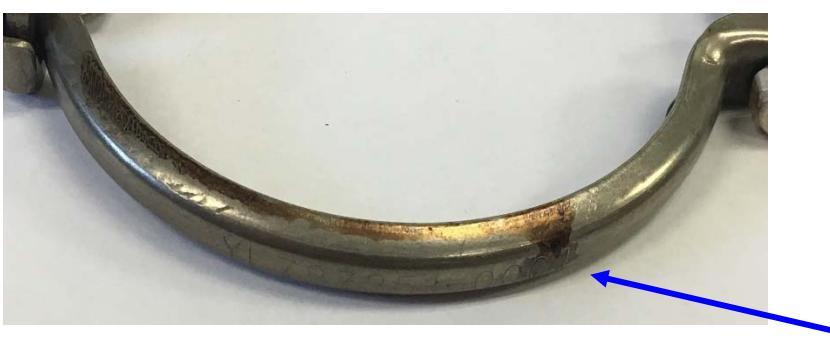
Oil/Coolant may fill the trough created by the inside of the V-Band (circled) from other sources and spill over at the lowest point. This can create the false appearance that the turbocharger is leaking (example of typical staining).

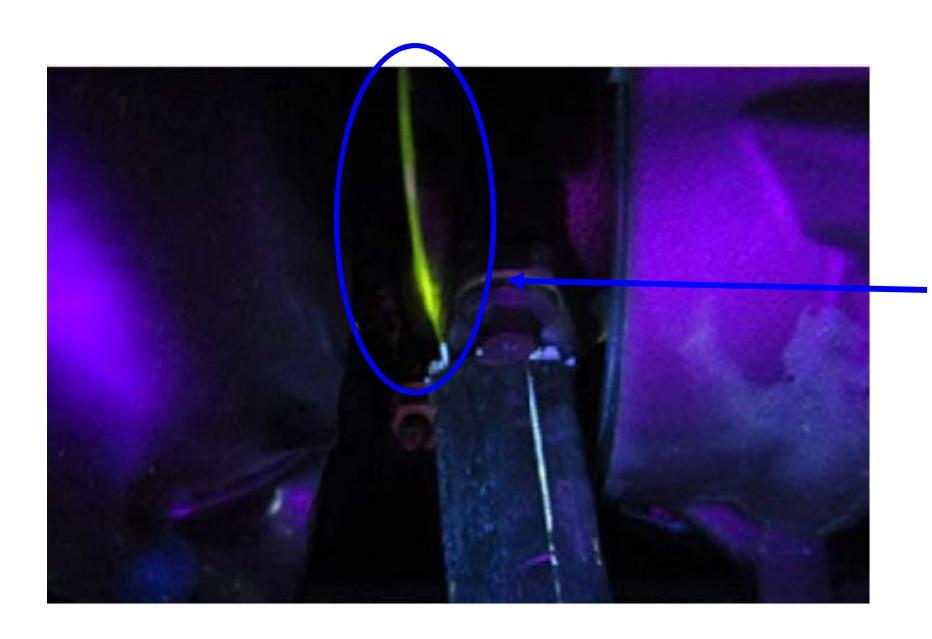
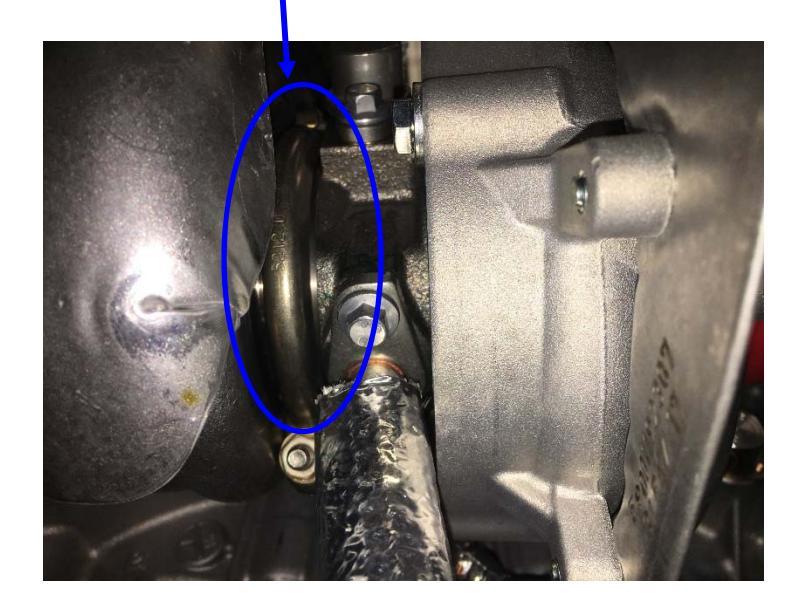
Ford Motor Company Printed Copies Uncontrolled • Oil with dye in it may appear under black light on the turbocharger as a bright yellow mark. The photo below shows a typical indication of oil on the external surface of the turbocharger from an oil feed line leak. This is <u>NOT</u> an indication of a faulty turbocharger.

Same location on turbocharger under black light (upper left) and under normal light (lower right) circled in blue.

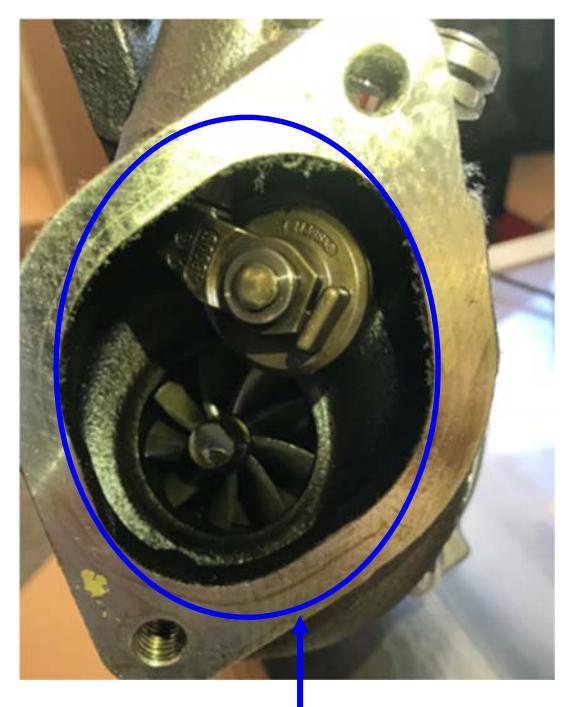
- A film of oil in the turbine or compressor housing is a normal byproduct of engine operation.
- Staining or wet oil / coolant drips may be present in the turbine outlet, compressor inlet, and compressor outlet.
- All these conditions are normal in a turbocharged engine and are **<u>NOT</u>** an indication of a faulty turbocharger.

Oil film / staining in turbine housing outlet to catalyst

• Do <u>NOT</u> replace gasoline engine turbochargers for oil or coolant leaks without first following the appropriate diagnostic procedures within the Workshop Manual.

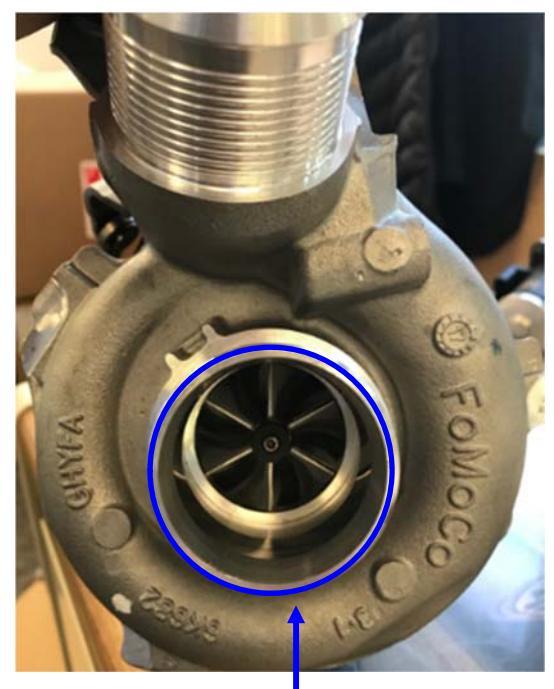
Oil film / staining in compressor housing inlet from fresh air tube

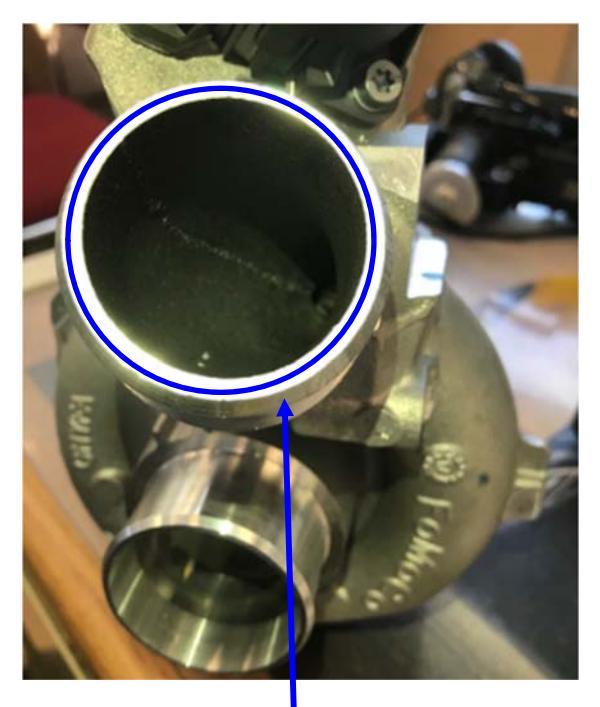
Oil film / staining in compressor housing outlet to high pressure tube
